FRAGMENT OF AN AEGIS OF NEÏTH 1886.305.0096 – LEADED BRONZE

Artefact name	Fragment of an Aegis of Neïth 1886.305.0096
Authors	Line. Pedersen (HE-Arc, Neuchâtel, Neuchâtel, Switzerland) & Christian. Degrigny (HE-Arc CR, Neuchâtel, Neuchâtel, Switzerland) & Valentin. Boissonnas (HE-Arc CR, Neuchâtel, Neuchâtel, Switzerland)
Url	/artefacts/1050/

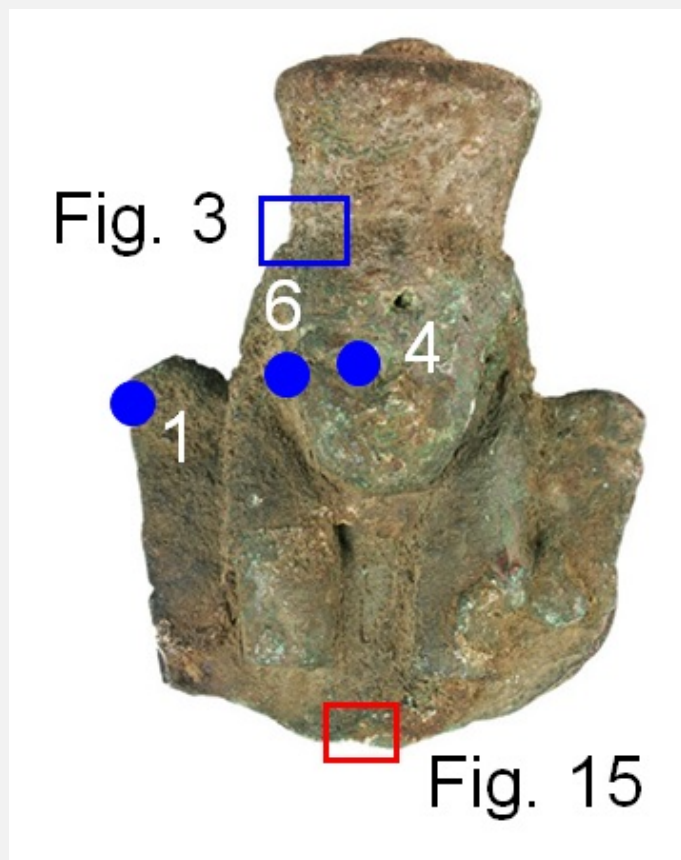
Fig. 2: Front face of the aegis with location of XRF measurements (blue spots), powder sample (red square) and gilding remains on the surface (blue square),

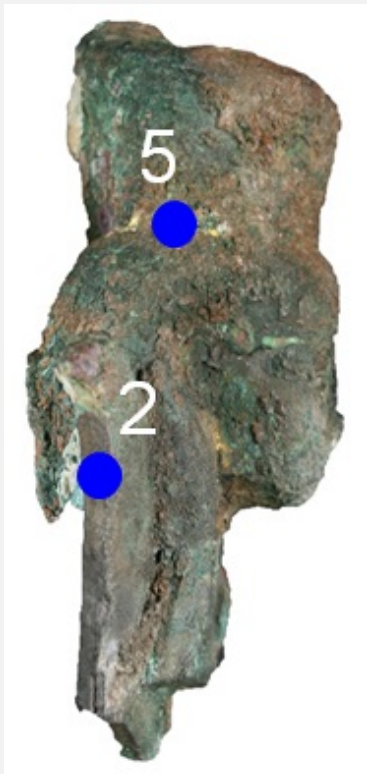
Fig. 4: Side view of the aegis with location of XRF measurements (blue spots),

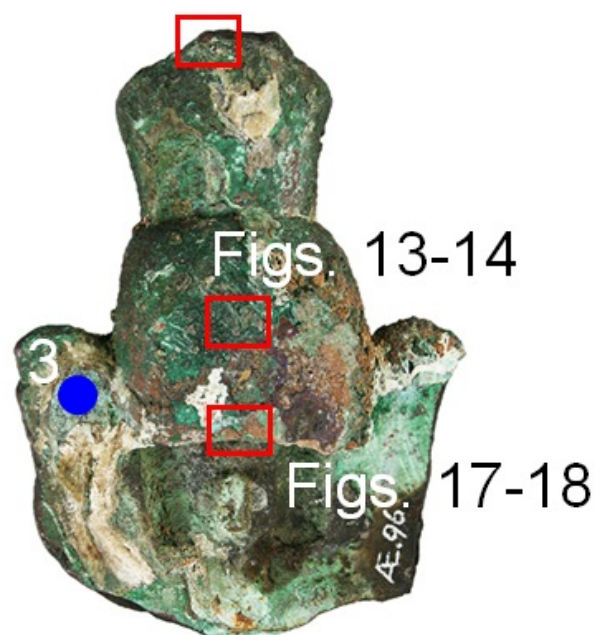
Fig. 5: Back face of the aegis with location of XRF measurement (blue spot) and powder samples (red squares),

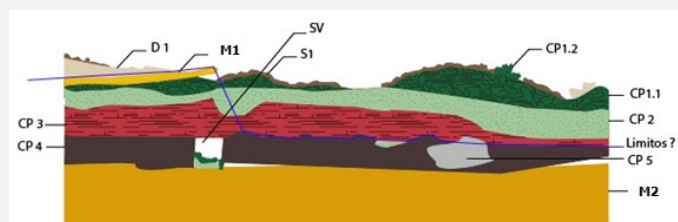
Fig. 6: Preliminary stratigraphy 1, corresponding to the front face of the aegis. S = soil, D = deposit, M = metal, CP = corrosion products, SV = structural void,

Captions	Colour, aspect, hardness and cohesion
S1	Brown, matte, can be scratched with scalpel blade but remains cohesive.
D1	White deposit: shiny, powdery when shaved with scalpel.
M1	Thin gold leaf trapped in corrosion products, brittle, yellow and not adherent.
CP1.1	Dark green corrosion layer, lumpy and matte, thick, hardly scratched by a scalpel blade, cohesive and compact.
CP1.2	Minor stratum of CP1.1. Dark green crystals appearing on the surface of the artefact. Easily scratched under the action a scalpel blade.
CP2	Light green corrosion layer, matte, thick in some places, powdery under the action of a scalpel blade. In some areas it is located directly on CP4.
CP3	Red corrosion layer, lumpy and matte, thick, sometimes hard and sometimes powdery under the action of a scalpel blade.
Limitos	Interface of the limit of the original surface. Shiny, straight and black with manufacturing traces.
CP4	Dark grey with red or green reflection. Shiny, hard, straight, dense and with traces of engraving and possible inlays.

CP5	Isolated white corrosion products: waxy and very soft.
SV	Void in CP4 resulting in loss of the limitos.
M2	Yellow stratum with metallic sheen, dense and hardly scratched by scalpel blade.

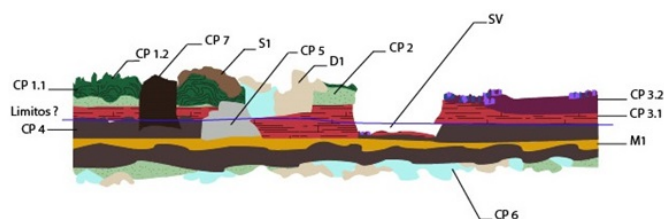
Fig. 7: Preliminary stratigraphy 2, corresponding to the back face of the aegis and interior (below part). S = soil, D = deposit, M = metal, CP = corrosion products, SV = structural void,

Captions	Colour, aspect, hardness and cohesion
S1	Brown, matte, can be scratched with scalpel blade but remains cohesive.
D1	White shiny deposit, powdery when shaved with scalpel.
CP1.1	Dark green corrosion layer, lumpy and matte, thick, hardly scratched by a scalpel blade, cohesive and compact.
CP1.2	Minor stratum of CP1.1. Dark green crystals appearing on the surface of the artefact. Easily scratched by a scalpel blade.
CP2	Light green corrosion layer, matte and thick in some places, powdery under the action of a scalpel blade. Sometimes located directly on CP4.
CP3.1	Red corrosion layer, lumpy and matte, thick, sometimes hard and sometimes powdery under the action of a scalpel blade.
CP3.2	Minor stratum of CP3.1. Purple with blue-purple crystals, hard and cohesive.
Limitos	Interface of the limit of the original surface. Shiny, straight, black, manufacturing traces.
CP4	Dark grey with red or green reflection. Shiny, hard, straight, dense and with traces of engraving and possible inlays.

CP5	Isolated white stratum: waxy and very soft.
CP6	Light blue stratum, chalky. Isolated on the exterior surface and extends on the interior surface.
CP7	Isolated black stratum, very hard, straight and shiny.
SV: Structural Void	Void in CP4, resulting in loss of the limitos. Presence of CP1.2 crystals inside the void.
M1	Yellow stratum with metallic sheen, dense and hardly scratched by scalpel blade.

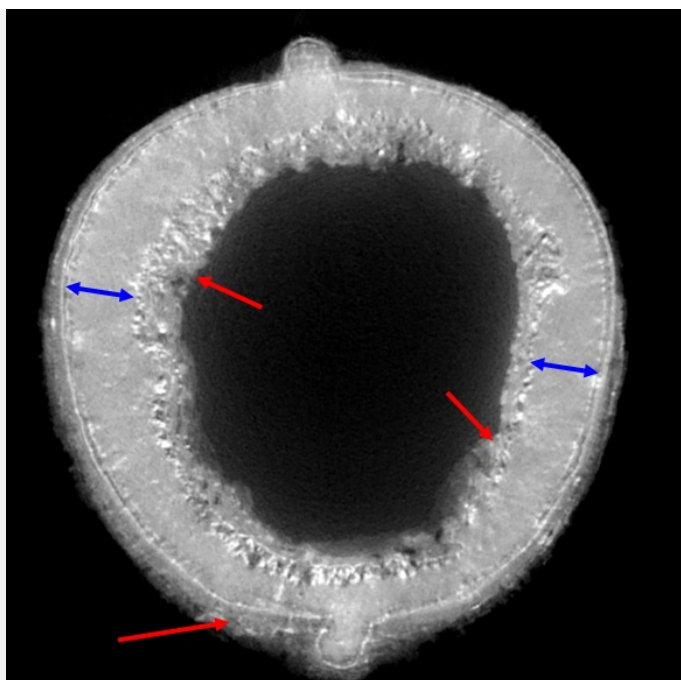
The metal seems to be a leaded bronze with remains of gold leaf on the surface (Table 1).
As indicated by the X-ray tomography, the metal of the aegis seems to be well preserved (Figs. 11-12).

Fig. 11: X-ray tomography by cross section of the crown showing a dense and non-porous metal core (blue arrows). The corrosion products however are porous (red arrows). The external limitos is visible as a fine line preserved under corrosion layers,

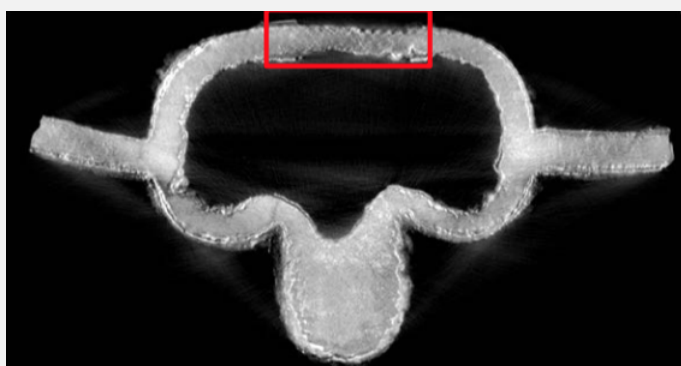
Fig. 12: X-ray tomography by cross section of the lower part showing that there are losses of the original surface (red square),

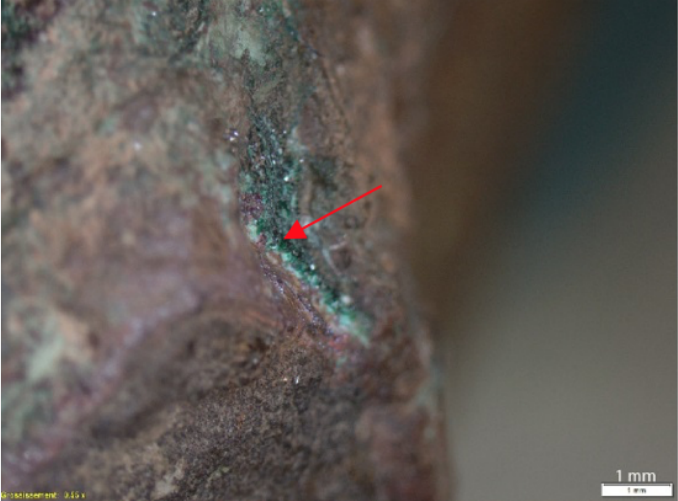
Fig. 13: Observation of the dark green corrosion product,

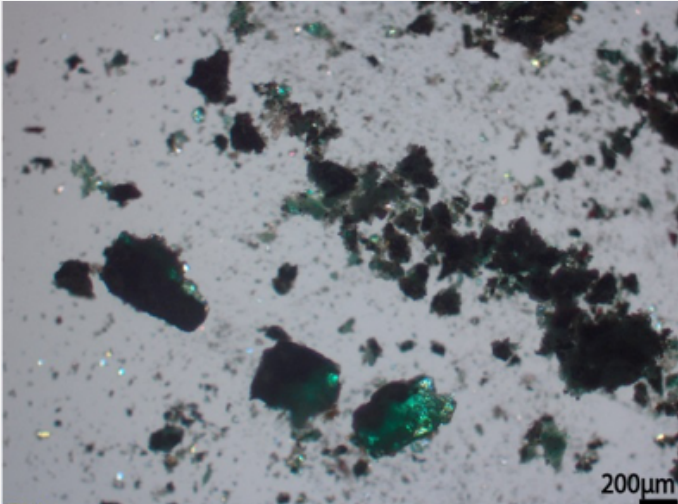
Fig. 14: Dark green corrosion product identified as paratacamite, atacamite Cu2Cl(OH)3 by XRD. Microscopic examination under polarized light,

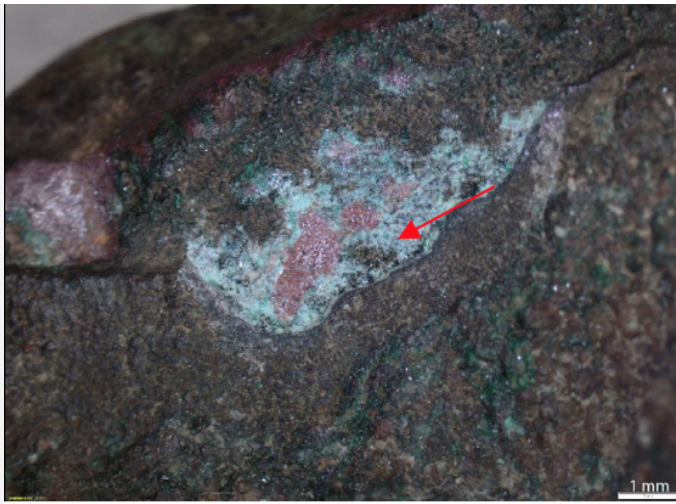
Fig. 15: Observation of the light green corrosion product,

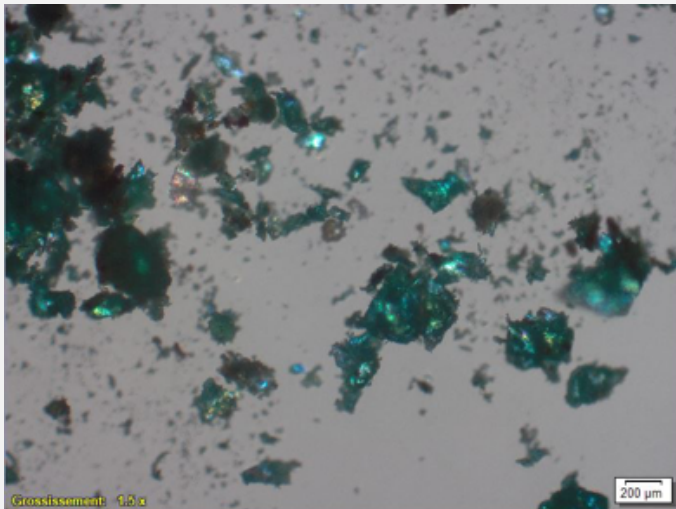
Fig. 16: Light green corrosion product identified as paratacamite, atacamite ($\text{Cu}_2\text{Cl}(\text{OH})_3$) by XRD. Microscopic examination under polarized light,

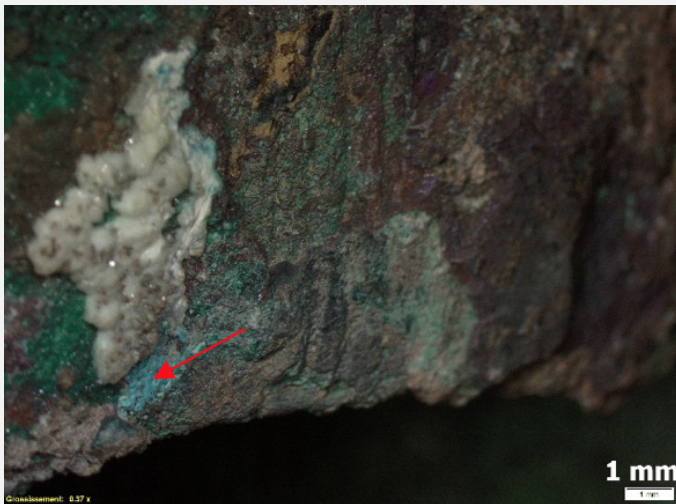
Fig. 17: Observation of the light blue corrosion product,

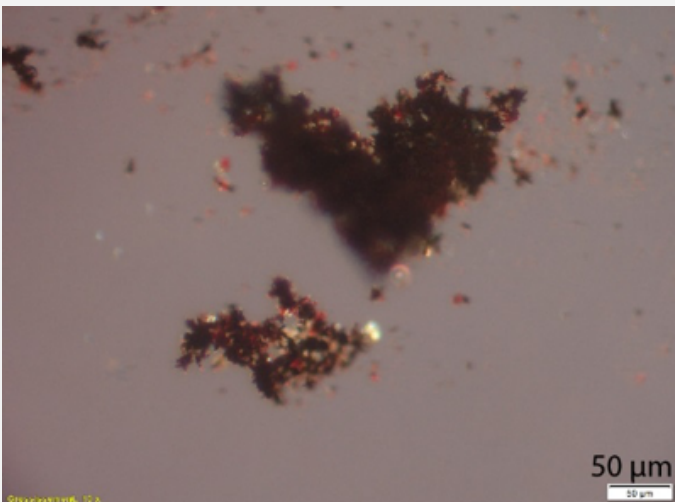
Fig. 20: Dark red corrosion product identified as cuprite Cu_2O as major component and tenorite CuO as minor component. Microscopic examination under polarized light,

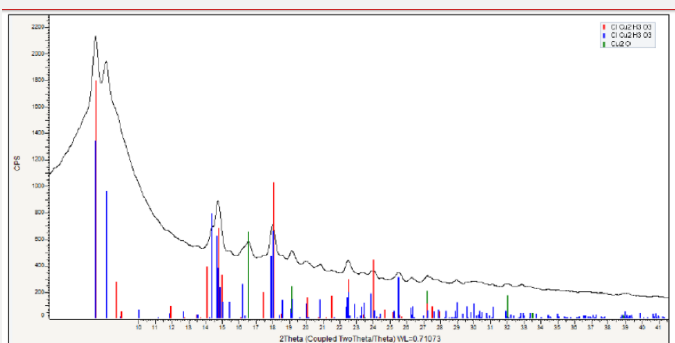
Fig. 21: XRD spectrum of the sample of the dark green corrosion product showing the presence of atacamite and paratacamite ($\text{Cu}_2\text{Cl}(\text{OH})_3$) as major compound and cuprite (Cu_2O) as minor compound,

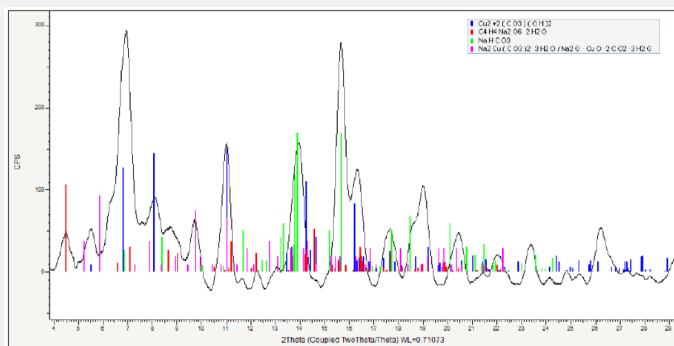
Fig. 23: XRD spectrum of the sample from the light blue corrosion product showing the presence of chalconatronite ($\text{Na}_2\text{Cu}(\text{CO}_3)_2 \cdot 3\text{H}_2\text{O}$). The other compounds are analysis supposition, but are not relevant,

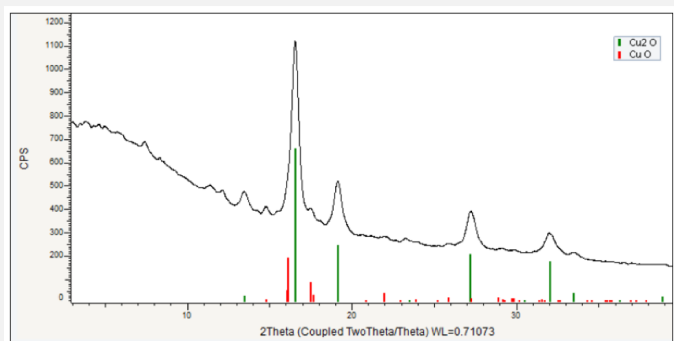
Fig. 24: XRD spectrum of the sample from the dark red corrosion product showing the presence of cuprite (Cu_2O) as major compound and tenorite (CuO) as minor compound,
