FRAGMENT OF AN AEGIS OF NEÏTH 1886.305.0096 – LEADED BRONZE

Artefact name Fragment of an Aegis of Neïth 1886.305.0096

Authors Line. Pedersen (HE-Arc, Neuchâtel, Neuchâtel, Switzerland) & Christian. Degrigny (HE-Arc CR, Neuchâtel, Neuchâtel, Switzerland) & Valentin. Boissonnas (HE-Arc CR, Neuchâtel, Neuchâtel, Switzerland)

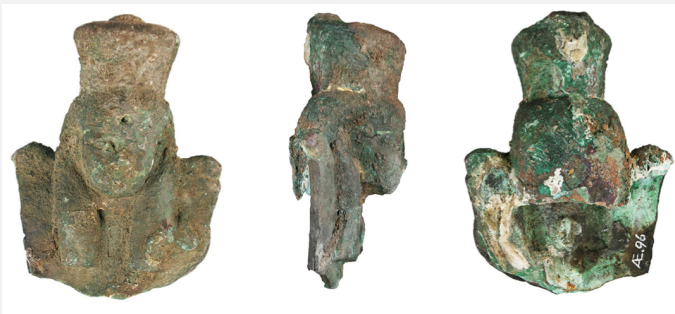
Fig. 1: Fragment of an Aegis of Neïth. From left to right: front, side view and back respectively,

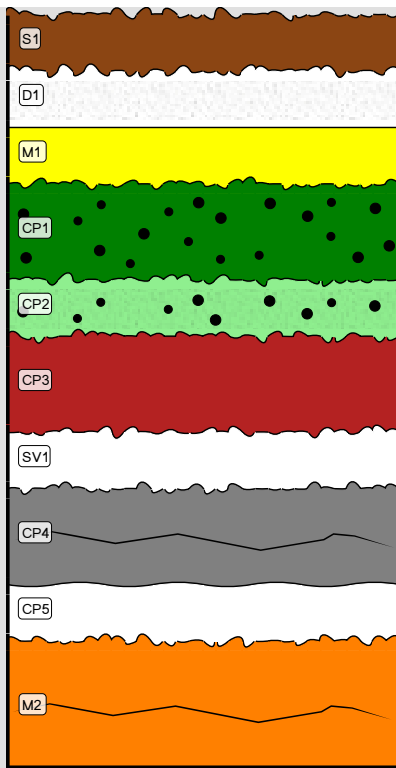
Fig.9: Schematic representation combining stratigraphies 1 and 2 under binocular microscope and using the MiCorr application. The characteristics of the strata are only accessible by clicking on the drawing that redirects you to the search tool by stratigraphy representation, Credit He-Arc CR, L.Pedersen.

The metal (M2 in Fig.9 and M1 in Fig. 10) was analysed on the broken edge of the bottom of the artefact where despite a highly corroded surface, the metal seems to be the best preserved. The XRF analyses revealed that the metal is a leaded bronze with remains of gold leaf on the surface (Table 1, Au was detected in the measurement spots 4,5 and 6) (Scott 2002; Gouda 2012; Mohammed 2012).

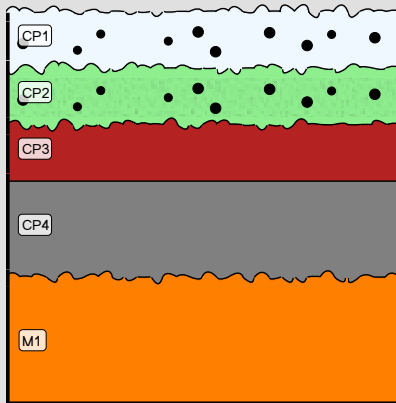
Fig.10: Schematic representation of stratigraphy 3 under binocular microscope and using the MiCorr application. CP1 is CP6 in Fig. 8. The characteristics of the strata are only accessible by clicking on the drawing that redirects you to the search tool by stratigraphy representation, Credit He-Arc CR, L. Pedersen.
