RING SMRA 16-17285-01 - CU ALLOY - ROMAN TIMES - SWITZERLAND

Artefact name	Ring SMRA 16-17285-01
Authors	Christian. Degrigny (HE-Arc CR, Neuchâtel, Neuchâtel, Switzerland) & Naima. Gutknecht (HE-Arc CR, Neuchâtel, Neuchâtel, Switzerland) & Valentina. Valbi (Laboratoire Métallurgie et Culture LMC-IRAMAT-CNRS-UTBM, Belfort, Franche-Comté, France)
Url	/artefacts/1102/

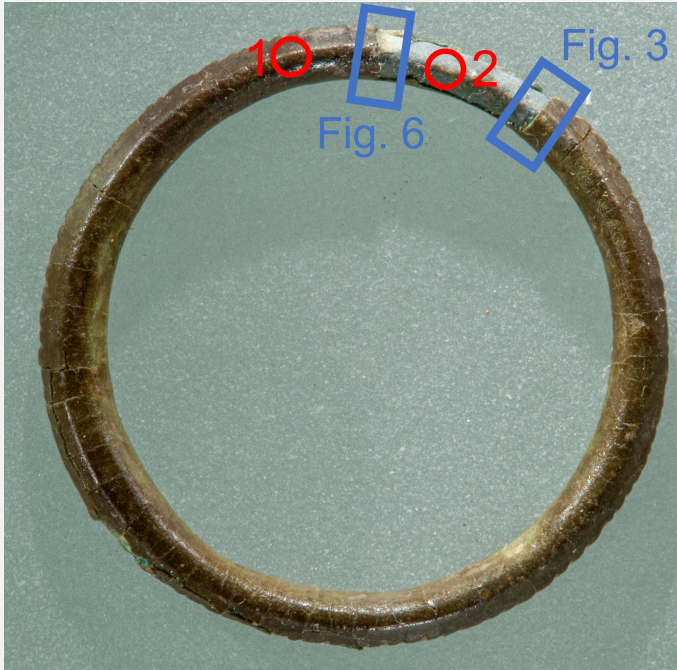
Fig. 2: Location of XRF analyses (red circles), Fig. 3 (blue square) and Fig. 6 (Raman spectroscopy (blue square)) on face A,

XRF analysis was carried out without sampling. For point 1, all strata (soil, corrosion products, and metal) are analyzed at the same time. As for point 2, the analysis was performed where corrosion layers flaked. Therefore, it reflects better the metal composition. The metal is presumably a copper-tin alloy with some lead, while the Si, Fe, Al and P are probably coming from the burial environment. The higher amount of tin on point 1 (with corrosion layers) than on point 2 (corrosion structure flaked, metal visible) is a strong indicator of tin enrichment on the corrosion layers.

Table 2: Chemical composition analysed with handheld XRF at the surface of the ring for two representative points shown in Fig.2. The results are rounded up to the nearest whole number.

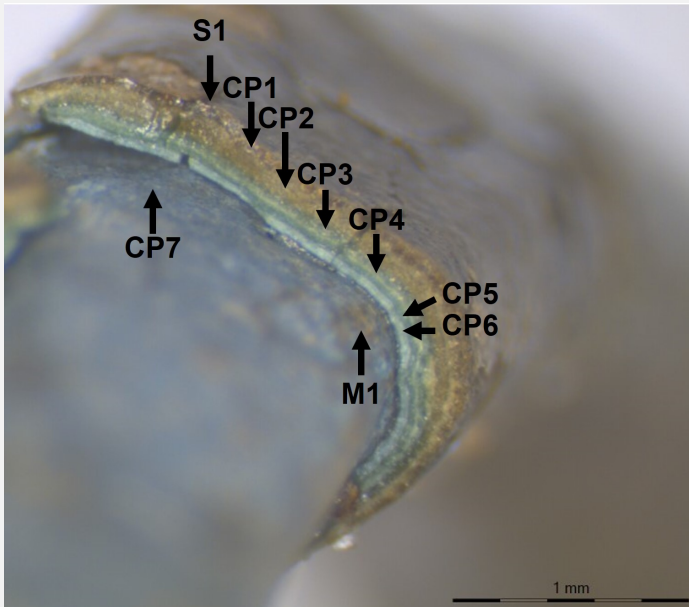
Fig. 3: Description of the corrosion structure,

The schematic representation below gives an overview of the corrosion structure encountered on the ring from a first visual macroscopic observation. There are cracks through CP1 to CP6 that generate the flaking of the layers.

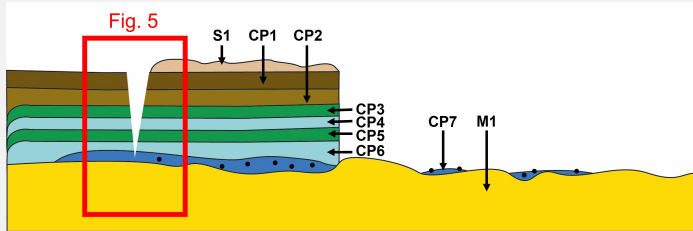
Fig. 4: Stratigraphic representation of the corrosion structure of the ring by macroscopic and binocular observation with indication of the corrosion structure used to build the MiCorr stratigraphy of Fig. 5 (red rectangular),

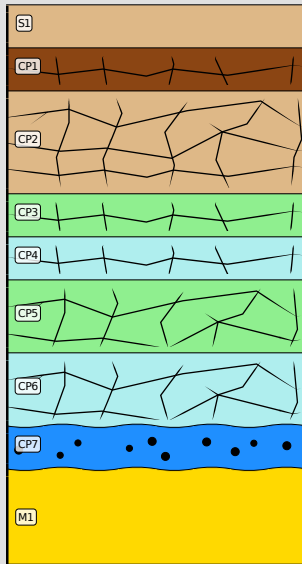
Fig. 5: Stratigraphic representation of the corrosion structure of the ring observed macroscopically under binocular using the MiCorr application with reference to Fig. 4. The characteristics of the strata, such a discontinuity, are accessible by clicking on the drawing that redirects you to the search tool by stratigraphy representation, Credit HE-Arc CR, N.Gutknecht.

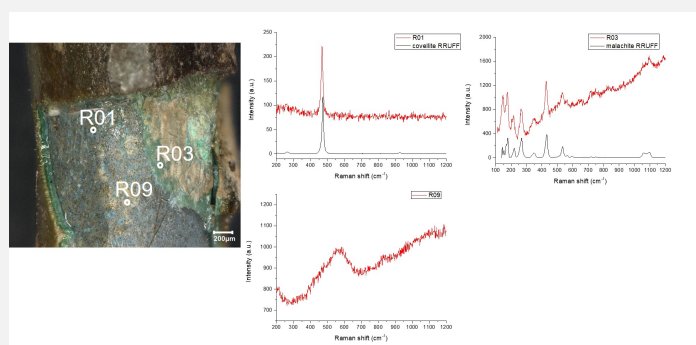
It was not possible to sample this artefact. Therefore, μ -Raman point analyses were performed on the surface of the object in an area where different strata of corrosion products were exposed, as shown in Fig. 6 in a micrograph taken by optical microscopy. The surface of the object appears brown (CP1). It covers a green stratum (CP5) and a blue/golden one (CP7 and M1) with black spots in it. The R01 analysis point was performed on one of the blackspots observed in the blue stratum and can be identified as covellite (CuS) by comparison with a reference spectrum. Point analyses performed on the blue (CP7) and golden stratum showed a spectrum with a large peak at around 560 cm^{-1} (R09) that can be identified as nanocassiterite (SnO2) by comparison with the work of Ospitali et al. 2012. The R03 point analysis was performed on the green stratum (CP5) and is identified as malachite (Cu2(CO3)(OH)2) by comparison with a reference spectrum.

Fig. 6: Raman points of analysis on the surface of the object and Raman spectra obtained for R01 (together with the covellite reference spectrum RRUFFID=R060306), R03 (together with the malachite reference spectrum RRUFFID=R050508) and R09,

The ring is a tin bronze probably with some lead. The identification of nanocassiterite as the most internal CP shows a phenomenon of decuprification typical of bronze corrosion, accompanied by the formation of copper hydroxycarbonate as a more external CP. The dark inclusions observed in the CP7 and identified as covellite are likely to be residuals of copper sulfide inclusions from the metal microstructure.
