RING SMRA 16-17285-01 - CU ALLOY - ROMAN TIMES - SWITZERLAND

Artefact name	Ring SMRA 16-17285-01
Authors	Christian. Degriigny (HE-Arc CR, Neuchâtel, Neuchâtel, Switzerland) & Naima. Gutknecht (HE-Arc CR, Neuchâtel, Neuchâtel, Switzerland) & Valentina. Valbi (Laboratoire Métallurgie et Culture LMC-IRAMAT-CNRS-UTBM, Belfort, Franche-Comté, France)
Url	/artefacts/1102/

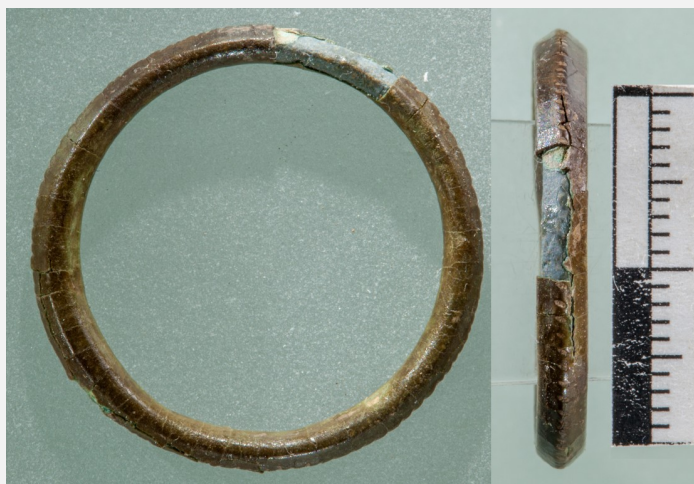
Fig. 1: Ring (face A and side views),

Description of the artefact	Ring with a diamond-shaped cross-section and decorated with ridges on the outside. Its original shape seems to be preserved although the brown corrosion structure is heavily cracked and even has a large lacuna on face A (Fig. 1). Diameter (external) = 2.5cm.
Type of artefact	Jewellery
Origin	Avenches, Switzerland, Avenches, Vaud, Switzerland
Recovering date	2016
Chronology category	Roman Times
chronology tpq	<input type="text"/> ---- ▾
chronology taq	<input type="text"/> ---- ▾
Chronology comment	
Burial conditions / environment	Soil
Artefact location	Site et musée romains Avenches, Avenches, Vaud
Owner	Site et musée romains Avenches, Avenches, Vaud
Inv. number	SMRA 16/17285-01
Recorded conservation data	Cleaning of soil with ethanol and consolidation with resin paraloid B72 in ethyl acetate. Drying at 50°C.

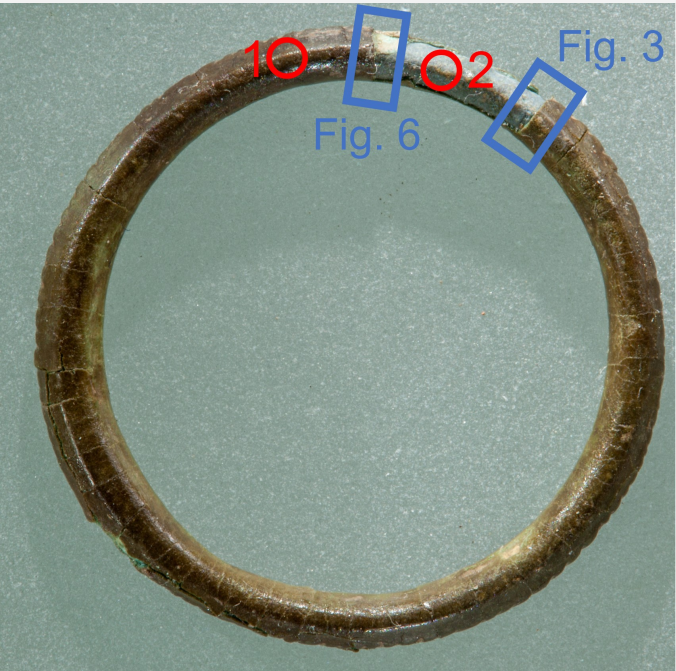
Fig. 2: Location of XRF analyses (red circles), Fig. 3 (blue square) and Fig. 6 (Raman spectroscopy (blue square)) on face A,

XRF analysis was carried out without sampling. For point 1, all strata (soil, corrosion products, and metal) are analyzed at the same time. As for point 2, the analysis was performed where corrosion layers flaked. Therefore, it reflects better the metal composition. The metal is presumably a copper-tin alloy with some lead, while the Si, Fe, Al and P are probably coming from the burial environment. The higher amount of tin on point 1 (with corrosion layers) than on point 2 (corrosion structure flaked, metal visible) is a strong indicator of tin enrichment on the corrosion layers.

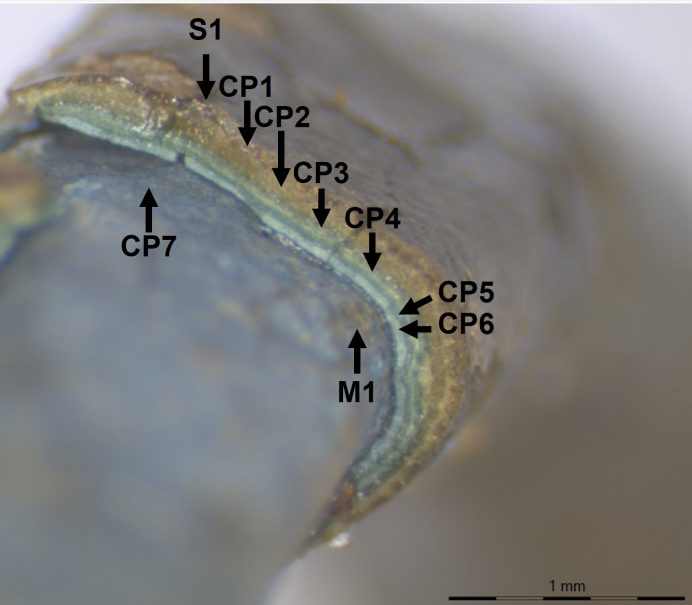
Fig. 3: Description of the corrosion structure,

The schematic representation below gives an overview of the corrosion structure encountered on the ring from a first visual macroscopic observation. There are cracks through CP1 to CP6 that generate the flaking of the layers.

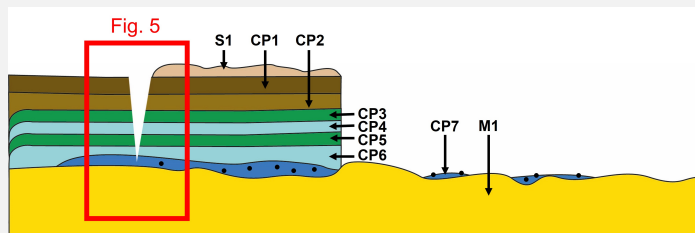
Fig. 4: Stratigraphic representation of the corrosion structure of the ring by macroscopic and binocular observation with indication of the corrosion structure used to build the MiCorr stratigraphy of Fig. 5 (red rectangular),

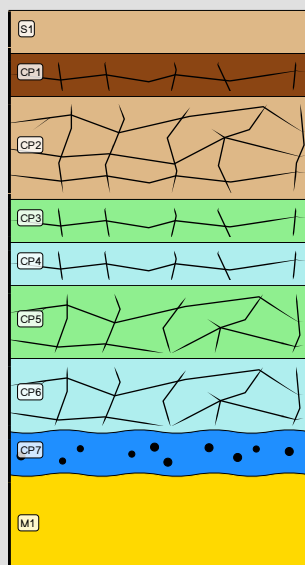
Fig. 5: Stratigraphic representation of the corrosion structure of the ring observed macroscopically under binocular using the MiCorr application with reference to Fig. 4. The characteristics of the strata, such a discontinuity, are accessible by clicking on the drawing that redirects you to the search tool by stratigraphy representation, Credit HE-Arc CR, N.Gutknecht.

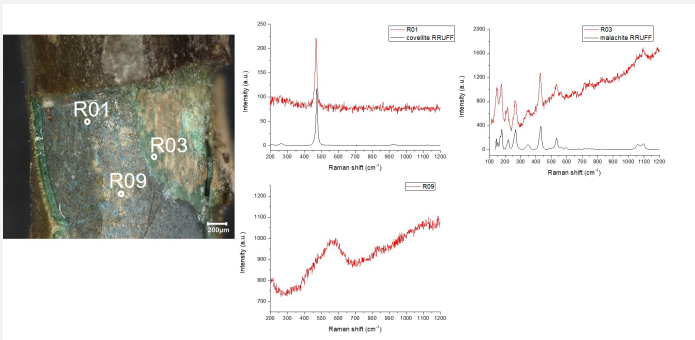
It was not possible to sample this artefact. Therefore, μ -Raman point analyses were performed on the surface of the object in an area where different strata of corrosion products were exposed, as shown in Fig. 6 in a micrograph taken by optical microscopy. The surface of the object appears brown (CP1). It covers a green stratum (CP5) and a blue/golden one (CP7 and M1) with black spots in it. The R01 analysis point was performed on one of the blackspots observed in the blue stratum and can be identified as covellite (CuS) by comparison with a reference spectrum. Point analyses performed on the blue (CP7) and golden stratum showed a spectrum with a large peak at around 560 cm^{-1} (R09) that can be identified as nanocassiterite (SnO_2) by comparison with the work of Ospitali et al. 2012. The R03 point analysis was performed on the green stratum (CP5) and is identified as malachite ($\text{Cu}_2(\text{CO}_3)(\text{OH})_2$) by comparison with a reference spectrum.

Fig. 6: Raman points of analysis on the surface of the object and Raman spectra obtained for R01 (together with the covellite reference spectrum RRUFFID=R060306), R03 (together with the malachite reference spectrum RRUFFID=R050508) and R09,

The ring is a tin bronze probably with some lead. The identification of nanocassiterite as the most internal CP shows a phenomenon of decuprification typical of bronze corrosion, accompanied by the formation of copper hydroxycarbonate as a more external CP. The dark inclusions observed in the CP7 and identified as covellite are likely to be residuals of copper sulfide inclusions from the metal microstructure.
