## RING SMRA 16-17285-01 – CU ALLOY – ROMAN TIMES – SWITZERLAND

Artefact name	Ring SMRA 16-17285-01
Authors	Christian. Degriigny (HE-Arc CR, Neuchâtel, Neuchâtel, Switzerland) & Naima. Gutknecht (HE-Arc CR, Neuchâtel, Neuchâtel, Switzerland) & Valentina. Valbi (Laboratoire Métallurgie et Culture LMC-IRAMAT-CNRS-UTBM, Belfort, Franche-Comté, France)
Url	/artefacts/1102/

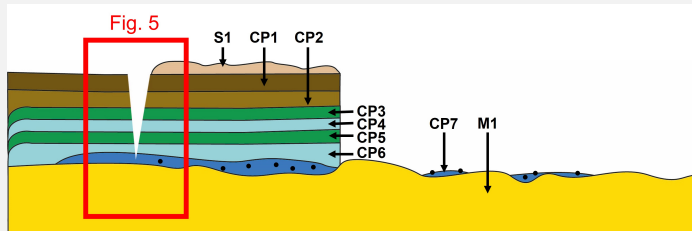
Fig. 4: Stratigraphic representation of the corrosion structure of the ring by macroscopic and binocular observation with indication of the corrosion structure used to build the MiCorr stratigraphy of Fig. 5 (red rectangular),

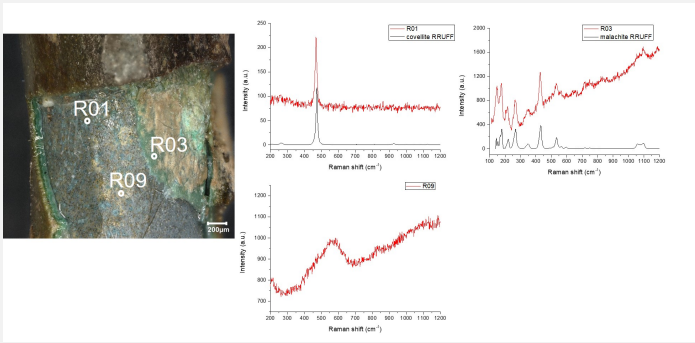
It was not possible to sample this artefact. Therefore,  $\mu$ -Raman point analyses were performed on the surface of the object in an area where different strata of corrosion products were exposed, as shown in Fig. 6 in a micrograph taken by optical microscopy. The surface of the object appears brown (CP1). It covers a green stratum (CP5) and a blue/golden one (CP7 and M1) with black spots in it. The R01 analysis point was performed on one of the blackpots observed in the blue stratum and can be identified as covellite ( $\text{CuS}$ ) by comparison with a reference spectrum. Point analyses performed on the blue (CP7) and golden stratum showed a spectrum with a large peak at around  $560\text{ cm}^{-1}$  (R09) that can be identified as nanocassiterite ( $\text{SnO}_2$ ) by comparison with the work of Ospitali et al. 2012. The R03 point analysis was performed on the green stratum (CP5) and is identified as malachite ( $\text{Cu}_2(\text{CO}_3)(\text{OH})_2$ ) by comparison with a reference spectrum.

Fig. 6: Raman points of analysis on the surface of the object and Raman spectra obtained for R01 (together with the covellite reference spectrum RRUFFID=R060306), R03 (together with the malachite reference spectrum RRUFFID=R050508) and R09,
