RING SMRA 16-17285-01 - CU ALLOY - ROMAN TIMES - SWITZERLAND

Artefact name	Ring SMRA 16-17285-01
Authors	Christian. Degrigny (HE-Arc CR, Neuchâtel, Neuchâtel, Switzerland) & Naima. Gutknecht (HE-Arc CR, Neuchâtel, Neuchâtel, Switzerland) & Valentina. Valbi (Laboratoire Métallurgie et Culture LMC-IRAMAT-CNRS-UTBM, Belfort, Franche-Comté, France)
Url	/artefacts/1103/

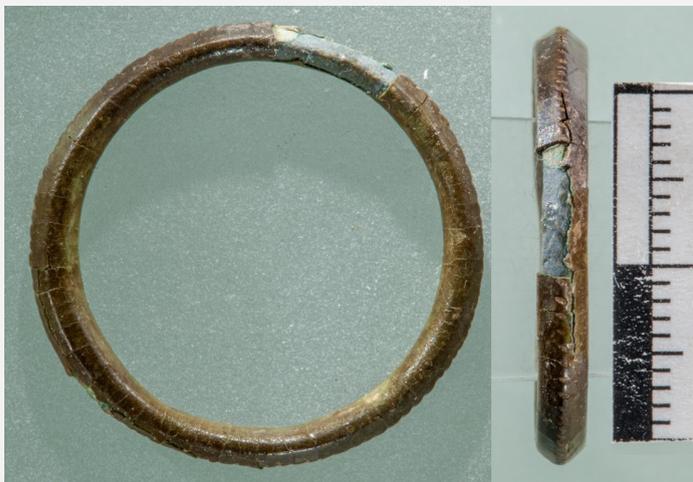
Fig. 1: Ring (face A and side views),

Description of the artefact	Ring with a diamond-shaped cross-section and decorated with ridges on the outside. Its original shape seems to be preserved although the brown corrosion structure is heavily cracked and even has a large lacuna on face A (Fig. 1). Diameter (external) = 2.5cm.
Type of artefact	Jewellery
Origin	Avenches, Switzerland, Avenches, Vaud, Switzerland
Recovering date	2016
Chronology category	Roman Times
chronology tpq	<input type="text"/> ---- ▾
chronology taq	<input type="text"/> ---- ▾
Chronology comment	
Burial conditions / environment	Soil
Artefact location	Site et musée romains Avenches, Avenches, Vaud
Owner	Site et musée romains Avenches, Avenches, Vaud
Inv. number	SMRA 16/17285-01
Recorded conservation data	Cleaning of soil with ethanol and consolidation with resin paraloid B72 in ethyl acetate. Drying at 50°C.

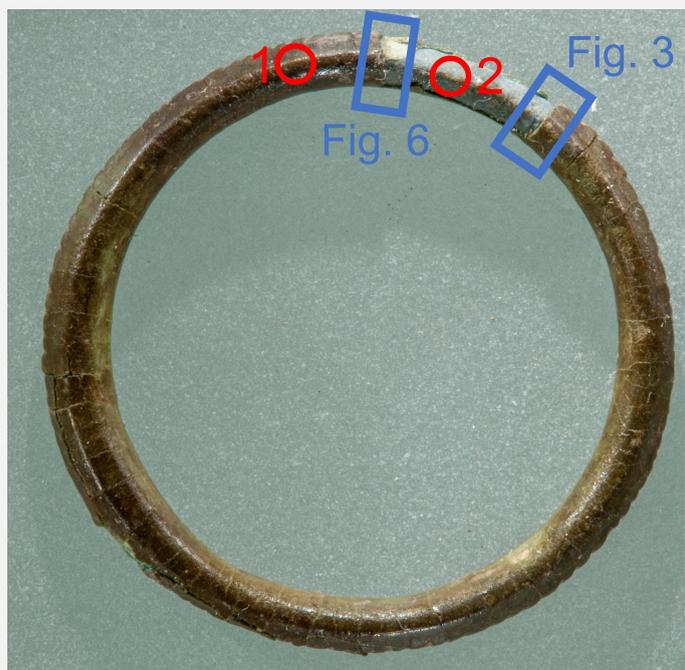
Fig. 2: Location of XRF analyses (red circles), Fig. 3 (blue square) and Fig. 6 (Raman spectroscopy (blue square)) on face A,

XRF analysis was carried out without sampling. For point 1, all strata (soil, corrosion products, and metal) are analyzed at the same time. As for point 2, the analysis was performed where corrosion layers flaked. Therefore, it reflects better the metal composition. The metal is presumably a copper-tin alloy with some lead, while the Si, Fe, Al and P are probably coming from the burial environment. The higher amount of tin on point 1 (with corrosion layers) than on point 2 (corrosion structure flaked, metal visible) is a strong indicator of tin enrichment on the corrosion layers.

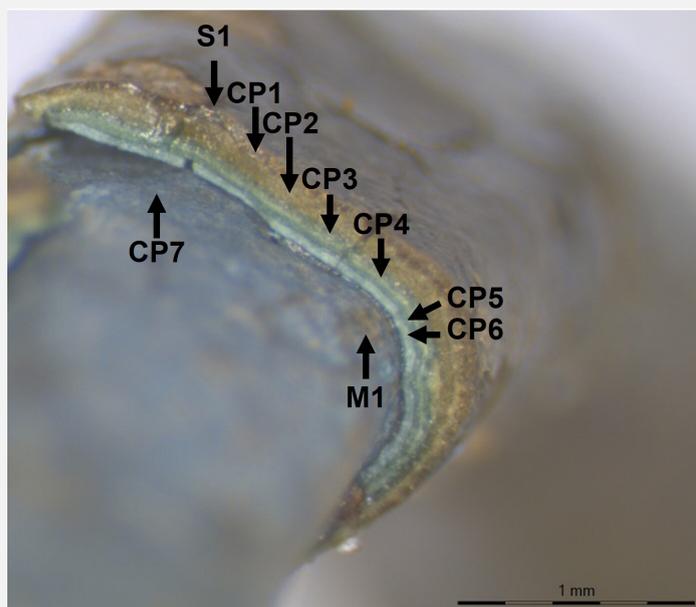
Fig. 3: Description of the corrosion structure,

The schematic representation below gives an overview of the corrosion structure encountered on the ring from a first visual macroscopic observation. There are cracks through CP1 to CP6 that generate the flaking of the layers.

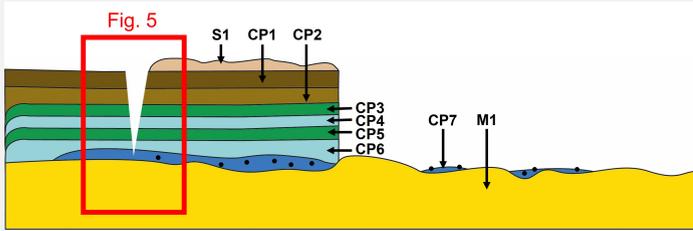
Fig. 4: Stratigraphic representation of the corrosion structure of the ring by macroscopic and binocular observation with indication of the corrosion structure used to build the MiCorr stratigraphy of Fig. 5 (red rectangular),

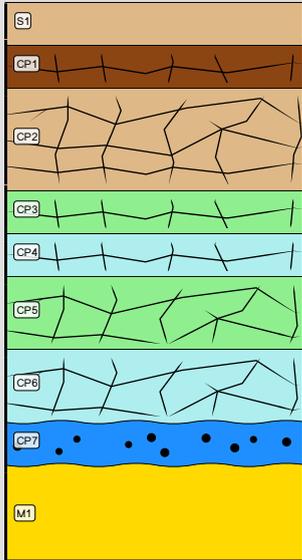
Fig. 5: Stratigraphic representation of the corrosion structure of the ring observed macroscopically under binocular using the MiCorr application with reference to Fig. 4. The characteristics of the strata, such a discontinuity, are accessible by clicking on the drawing that redirects you to the search tool by stratigraphy representation, Credit HE-Arc CR, N.Gutknecht.

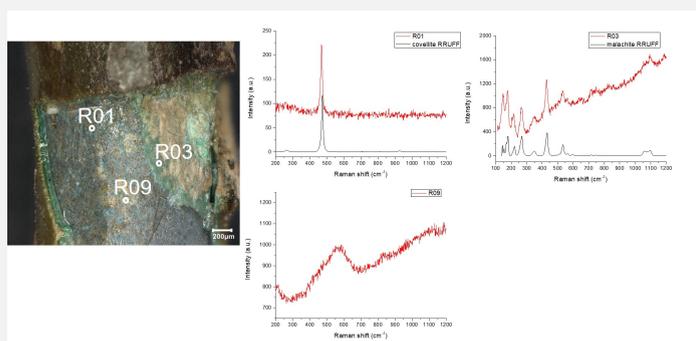
It was not possible to sample this artefact. Therefore, μ -Raman point analyses were performed on the surface of the object in an area where different strata of corrosion products were exposed, as shown in Fig. 6 in a micrograph taken by optical microscopy. The surface of the object appears brown (CP1). It covers a green stratum (CP5) and a blue/golden one (CP7 and M1) with black spots in it. The R01 analysis point was performed on one of the blackspots observed in the blue stratum and can be identified as covellite (CuS) by comparison with a reference spectrum. Point analyses performed on the blue (CP7) and golden stratum showed a spectrum with a large peak at around 560 cm^{-1} (R09) that can be identified as nanocassiterite (SnO₂) by comparison with the work of Ospitali et al. 2012. The R03 point analysis was performed on the green stratum (CP5) and is identified as malachite (Cu₂(CO₃)(OH)₂) by comparison with a reference spectrum.

Fig. 6: Raman points of analysis on the surface of the object and Raman spectra obtained for R01 (together with the covellite reference spectrum RRUFFID=R060306), R03 (together with the malachite reference spectrum RRUFFID=R050508) and R09,

The ring is a tin bronze probably with some lead. The identification of nanocassiterite as the most internal CP shows a phenomenon of decuprification typical of bronze corrosion, accompanied by the formation of copper hydroxycarbonate as a more external CP. The dark inclusions observed in the CP7 and identified as covellite are likely to be residuals of copper sulfide inclusions from the metal microstructure.
