RING SMRA 16-17285-01 – CU ALLOY – ROMAN TIMES – SWITZERLAND

Artefact name	Ring SMRA 16-17285-01
Authors	Christian. Degriigny (HE-Arc CR, Neuchâtel, Neuchâtel, Switzerland) & Naima. Gutknecht (HE-Arc CR, Neuchâtel, Neuchâtel, Switzerland) & Valentina. Valbi (Laboratoire Métallurgie et Culture LMC-IRAMAT-CNRS-UTBM, Belfort, Franche-Comté, France)
Url	/artefacts/1103/

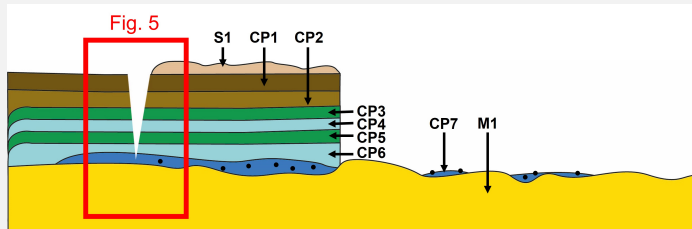
Fig. 4: Stratigraphic representation of the corrosion structure of the ring by macroscopic and binocular observation with indication of the corrosion structure used to build the MiCorr stratigraphy of Fig. 5 (red rectangular),
