# SACRIFICIAL KNIFE (TUMI) IVC 24745 – CU ALLOY – UNKNOWN – PERU

**Artefact name** Sacrificial knife (tumi) IVC 24745

**Authors** Christian. Degrigny (HE-Arc CR, Neuchâtel, Neuchâtel, Switzerland) & Marion. Billot (HE-Arc CR, Neuchâtel, Neuchâtel, Switzerland) & Valentin. Boissonnas (HE-Arc CR, Neuchâtel, Neuchâtel, Switzerland)

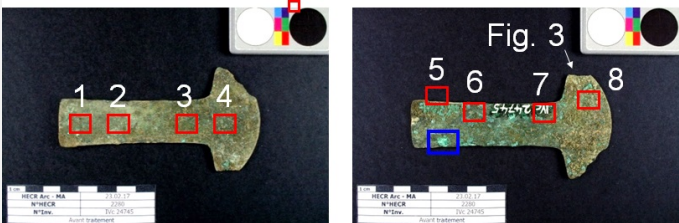
Fig. 2: Location of Fig. 3, XRF analyses (red squares) and the sampling area (blue square),

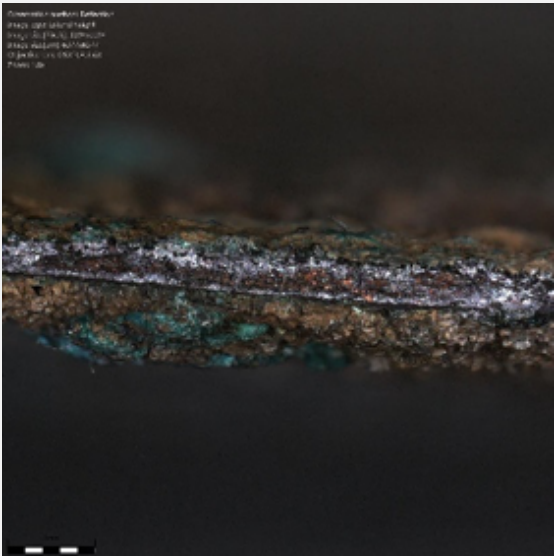
Fig. 3: Detail of the corrosion structure of the fractured cutting edge of the knife. To be related to the schematic stratigraphy of Fig. 6,

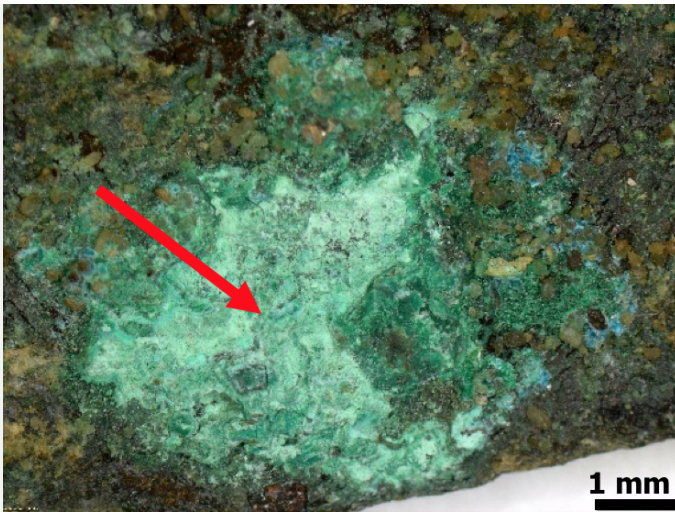
Fig. 4: Detail from Fig. 2 of the sampling area for XRF and XRD analysis,

<b>Description of sample</b>	Invasive sampling was not authorized by the museum. Only one powder sample was taken of the green corrosion product (Fig. 4).
<b>Alloy</b>	Cu Alloy
<b>Technology</b>	Cold worked (laminated)
<b>Lab number of sample</b>	1
<b>Sample location</b>	HE-Arc CR, Neuchâtel, Neuchâtel
<b>Responsible institution</b>	HE-Arc CR, Neuchâtel, Neuchâtel
<b>Date and aim of sampling</b>	02.04.2017, chemical and structural analyses

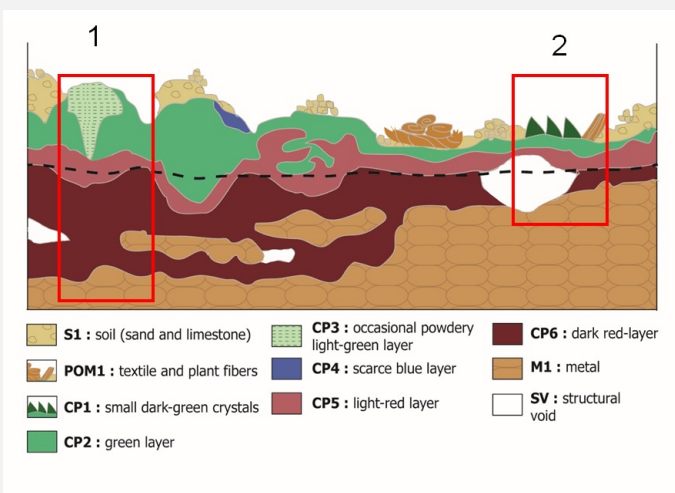
The schematic representation below gives an overview of the corrosion layers encountered on the tumi from a first visual macroscopic observation under binocular microscope.

Fig. 5: Stratigraphic representation of the sacrificial knife by macroscopic observation with indication of corrosion structures 1 and 2 used to build the MiCorr stratigraphy of Fig. 6,

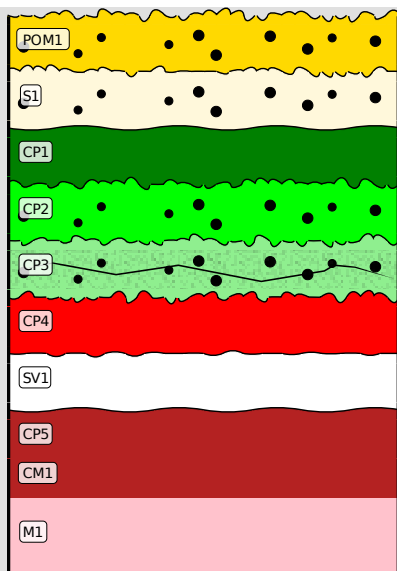
Fig. 6. Stratigraphic representation of the corrosion structure of the knife (combination of corrosion structures 1 and 2 of Fig. 5) observed macroscopically under binocular microscope using the MiCorr application. The characteristics of the strata are only accessible by clicking on the drawing that redirects you to the search tool by stratigraphy representation, Credit HE-Arc CR, M.Billot.

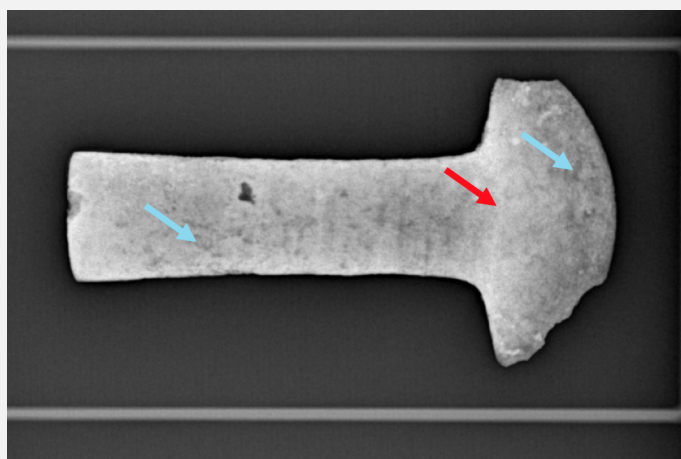
As indicated above, the metal of the knife might be an arsenic-copper alloy. Its manufacturing technique is not known but the X-radiography image seems to indicate that the artefact might have been produced as-cast with internal flaws (Fig. 7). The object has still a lot of remaining metal. Irregularities and different thicknesses are visible and parallel lines show that the knife was hammered. The whiter the area, the thicker the metal is.

Fig. 7: X-ray radiography of the knife. The base of the blade is thicker and is probably as-cast (red arrow). The blue arrows indicate casting flaws or localized corrosion,

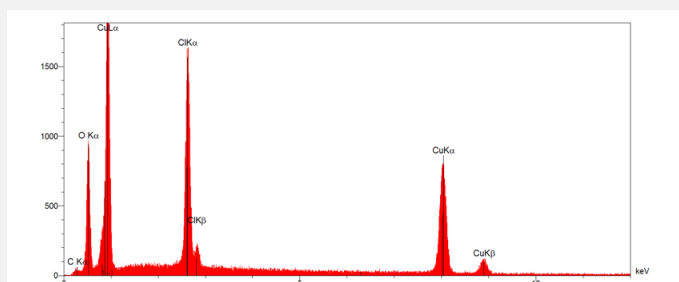
Results from XRF analyses of the non-cleaned metal surface (Table 1) indicate the presence of chlorine. The exogenous elements come from the landfill are mainly Si and Al, certainly associated to aluminosilicates. A sample was taken in the powdered light-green isolated layer (Figs. 2, 4 and 5). Chlorine, copper and oxygen was analysed by EDS-SEM. The presence of a high amount of Cl as well as Cu and O seems to indicate active corrosion (Fig. 8). XRD analysis confirmed the presence of paratacamite often associated to active corrosion (Fig. 9).

Fig. 8: EDS spectrum of a sample of the powdered light-green isolated layer (Fig. 4), Lab of Electronic Microscopy and Microanalysis (Néode),

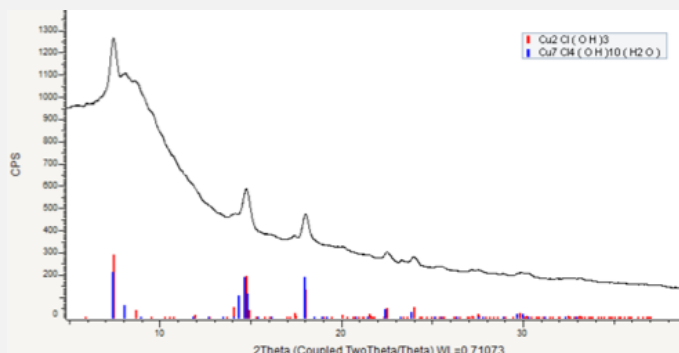
Fig. 9: XRD spectrum of a sample of the powdered light-green isolated layer (Fig. 4), Laboratory of Analytical Chemistry, Empa, HE-Arc,

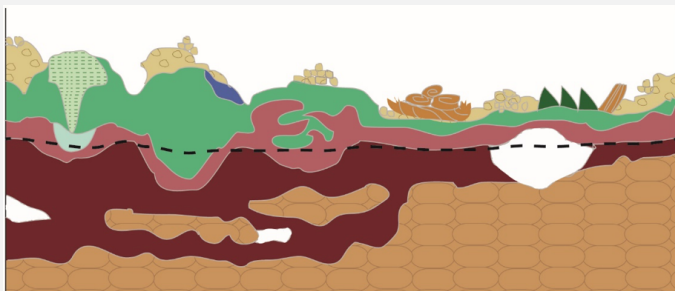
The schematic representation of corrosion layers of Fig. 5 integrating additional information based on the analyses carried out is given in Fig. 10. The limit of the original surface (represented by the dotted line on the figure below) was identified as still present and is located at the interface between CP6 and CP7.

Fig. 10: Improved stratigraphic representation of the tumi from visual observations and analyses,

Name	Aspect	Composition
	S1	Soil (sand and limestone)	Si, O, C, Al, K, P, Ca, S ( $\text{Al}_2\text{O}_3$ , $\text{SiO}_2$ , etc.)
	POM1	Textile and plant fibers	
	CP1	Small dark-green crystals	Unknown, maybe paratacamite $\text{Cu}_2\text{Cl}(\text{OH})_3$ ?
	CP2	Green layer	Unknown, probably malachite $\text{Cu}_2\text{CO}_3(\text{OH})_2$
	CP3	Occasional powdery light-green layer	Paratacamite $\text{Cu}_2\text{Cl}(\text{OH})_3$ and hydrated hydroxychloride $\text{Cu}_7\text{Cl}_4(\text{OH})_{10}$ ( $\text{H}_2\text{O}$ )
	CP4	Light-blue punctual layer	Unknown, probably nantokite $\text{CuCl}$
	CP5	Scarce blue layer	Unknown, probably azurite $\text{Cu}_2\text{CO}_3(\text{OH})_2$
	CP6	Light-red layer	Unknown, probably cuprite $\text{Cu}_2\text{O}$
	CP7	Dark red-layer	Unknown, probably cuprite $\text{Cu}_2\text{O}$
	M1	Metal	Probably Cu with low percent of As and Fe. Trace of Ag.
	SV	Structural void	—

The limit of the original surface has been altered by the corrosion products but can be found at the interface of CP6 and CP7. This tumi follows the type II corrosion model of L. Robbiola.
