# VOTIVE FIGURE OF A BAT IVB4168 – GILDED BRASS – MODERN TIMES

**Artefact name** Votive figure of a bat IVb4168

**Authors** Christian. Degriigny (HE-Arc CR, Neuchâtel, Neuchâtel, Switzerland) & Naima. Gutknecht (HE-Arc CR, Neuchâtel, Neuchâtel, Switzerland) & Valentin. Boissonnas (HE-Arc CR, Neuchâtel, Neuchâtel, Switzerland)

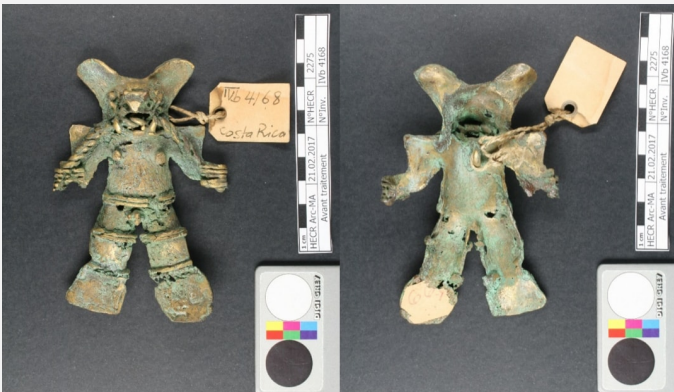
Fig. 1: Votive figure of a bat, front (left) and back (right) view,

**Description of the artefact** The object represents a bat-like figure holding and chewing a rope (Fig. 1). There are remains of a surface gilding. The object has a red-brown adherent layer where the gold has flaked off with a heterogenous green and white loosely bound layer on top. Dimensions: Length = 110 mm; Width = 73mm; Height = 25mm; WT = 60g.

The metal seems to have been heavily attacked (acid dissolution). There are several perforations on the lower part of the object, and where the gold layer is absent the surface is unevenly pitted by corrosion (Figs. 1, 2 and 7). The submetallic core is not visible from the surface.

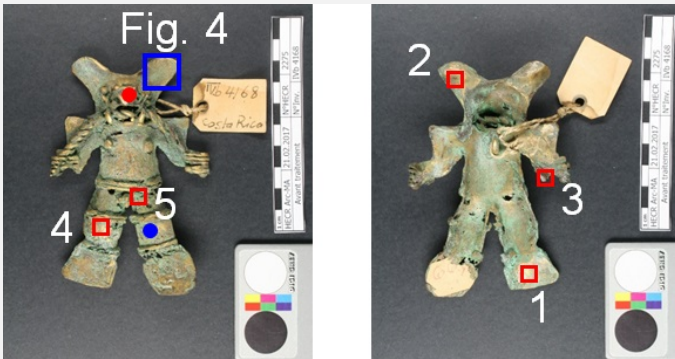
Fig. 2: Bat figure, front (left) and back (right) views with location of Fig. 4 (blue square), XRF analyses (red squares), FTIR analysis with sampling (blue point) and SEM-EDS analysis (red point),

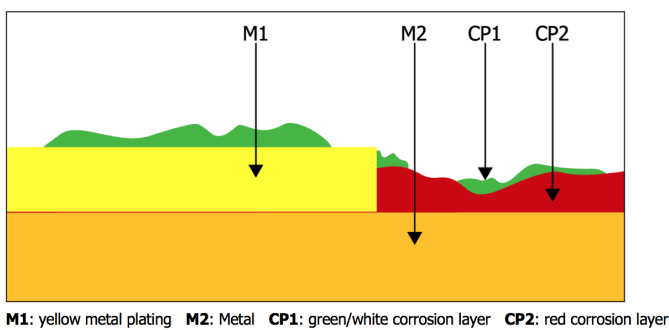
M1: yellow metal plating M2: Metal CP1: green/white corrosion layer CP2: red corrosion layer

Fig. 3: Stratigraphic representation of the bat by visual macroscopic observation,

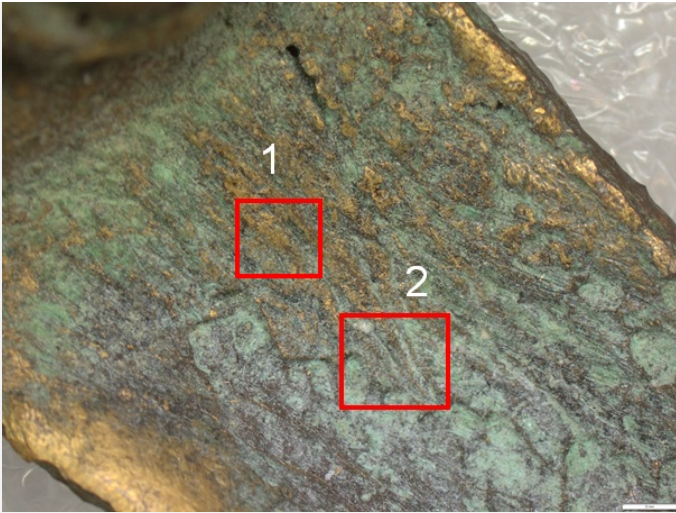
Fig. 4: Location of the areas 1 and 2 used to build the MiCorr stratigraphies of Figs. 5 and 6,

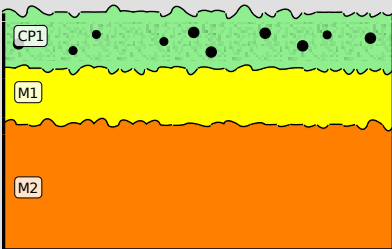
Fig 5: Stratigraphic representation of the corrosion structure of area 1 (Fig. 4) observed macroscopically under binocular microscope using the MiCorr application. The characteristics of the strata are only accessible by clicking on the drawing that redirects you to the search tool by stratigraphy representation, Credit HE-Arc CR, N.Gutknecht.

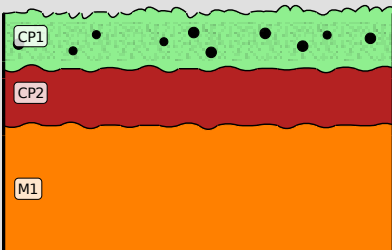
Fig. 6: Stratigraphic representation of the corrosion structure of area 2 (Fig. 4) observed macroscopically under binocular microscope using the MiCorr application. M1 is M2 in Fig. 5. The characteristics of the strata are only accessible by clicking on the drawing that redirects you to the search tool by stratigraphy representation, Credit HE-Arc CR, N.Gutknecht.

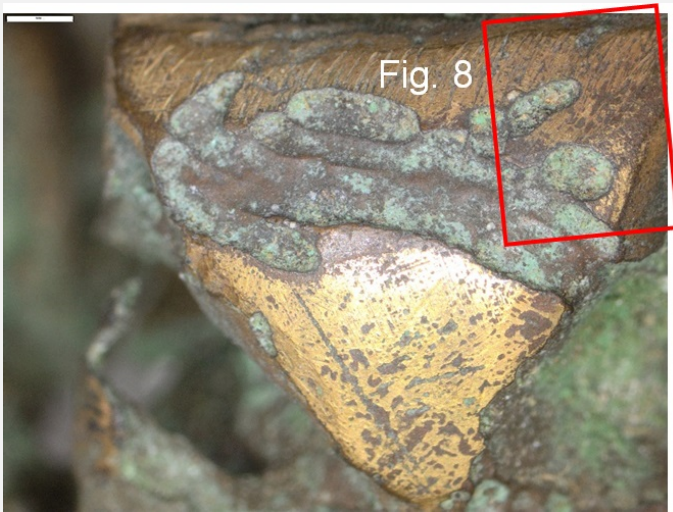
There are two corrosion products (Figs. 7 and 8). The red one (CP2) has a submetallic brightness and is opaque, non-magnetic, compact, hard and adherent. It is very thin (less than a few microns thick) and only appears where the gold layer has been lost. The EDX spectrum (Fig. 9) shows that it is a Cu- and O rich product, probably cuprite ( $\text{Cu}_2\text{O}$ ).

Fig. 7: Binocular image of the nose of the bat showing detail of Fig. 8,

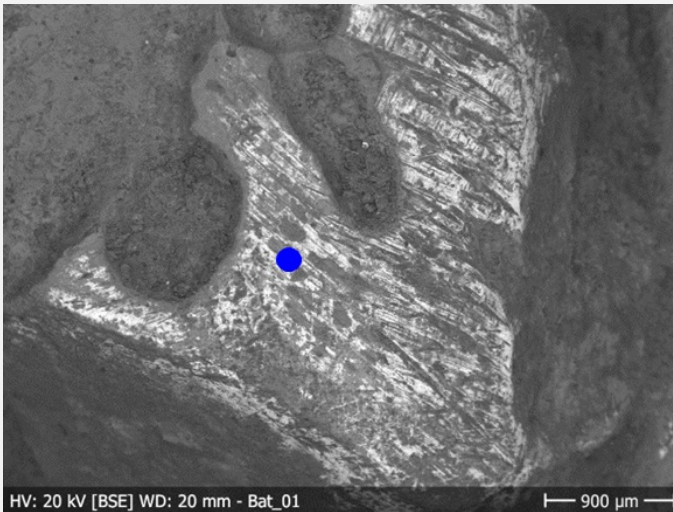
Figs. 8: SEM images of the metal on the nose of the bat. The blue point represents the area for the EDS point analysis (Fig. 9),

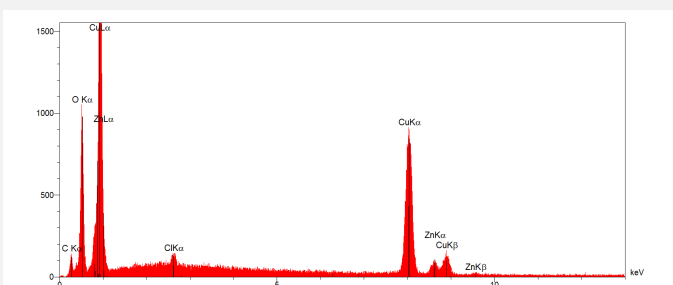
Fig. 9: EDS analysis of the red corrosion product. Method of analysis: SEM-EDS, Lab of Electronic Microscopy and Microanalysis, Néode, HEI Arc,

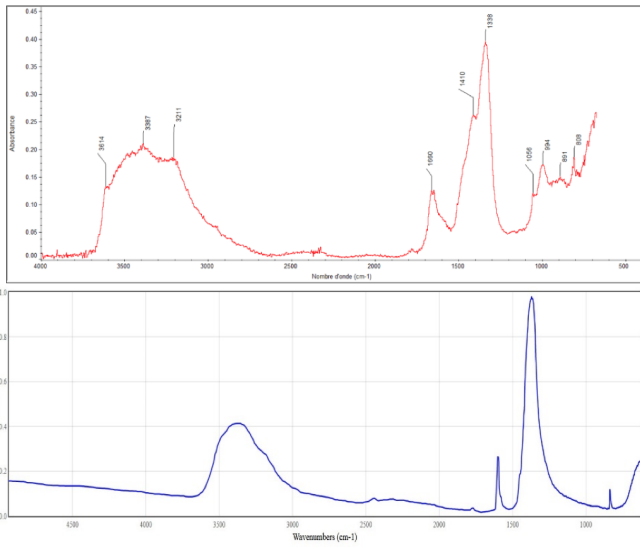
The light green to white corrosion product (CP1) has a waxy consistency and is thin, translucent, non-magnetic, powdery and very soft. It is very loosely bound. It is distributed on the whole object (front and back) as disparate clumps. It is mainly located on the cavities and irregularities of the surface. FTIR analyses (ATR mode) of both green and white areas of CP1 have similar spectra and were identified as copper nitrate (Fig. 10).

Fig. 10: FTIR spectrum (ATR mode) of the white corrosion product (top), and of synthesized copper nitrate ( $\text{Cu}(\text{NO}_3)_2 \cdot 3\text{H}_2\text{O}$ ) (bottom),

FTIR analysis of the green/white corrosion product suggests that it is a copper nitrate, a highly water soluble corrosion product that cannot be found in an archaeological context. However, it has been recorded on artificially patinated copper alloys (Scott 2000; Craddock 2009).
