# VOTIVE FIGURE OF A BAT IVB4168 – GILDED BRASS – MODERN TIMES

**Artefact name** Votive figure of a bat IVb4168

**Authors** Christian. Degriigny (HE-Arc CR, Neuchâtel, Neuchâtel, Switzerland) & Naima. Gutknecht (HE-Arc CR, Neuchâtel, Neuchâtel, Switzerland) & Valentin. Boissonnas (HE-Arc CR, Neuchâtel, Neuchâtel, Switzerland)

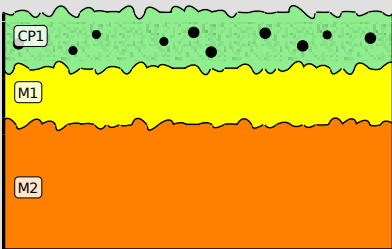
Fig 5: Stratigraphic representation of the corrosion structure of area 1 (Fig. 4) observed macroscopically under binocular microscope using the MiCorr application. The characteristics of the strata are only accessible by clicking on the drawing that redirects you to the search tool by stratigraphy representation, Credit HE-Arc CR, N.Gutknecht.

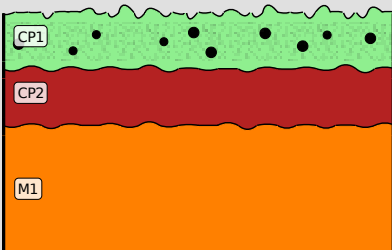
Fig. 6: Stratigraphic representation of the corrosion structure of area 2 (Fig. 4) observed macroscopically under binocular microscope using the MiCorr application. M1 is M2 in Fig. 5. The characteristics of the strata are only accessible by clicking on the drawing that redirects you to the search tool by stratigraphy representation, Credit HE-Arc CR, N.Gutknecht.

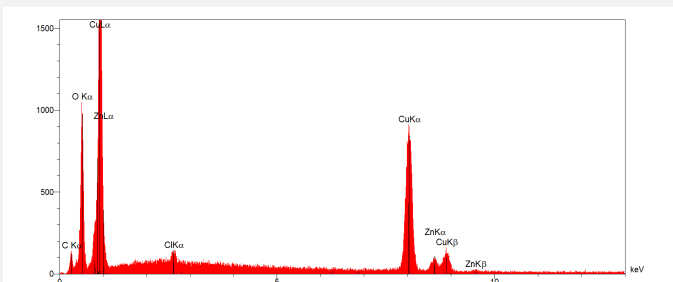
There are two corrosion products (Figs. 7 and 8). The red one (CP2) has a submetallic brightness and is opaque, non-magnetic, compact, hard and adherent. It is very thin (less than a few microns thick) and only appears where the gold layer has been lost. The EDX spectrum (Fig. 9) shows that it is a Cu- and O rich product, probably cuprite ( $\text{Cu}_2\text{O}$ ).

Fig. 9: EDS analysis of the red corrosion product. Method of analysis: SEM-EDS, Lab of Electronic Microscopy and Microanalysis, Néode, HEI Arc,
