## VOTIVE FIGURE OF A BAT IVB4168 – GILDED BRASS – MODERN TIMES

**Artefact name** Votive figure of a bat IVb4168

**Authors** Christian. Degrigny (HE-Arc CR, Neuchâtel, Neuchâtel, Switzerland) & Naima. Gutknecht (HE-Arc CR, Neuchâtel, Neuchâtel, Switzerland) & Valentin. Boissonnas (HE-Arc CR, Neuchâtel, Neuchâtel, Switzerland)

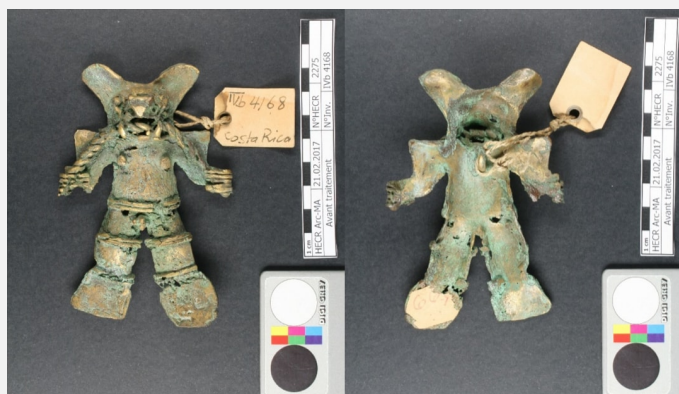
Fig. 1: Votive figure of a bat, front (left) and back (right) view,

<b>Description of the artefact</b>	The object represents a bat-like figure holding and chewing a rope (Fig. 1). There are remains of a surface gilding. The object has a red-brown adherent layer where the gold has flaked off with a heterogenous green and white loosely bound layer on top. Dimensions: Length = 110 mm; Width = 73mm; Height = 25mm; WT = 60g.
<b>Type of artefact</b>	Votive figure
<b>Origin</b>	Costa Rica
<b>Recovering date</b>	Unknown, acquisition in 1970
<b>Chronology category</b>	Modern Times
<b>chronology tpq</b>	<input type="text"/> <input type="button" value="v"/>
<b>chronology taq</b>	<input type="text"/> <input type="button" value="v"/>
<b>Chronology comment</b>	20th century (fake)

The metal seems to have been heavily attacked (acid dissolution). There are several perforations on the lower part of the object, and where the gold layer is absent the surface is unevenly pitted by corrosion (Figs. 1, 2 and 7). The submetallic core is not visible from the surface.

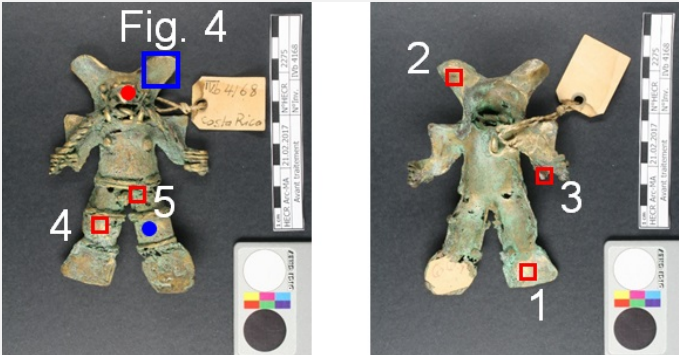
Fig. 2: Bat figure, front (left) and back (right) views with location of Fig. 4 (blue square), XRF analyses (red squares), FTIR analysis with sampling (blue point) and SEM-EDS analysis (red point),

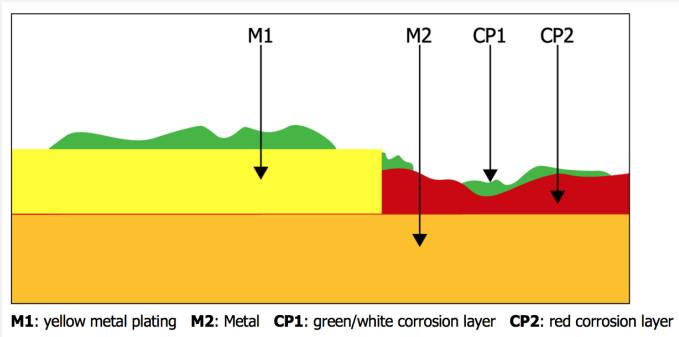
Fig. 3: Stratigraphic representation of the bat by visual macroscopic observation,

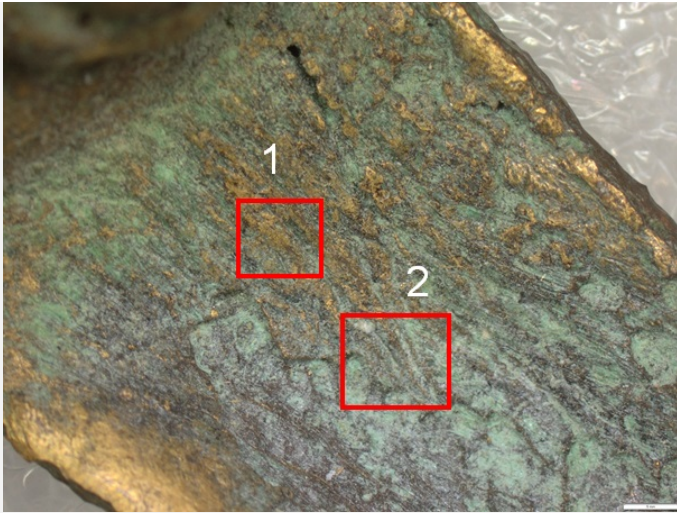
Fig. 4: Location of the areas 1 and 2 used to build the MiCorr stratigraphies of Figs. 5 and 6,

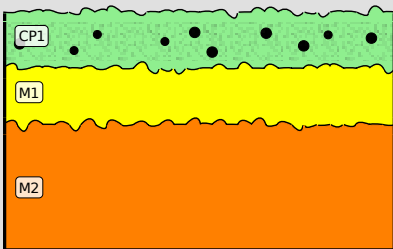
Fig 5: Stratigraphic representation of the corrosion structure of area 1 (Fig. 4) observed macroscopically under binocular microscope using the MiCorr application. The characteristics of the strata are only accessible by clicking on the drawing that redirects you to the search tool by stratigraphy representation, Credit HE-Arc CR, N.Gutknecht.

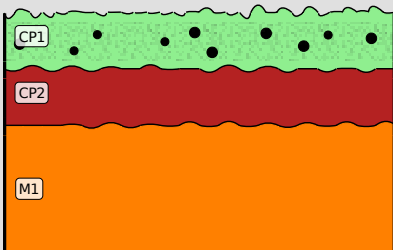
Fig. 6: Stratigraphic representation of the corrosion structure of area 2 (Fig. 4) observed macroscopically under binocular microscope using the MiCorr application. M1 is M2 in Fig. 5. The characteristics of the strata are only accessible by clicking on the drawing that redirects you to the search tool by stratigraphy representation, Credit HE-Arc CR, N.Gutknecht.

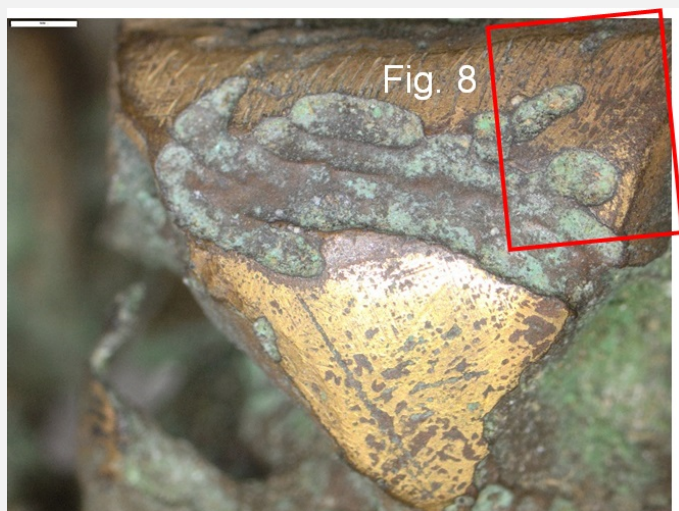
There are two corrosion products (Figs. 7 and 8). The red one (CP2) has a submetallic brightness and is opaque, non-magnetic, compact, hard and adherent. It is very thin (less than a few microns thick) and only appears where the gold layer has been lost. The EDX spectrum (Fig. 9) shows that it is a Cu- and O rich product, probably cuprite ( $\text{Cu}_2\text{O}$ ).

Fig. 7: Binocular image of the nose of the bat showing detail of Fig. 8,

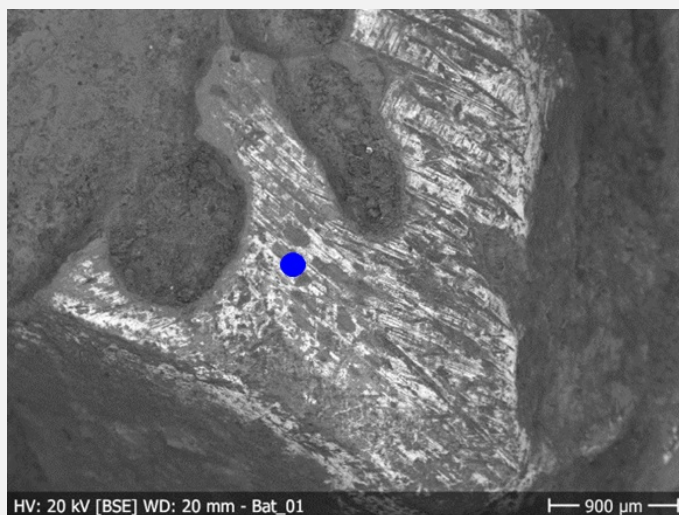
Figs. 8: SEM images of the metal on the nose of the bat. The blue point represents the area for the EDS point analysis (Fig. 9),

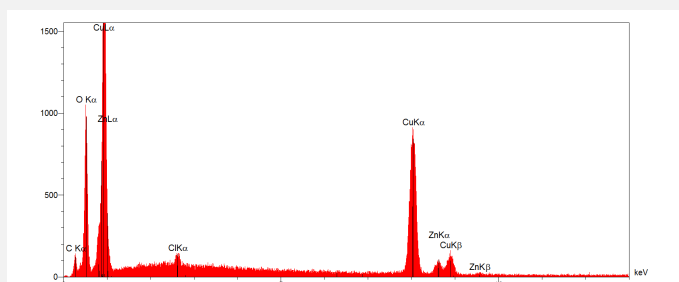
Fig. 9: EDS analysis of the red corrosion product. Method of analysis: SEM-EDS, Lab of Electronic Microscopy and Microanalysis, Néode, HEI Arc,

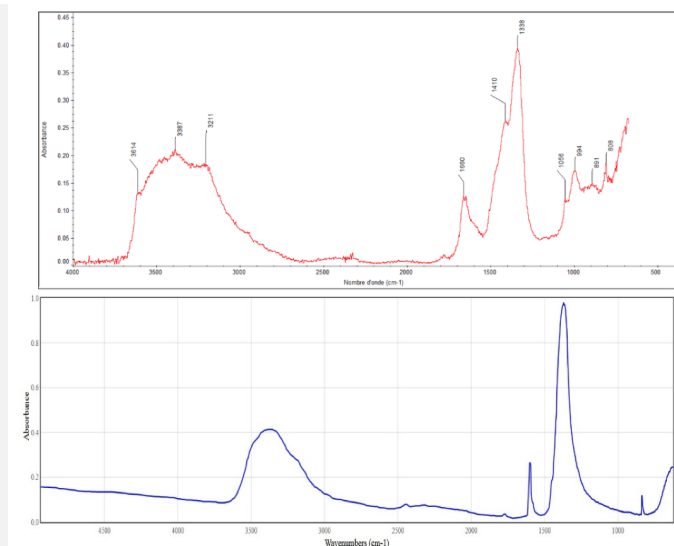
The light green to white corrosion product (CP1) has a waxy consistency and is thin, translucent, non-magnetic, powdery and very soft. It is very loosely bound. It is distributed on the whole object (front and back) as disparate clumps. It is mainly located on the cavities and irregularities of the surface. FTIR analyses (ATR mode) of both green and white areas of CP1 have similar spectra and were identified as copper nitrate (Fig. 10).

Fig. 10: FTIR spectrum (ATR mode) of the white corrosion product (top), and of synthesized copper nitrate ( $\text{Cu}(\text{NO}_3)_2 \cdot 3\text{H}_2\text{O}$ ) (bottom),

FTIR analysis of the green/white corrosion product suggests that it is a copper nitrate, a highly water soluble corrosion product that cannot be found in an archaeological context. However, it has been recorded on artificially patinated copper alloys (Scott 2000; Craddock 2009).
