FRAGMENT OF AN AEGIS OF NEITH 1886.305.0096 – LEADED BRONZE

Artefact name Fragment of an Aegis of Neith 1886.305.0096

Authors Line. Pedersen (HE-Arc, Neuchâtel, Neuchâtel, Switzerland) & Christian. Degrigny (HE-Arc CR, Neuchâtel, Neuchâtel, Switzerland) & Valentin. Boissonnas (HE-Arc CR, Neuchâtel, Neuchâtel, Switzerland)

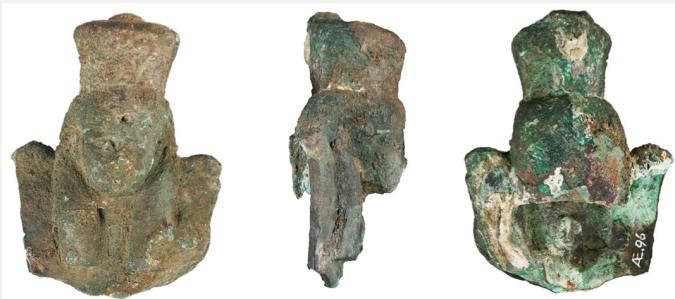
Fig. 1: Fragment of an Aegis of Neith. From left to right: front, side view and back respectively,

Fragment of an aegis surmounted by the head of Neith, the Egyptian goddess of war (Fig. 1). Traces of leaf gilding is still present in certain areas (Fig. 3). The lower part of the collar and the upper part of the crown are broken (Fig. 2 and 4). The surface is covered with a thick and hard, green-brown corrosion crust (Fig. 2, 3 and 4). A cross-section was studied on the lower edge that was broken after excavation. Dimensions: L = 96mm; W = 72mm; T = 40mm; WT = 216g.

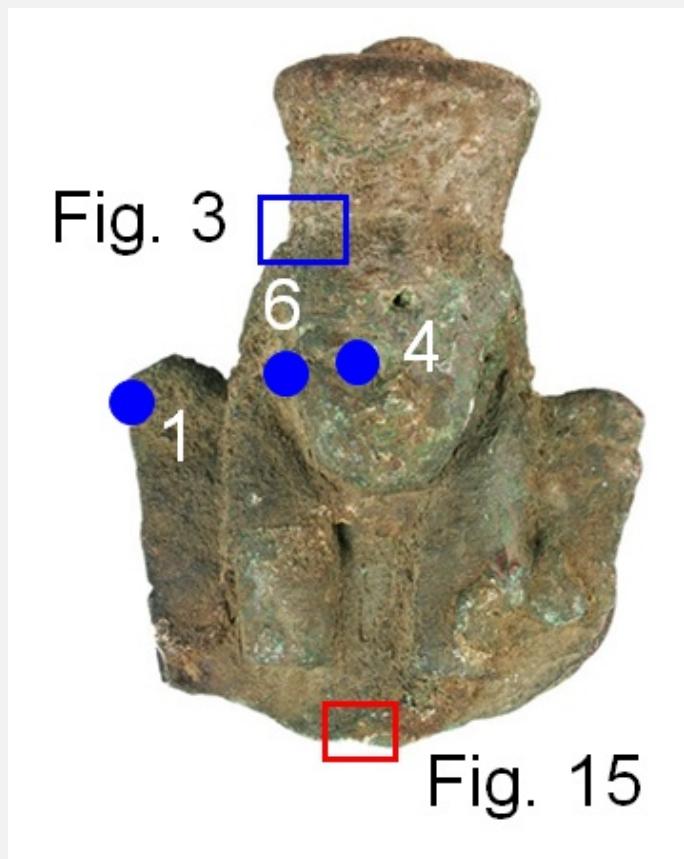
Fig. 2: Front face of the aegis with location of XRF measurements (blue spots), powder sample (red square) and gilding remains on the surface (blue square),

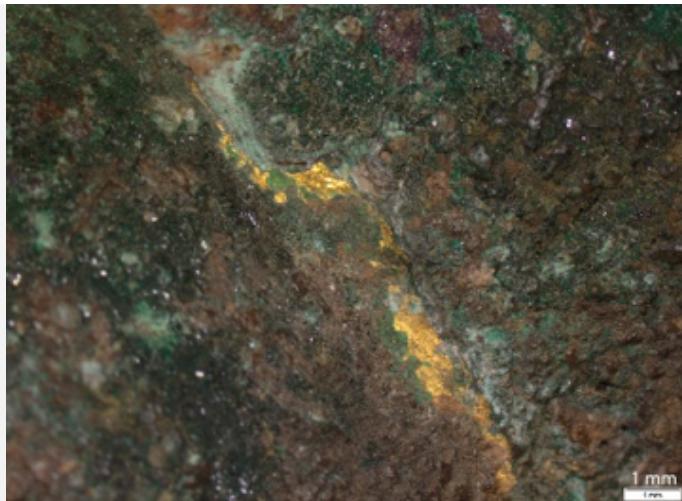
Fig. 3: Remains of foil-gilding on the corroded surface,

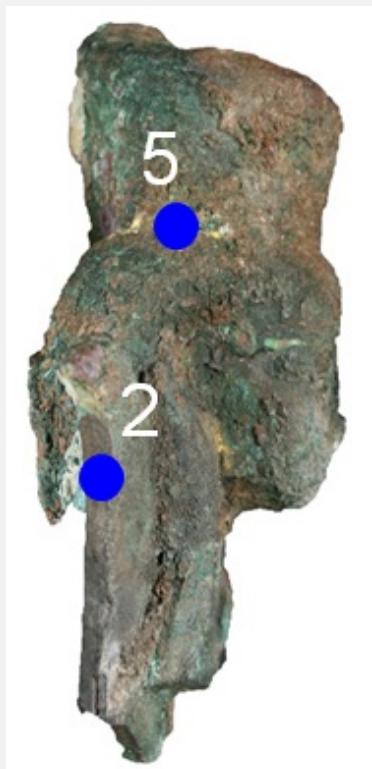
Fig. 4: Side view of the aegis with location of XRF measurements (blue spots),

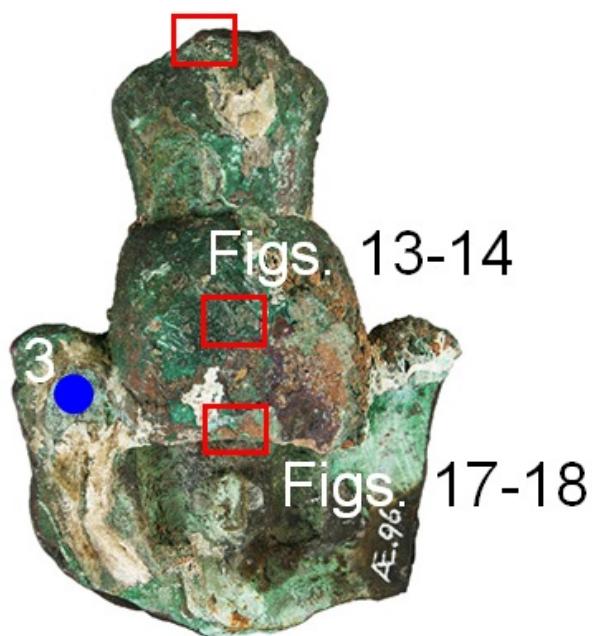
Fig. 5: Back face of the aegis with location of XRF measurement (blue spot) and powder samples (red squares),

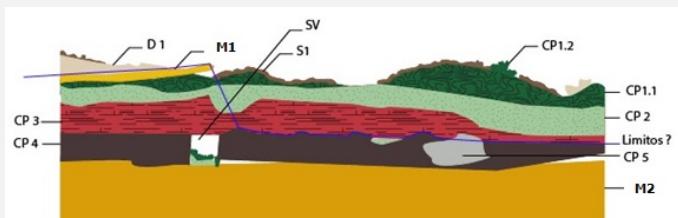
Fig. 6: Preliminary stratigraphy 1, corresponding to the front face of the aegis. S = soil, D = deposit, M = metal, CP = corrosion products, SV = structural void,

Captions	Colour, aspect, hardness and cohesion
S1	Brown, matte, can be scratched with scalpel blade but remains cohesive.
D1	White deposit: shiny, powdery when shaved with scalpel.
M1	Thin gold leaf trapped in corrosion products, brittle, yellow and not adherent.
CP1.1	Dark green corrosion layer, lumpy and matte, thick, hardly scratched by a scalpel blade, cohesive and compact.
CP1.2	Minor stratum of CP1.1. Dark green crystals appearing on the surface of the artefact. Easily scratched under the action a scalpel blade.
CP2	Light green corrosion layer, matte, thick in some places, powdery under the action of a scalpel blade. In some areas it is located directly on CP4.
CP3	Red corrosion layer, lumpy and matte, thick, sometimes hard and sometimes powdery under the action of a scalpel blade.
Limitos	Interface of the limit of the original surface. Shiny, straight and black with manufacturing traces.
CP4	Dark grey with red or green reflection. Shiny, hard, straight, dense and with traces of engraving and possible inlays.

CP5	Isolated white corrosion products: waxy and very soft.
SV	Void in CP4 resulting in loss of the limitos.
M2	Yellow stratum with metallic sheen, dense and hardly scratched by scalpel blade.

The corrosion layers are thick and very hard due to the burial context which was probably rich in chlorides. From the top to the bottom of the corrosion layers, there is a large amount of dark and light green corrosion product identified as copper oxychlorides followed by a layer of red corrosion product identified as copper oxide (cuprite) and a dark red corrosion layer identified as copper oxide (tenorite). In certain localised areas we were able to identify chalconatronite, a light blue corrosion product typically formed by natron salt from the Egyptian soil. Due to the presence of manufacturing traces and engravings, the limit of the original surface is localised mainly in the dark red corrosion layer. In certain areas there are remains of gilding-foil identified as gold by XRF elemental analysis. The foil is preserved on the top of the corrosion layer. Because gold is a noble metal, it had not corroded and was lifted by the corrosion products of the copper alloy. Thus, the limit of the original surface is displaced in some areas (Fig. 6, see limitos).

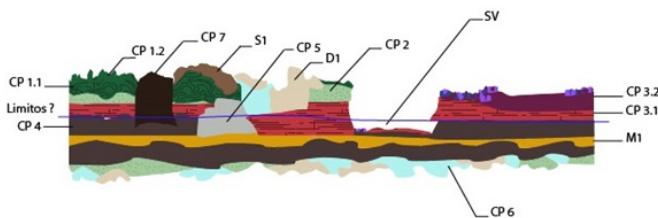
Fig. 7: Preliminary stratigraphy 2, corresponding to the back face of the aegis and interior (below part). S = soil, D = deposit, M = metal, CP = corrosion products, SV = structural void,

Captions	Colour, aspect, hardness and cohesion
S1	Brown, matte, can be scratched with scalpel blade but remains cohesive.
D1	White shiny deposit, powdery when shaved with scalpel.
CP1.1	Dark green corrosion layer, lumpy and matte, thick, hardly scratched by a scalpel blade, cohesive and compact.
CP1.2	Minor stratum of CP1.1. Dark green crystals appearing on the surface of the artefact. Easily scratched by a scalpel blade.
CP2	Light green corrosion layer, matte and thick in some places, powdery under the action of a scalpel blade. Sometimes located directly on CP4.
CP3.1	Red corrosion layer, lumpy and matte, thick, sometimes hard and sometimes powdery under the action of a scalpel blade.
CP3.2	Minor stratum of CP3.1. Purple with blue-purple crystals, hard and cohesive.
Limitos?	Interface of the limit of the original surface. Shiny, straight, black, manufacturing traces.
CP4	Dark grey with red or green reflection. Shiny, hard, straight, dense and with traces of engraving and possible inlays.

CP5	Isolated white stratum: waxy and very soft.
CP6	Light blue stratum, chalky. Isolated on the exterior surface and extends on the interior surface.
CP7	Isolated black stratum, very hard, straight and shiny.
SV: Structural Void	Void in CP4, resulting in loss of the limitos. Presence of CP1.2 crystals inside the void.
M1	Yellow stratum with metallic sheen, dense and hardly scratched by scalpel blade.

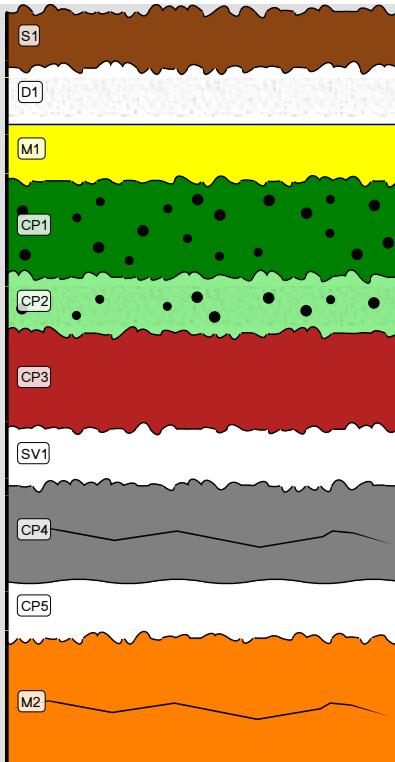
Fig.9: Schematic representation combining stratigraphies 1 and 2 under binocular microscope and using the MiCorr application. The characteristics of the strata are only accessible by clicking on the drawing that redirects you to the search tool by stratigraphy representation, Credit He-Arc CR, L.Pedersen.

The metal (M2 in Fig.9 and M1 in Fig. 10) was analysed on the broken edge of the bottom of the artefact where despite a highly corroded surface, the metal seems to be the best preserved. The XRF analyses revealed that the metal is a leaded bronze with remains of gold leaf on the surface (Table 1, Au was detected in the measurement spots 4,5 and 6) (Scott 2002; Gouda 2012; Mohammed 2012).

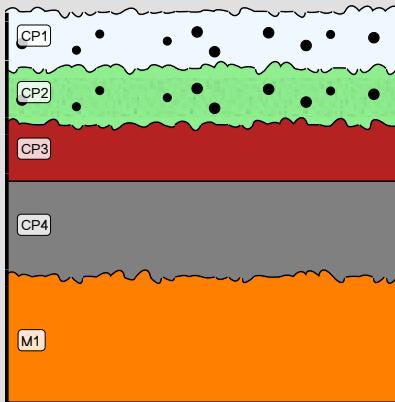
Fig.10: Schematic representation of stratigraphy 3 under binocular microscope and using the MiCorr application. CP1 is CP6 in Fig. 8. The characteristics of the strata are only accessible by clicking on the drawing that redirects you to the search tool by stratigraphy representation, Credit He-Arc CR, L. Pedersen.

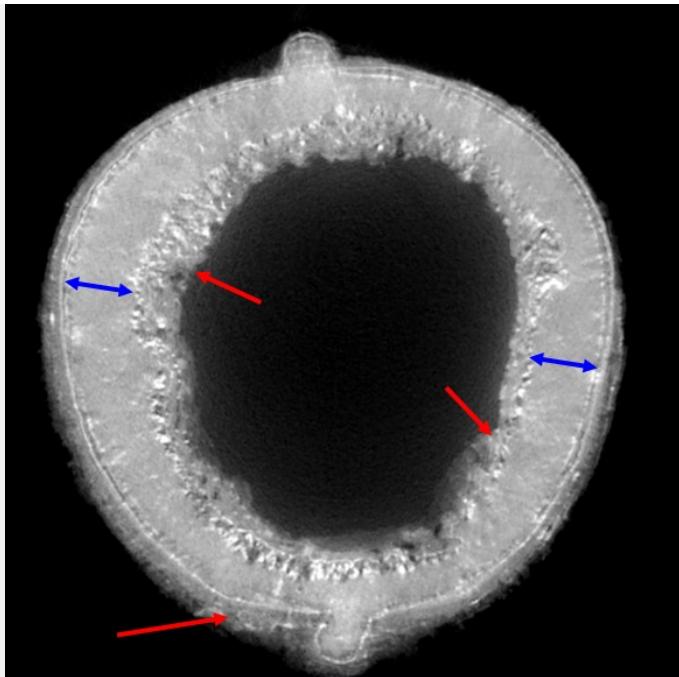
As indicated by the X-ray tomography, the metal of the aegis seems to be well preserved (Figs. 11-12).

Fig. 11: X-ray tomography by cross section of the crown showing a dense and non-porous metal core (blue arrows). The corrosion products however are porous (red arrows). The external limitos is visible as a fine line preserved under corrosion layers,

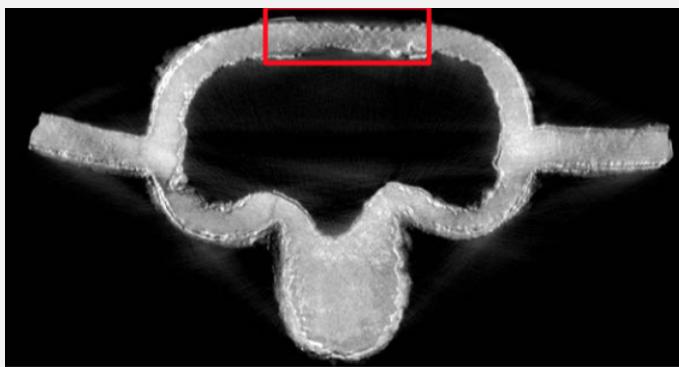
Fig. 12: X-ray tomography by cross section of the lower part showing that there are losses of the original surface (red square),

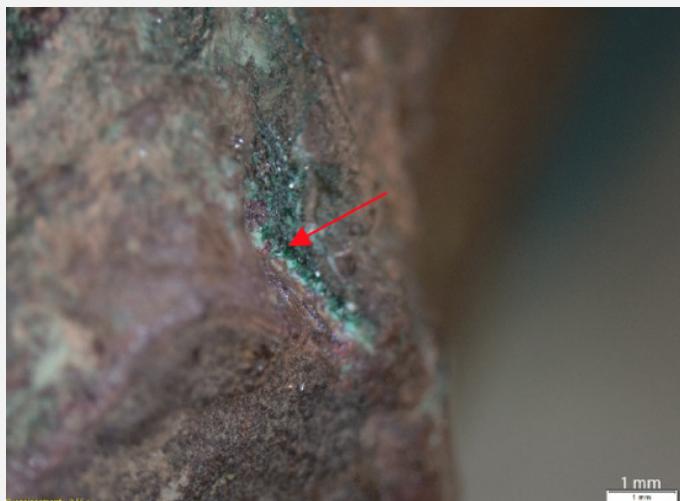
Fig. 13: Observation of the dark green corrosion product,

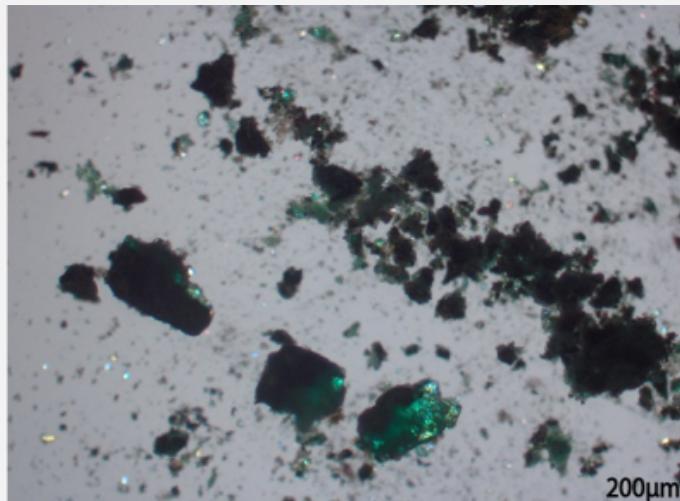
Fig. 14: Dark green corrosion product identified as paratacamite, atacamite $\text{Cu}_2\text{Cl}(\text{OH})_3$ by XRD. Microscopic examination under polarized light,

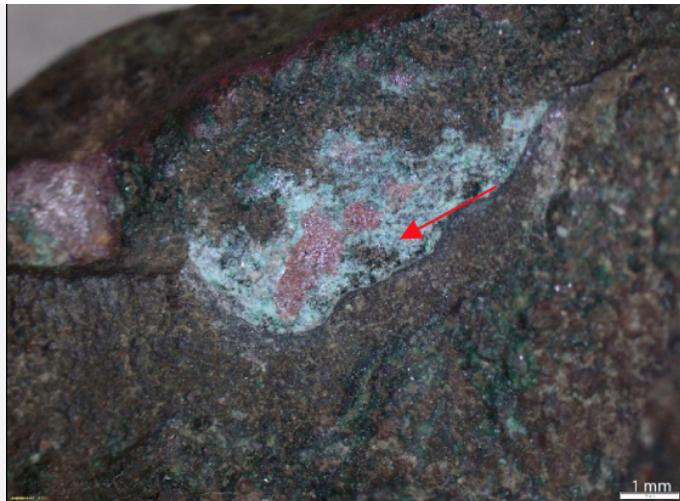
Fig. 15: Observation of the light green corrosion product,

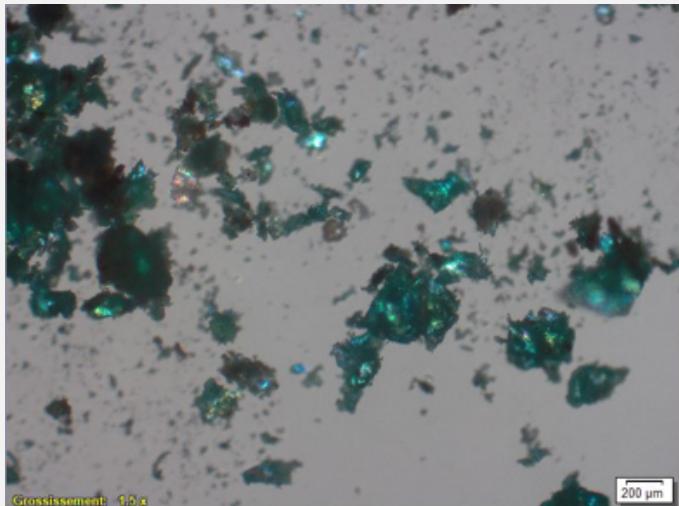
Fig. 16: Light green corrosion product identified as paratacamite, atacamite ($\text{Cu}_2\text{Cl}(\text{OH})_3$) by XRD. Microscopic examination under polarized light,

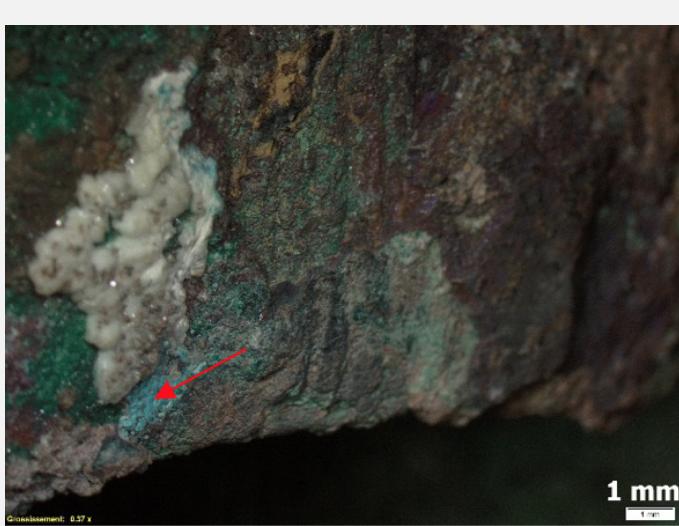
Fig. 17: Observation of the light blue corrosion product,

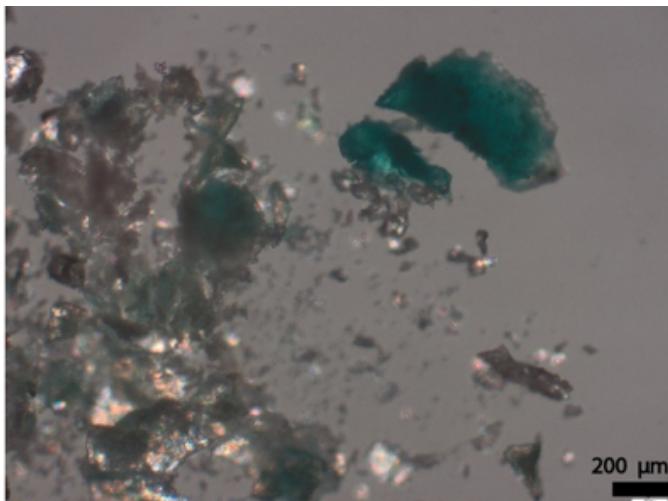
Fig. 18: Light blue corrosion product identified as chalconatronite $\text{Na}_2\text{Cu}(\text{CO}_3)_2 \cdot 3\text{H}_2\text{O}$ by XRD. Microscopic examination under polarized light,

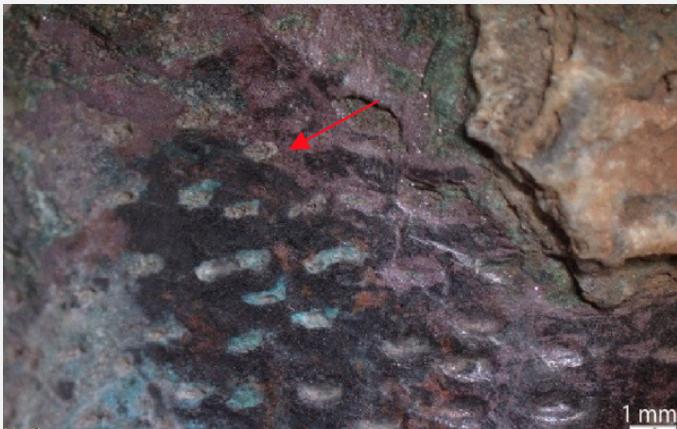
Fig. 19: Observation of the red corrosion product above the black original surface containing corresponding markers such as engravings,

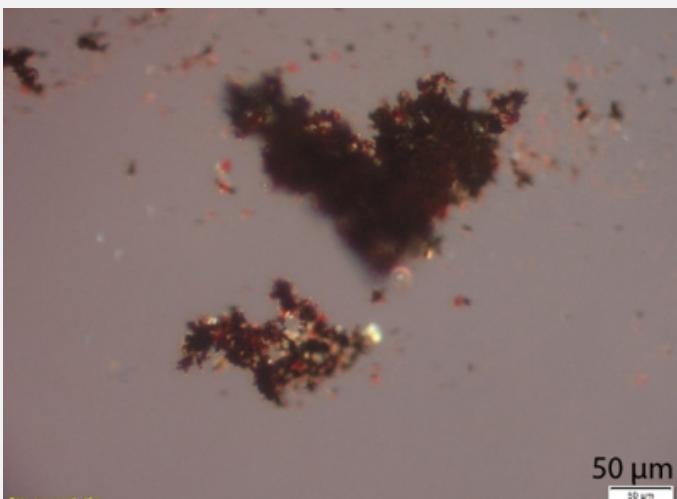
Fig. 20: Dark red corrosion product identified as cuprite Cu_2O as major component and tenorite CuO as minor component. Microscopic examination under polarized light,

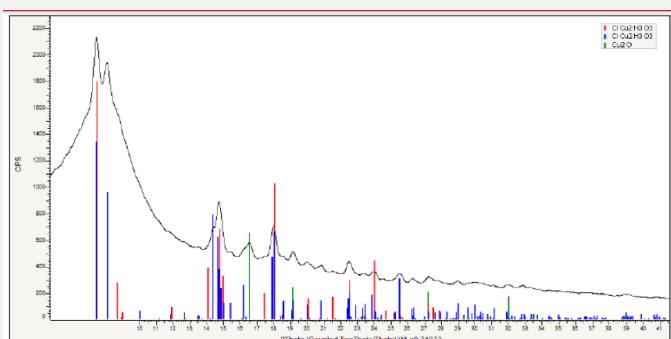
Fig. 21: XRD spectrum of the sample of the dark green corrosion product showing the presence of atacamite and paratacamite ($\text{Cu}_2\text{Cl}(\text{OH})_3$) as major compound and cuprite (Cu_2O) as minor compound,

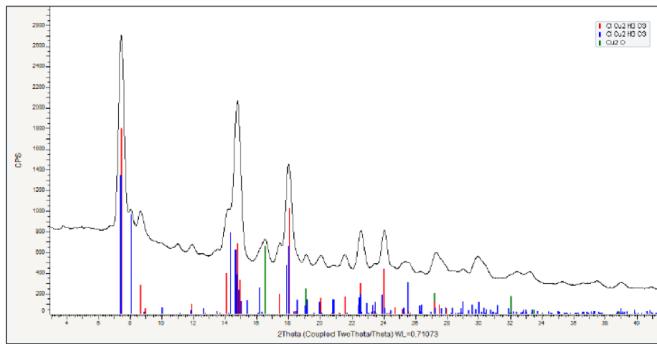
Fig. 22: XRD spectrum of the sample from the light green corrosion product showing the presence of atacamite and paratacamite ($\text{Cu}_2\text{Cl}(\text{OH})_3$) as major compound and cuprite (Cu_2O) as minor compound,

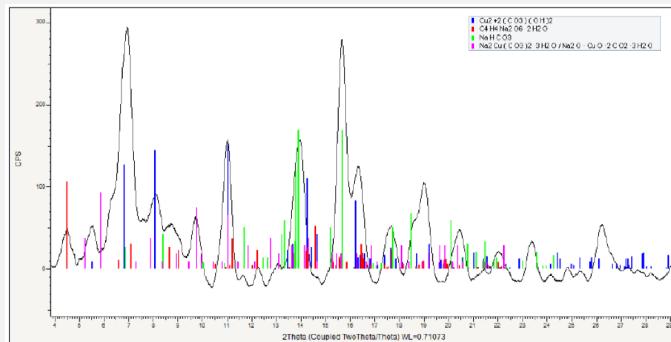
Fig. 23: XRD spectrum of the sample from the light blue corrosion product showing the presence of chalconatronite ($\text{Na}_2\text{Cu}(\text{CO}_3)_2 \cdot 3\text{H}_2\text{O}$). The other compounds are analysis supposition, but are not relevant,

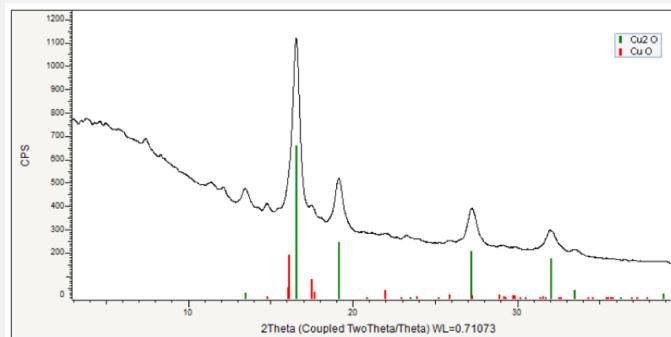
Fig. 24: XRD spectrum of the sample from the dark red corrosion product showing the presence of cuprite (Cu_2O) as major compound and tenorite (CuO) as minor compound,
