# BUGATTI 37 CYLINDER HEAD GASKET 0416 – AL ALLOY – MODERN TIMES – FRANCE

**Artefact name** Bugatti 37 cylinder head gasket 0416

**Authors** Christian. Degrigny (HE-Arc CR, Neuchâtel, Neuchâtel, Switzerland) & Elodie. Granget (HE-Arc CR, Neuchâtel, Neuchâtel, Switzerland) & Brice. Chalançon (MNAM (Musée National de l'Automobile de Mulhouse), Mulhouse, Alsace, France)

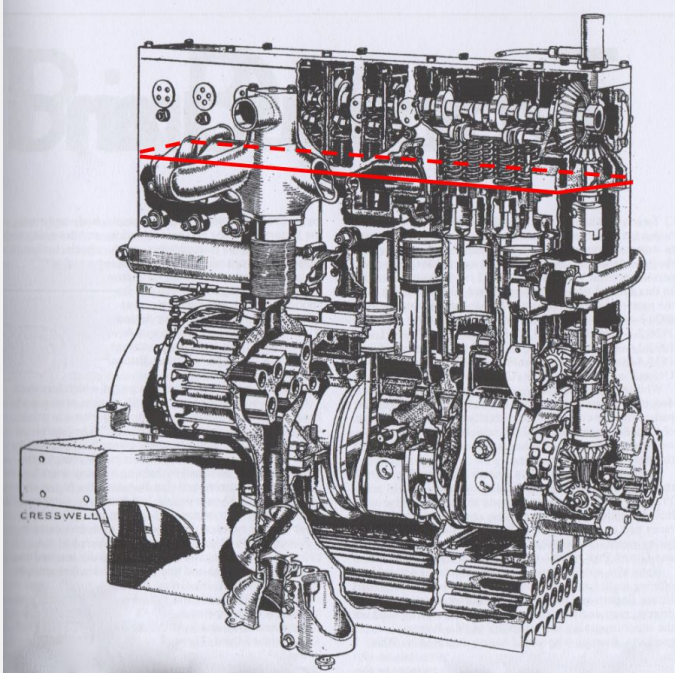
Fig. 2: Gasket located in red on technical drawing of the engine from Cresswell,

<b>Description of the artefact</b>	A coolant flows through the cylinder block inside galleries. This aluminium gasket is making a tight junction between the camshaft and the top of the block (Fig. 2). It keeps the water or coolant (water + glycol-based antifreeze) from mixing with the lubricant used on the shaft, the pistons and the cylinders. The wet side is facing the cylinder block. The other side is dry.
<b>Type of artefact</b>	Technical object
<b>Origin</b>	MNAM (Musée National de l'Automobile de Mulhouse), Mulhouse, Alsace, France
<b>Recovering date</b>	Unknown
<b>Chronology category</b>	Modern Times
<b>chronology tpq</b>	<input type="text" value="1926"/> A.D. ▾
<b>chronology taq</b>	<input type="text" value=""/> ---- ▾
<b>Chronology comment</b>	The production of this model started in 1926
<b>Burial conditions / environment</b>	Outdoor to indoor atmosphere
<b>Artefact location</b>	MNAM (Musée National de l'Automobile de Mulhouse), Mulhouse, Alsace

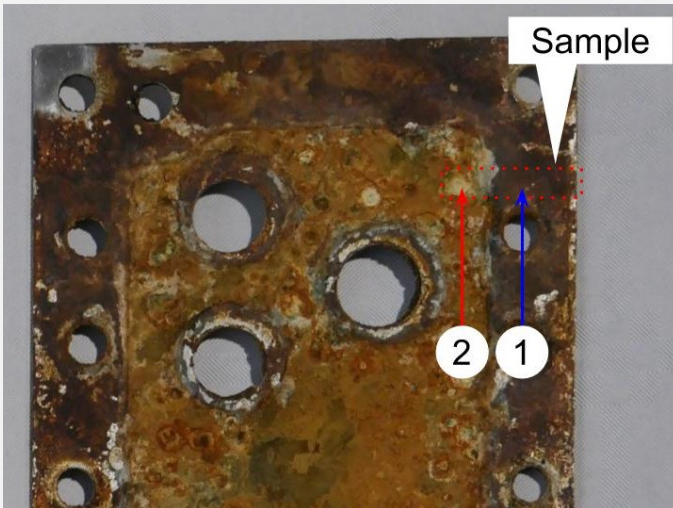
Fig. 3: Bugatti Type 37 cylinder head gasket. Location of the sampling area (red rectangle). Stratigraphic observation sites, in contact with the block [1] and in contact with the coolant [2],

Fig.3 clearly shows the limit where the gasket is in contact with the cylinder block ([1] edges and circular openings in the center) and where it is in contact with the coolant ([2] center).

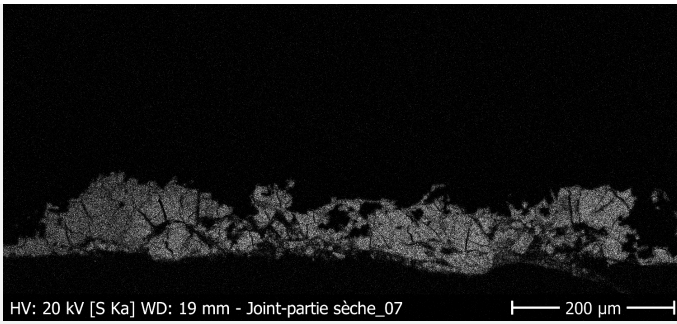
Fig. 12: S chemical distribution of the area of Fig. 10. Method of analysis: SEM-EDS. Lab. of Electronic Microscopy and Microanalysis, Néode, HEI Arc.

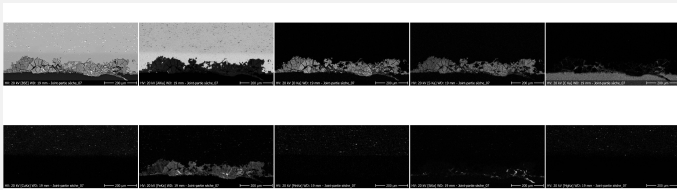
Fig. 13: SEM image and elemental chemical distribution of the area of Fig. 10. Method of analysis: SEM-EDS. Lab. of Electronic Microscopy and Microanalysis, Néode, HEI Arc.

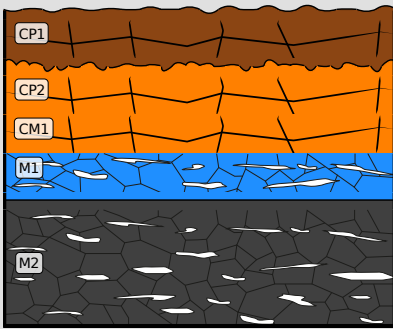
Fig. 14: Stratigraphic representation of the gasket (zone 1) in cross-section (dark field), using the MiCorr application. The characteristics of the strata are only accessible by clicking on the drawing that redirects you to the search tool by stratigraphy representation. This representation can be compared to Fig. 7, Credit HE-Arc CR, E.Granget.

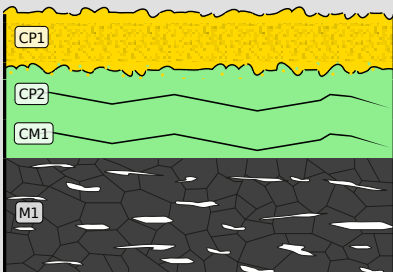
Fig. 15: Stratigraphic representation of the gasket (zone 2) in cross-section (dark field), using the MiCorr application. The characteristics of the strata are only accessible by clicking on the drawing that redirects you to the search tool by stratigraphy representation. This representation can be compared to Fig. 9, Credit HE-Arc CR, E.Granget.
