# BUGATTI 37 CYLINDER HEAD GASKET 0416 – AL ALLOY – MODERN TIMES – FRANCE

**Artefact name** Bugatti 37 cylinder head gasket 0416

**Authors** Christian. Degriigny (HE-Arc CR, Neuchâtel, Neuchâtel, Switzerland) & Elodie. Granget (HE-Arc CR, Neuchâtel, Neuchâtel, Switzerland) & Brice. Chalançon (MNAM (Musée National de l'Automobile de Mulhouse), Mulhouse, Alsace, France)

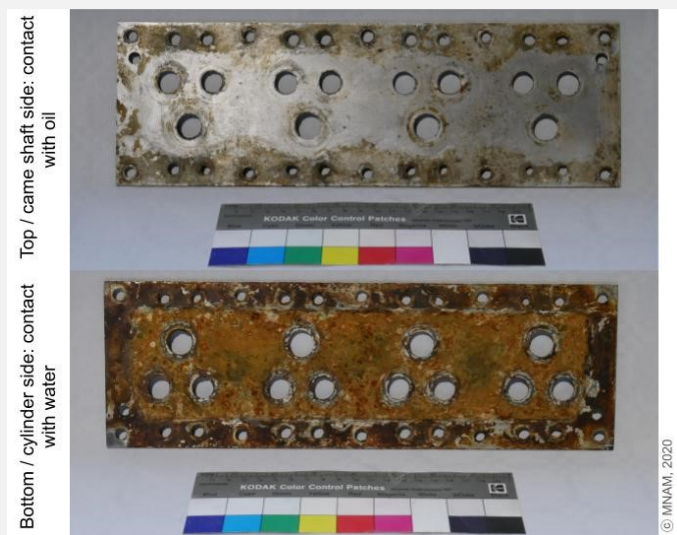
Fig. 1: General picture of the corroded cylinder head gasket of the Bugatti Type 37. Top side facing the camshaft and bottom part in contact with the coolant of the block,

The Bugatti Type 37 will be restored. When the car was dismantled, this gasket was deemed too corroded to be kept. A new part will be put in its place during the restoration. Consequently, this part has been classified as study material, allowing for sampling for metallography.

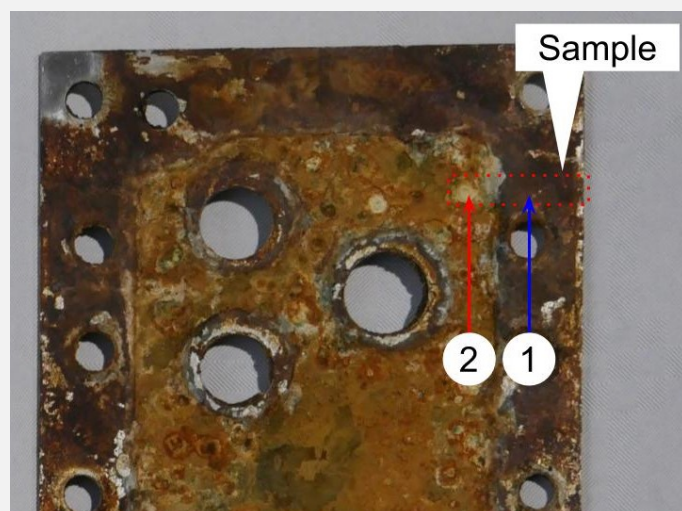
Fig. 3: Bugatti Type 37 cylinder head gasket. Location of the sampling area (red rectangle). Stratigraphic observation sites, in contact with the block [1] and in contact with the coolant [2],

Fig.3 clearly shows the limit where the gasket is in contact with the cylinder block ([1] edges and circular openings in the center) and where it is in contact with the coolant ([2] center).

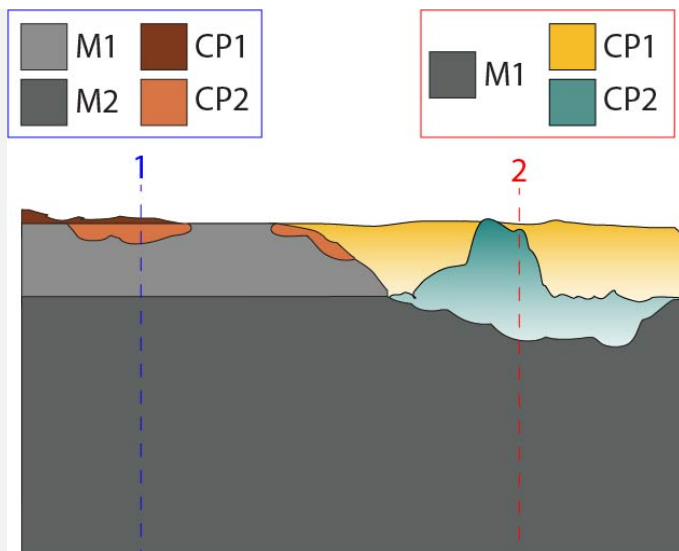
The schematic representation below gives an overview of the corrosion layers encountered on these areas (Fig. 4). The metal core (M1) is colaminated on both sides with metal M2.

| Stratigraphy [1] | Stratigraphy [2] |
|--|--|
| The metal contains the strata M1 and M2. | The first metal stratum is missing and only the core metal (M2 in strat.[1], now M1) remains. |
| The CP1 is a thin brown layer loosely attached to the surface of M1. It can be removed with a firm brush. | The CP1 is a thick bright orange layer, really powdery and easily detached. It can be partly removed with a firm brush. The coloration is less important closer to the metal interface, where the products are white. This layer is also really fragile and friable. |
| In some places, CP2 develops within M1. It is colored in bright orange and can be broken in pieces with a toothpick. | The CP2 is peaking through CP1 in some places, colored in green. |

Fig. 4: Stratigraphic representation of corrosion zones in contact with the block [1] and in contact with the coolant [2],

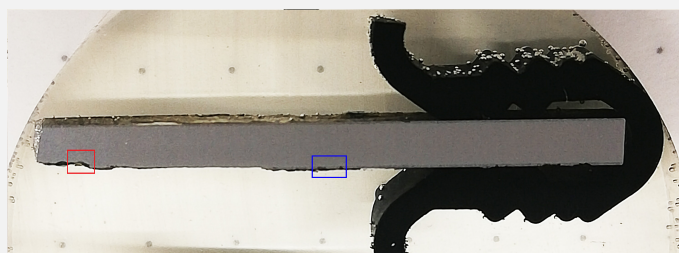
Fig. 5: Micrograph of the cross-section sampled from the Bugatti T37 gasket showing the location of zone 1 in blue (Fig. 6) and zone 2 in red (Fig. 8),

The sample shown on Fig.5 is a transversal cut of the gasket presenting 3 different corrosion sites.

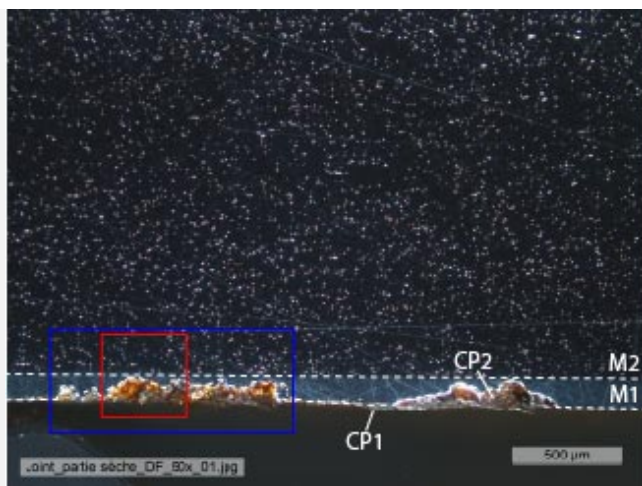
Fig. 6: Micrograph of the cross-section of the gasket, zone 1, shown on Fig. 5 unetched, dark field, showing the location of the EDS elemental chemical distribution of Fig. 10 to 13 (in blue) and of the SEM image of Fig. 7 (in red),

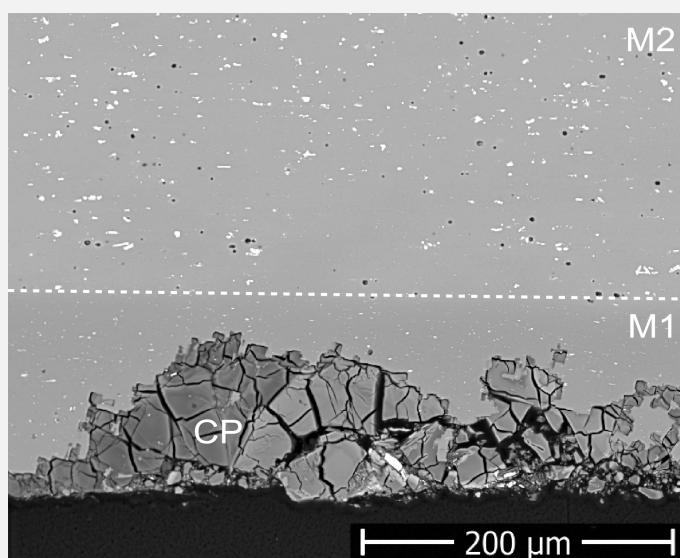
Fig. 7 shows oriented inclusions on both M1 and M2, as well as a lot of small pores in M2.

Local analyses on each phase appearing on Fig. 7 showed that the roll-bounded metal M1 is a compact (non-porous) sheet of pure Al (Table 1) with oriented inclusions of Fe and Si. The core M2 is a very porous alloy composed of Al with bigger oriented inclusions of Si, Mn, Fe, Mg.

Fig 7: SEM detail (BSE mode) of zone 1 of the colaminated sheet in cross-section. The core metal (M2) is porous (in black) and shows oriented inclusions (in white) and the colaminated metal (M1) is compact and has smaller oriented inclusions (in white). Corrosion products (in dark grey) are limited to M1,

Fig. 7 shows that the corrosion products progress through M1 and develop a network of cracks. Fig. 8 shows that the corrosion can expand even further through M2 (zone 2), the corrosion products being more stratified (Fig. 9).

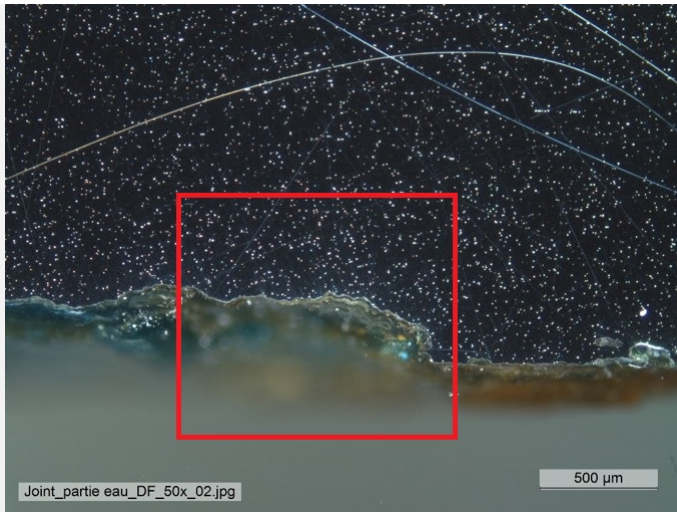
Fig. 8: Micrograph of the cross-section of the gasket, zone 2, shown on Fig. 5 unetched, dark field, showing the location of

the SEM image of Fig. 9 (in red),

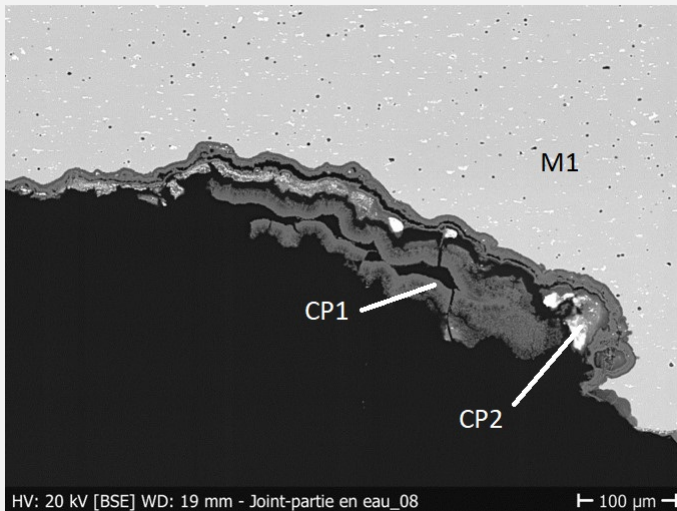
Fig 9: SEM detail (BSE mode) of zone 2 of the gasket in cross-section. The colaminated Al is missing. The core metal (now M1) is porous (black spots) and shows oriented inclusions (in white). The corrosion products (CP1) are very friable and retain clusters of inclusions that are also corroded (CP2),

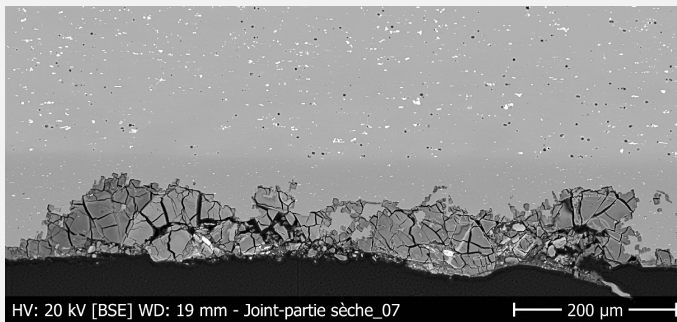
Fig. 10: SEM image (BSE mode) of the cross-section of zone 2 of the gasket (detail of Fig. 6) showing the core metal on top (M2) and the heavily corroded colaminated metal (M1),

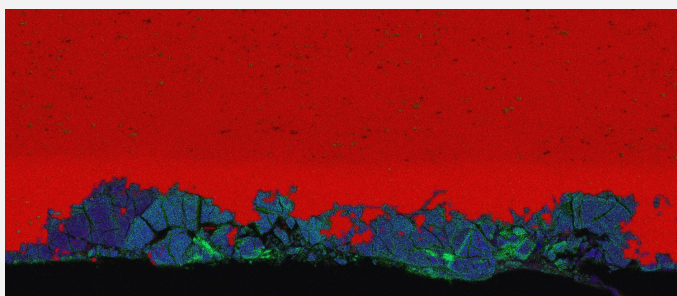
The EDS elemental chemical distribution of zone 1 is given in Fig. 11 to 13. The corrosion layers contain S (probably aluminium sulfate (Fig. 12), polluted with Fe (Fig. 11)). The presence of sulfur can be explained by the proximity of the gasket to the combustion chamber. As for the iron, it is probably coming from the steel block.

Fig. 11: Al (red), O (blue) and Fe (green) chemical distribution of the area of Fig. 10. Method of analysis: SEM-EDS. Lab. of Electronic Microscopy and Microanalysis, Néode, HEI Arc.

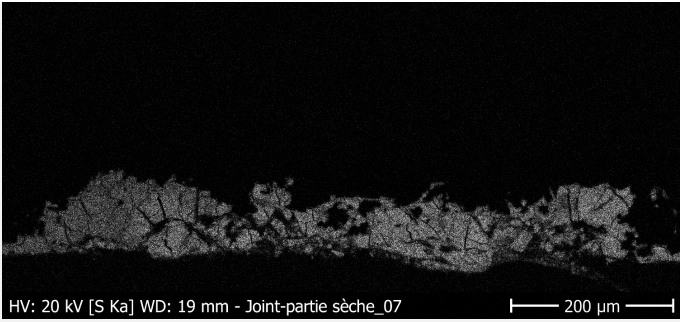
Fig. 12: S chemical distribution of the area of Fig. 10. Method of analysis: SEM-EDS. Lab. of Electronic Microscopy and Microanalysis, Néode, HEI Arc.

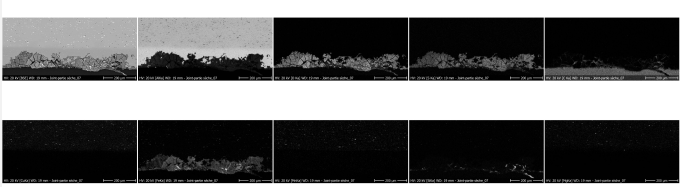
Fig. 13: SEM image and elemental chemical distribution of the area of Fig. 10. Method of analysis: SEM-EDS. Lab. of Electronic Microscopy and Microanalysis, Néode, HEI Arc.

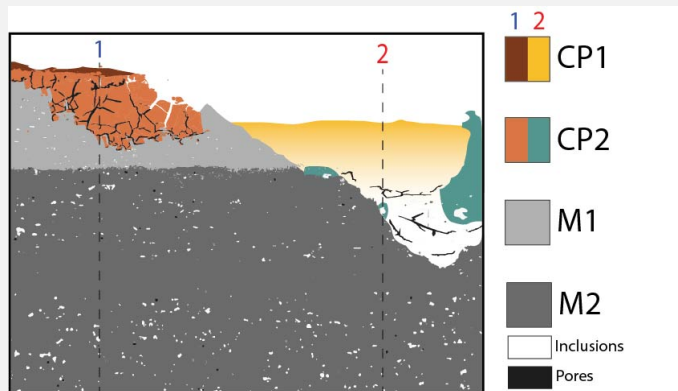
Fig. 16: Improved stratigraphic representation of the 2 corrosion structures of the Bugatti cylinder head gasket. CP1 could not be analysed,

The side of the gasket facing the cylinder block has a different corrosion pattern depending on whether the area is immersed or not. The surface in contact with the cylinder block shows a priori corrosion consisting of highly cracked aluminium sulphate (network). The surface immersed in the coolant is heavily corroded. The colaminated Al sheet has been completely consumed, and the corrosion progresses through the support metal, retaining inclusions of the alloy in its products. This layer is very brittle and tends to delaminate.

All the corrosion products are contaminated with iron oxides, probably from the block. The immersed part is covered with a thick crust of what is believed to be a mixture of ferrous and aluminium-based products.
