BUGATTI COOLING SYSTEM PIPE - AL ALLOY - UNKNOWN - FRANCE

Artefact name Bugatti cooling system pipe

Authors Christian. Degrigny (HE-Arc CR, Neuchâtel, Neuchâtel, Switzerland) & Elodie. Granget (HE-Arc CR, Neuchâtel, Neuchâtel, Switzerland) & Brice. Chalançon (MNAM (Musée National de l'Automobile de Mulhouse), Mulhouse, Alsace, France)

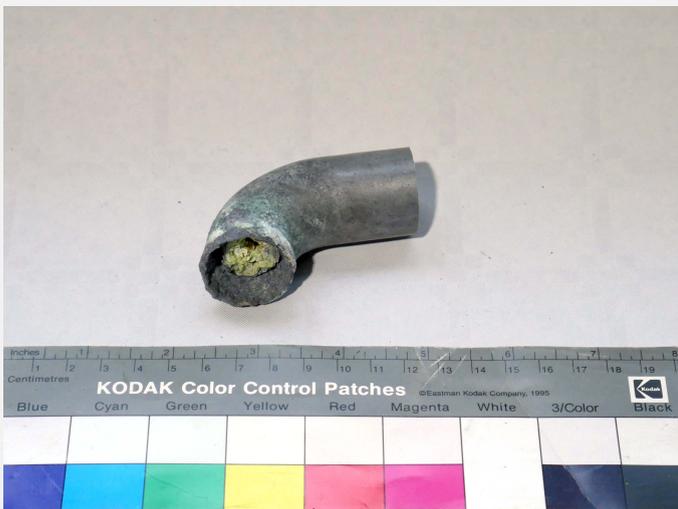
Fig. 1: Bugatti water pipe, unknown model,

Description of the artefact	<p>This section of a pipe was given to the MNAM as study material, without indication of provenance. The pipe is angled, sharply cut on one end and heavily corroded on the other, the inside being clogged by a brittle yellowish deposit.</p> <p>Looking at its shape, it is safe to assume that this is an exit pipe from the upper part of the engine (Fig. 2 and complementary information below).</p>
Type of artefact	Technical object
Origin	MNAM (Musée National de l'Automobile de Mulhouse), Mulhouse, Alsace, France
Recovering date	Unknown
Chronology category	Unknown
chronology tpq	<input type="text" value="1920"/> A.D. ▾
chronology taq	<input type="text" value="1930"/> A.D. ▾
Chronology comment	
Burial conditions / environment	Outdoor to indoor atmosphere
Artefact location	MNAM (Musée National de l'Automobile de Mulhouse), Mulhouse, Alsace
Owner	MNAM (Musée National de l'Automobile de Mulhouse), Mulhouse, Alsace

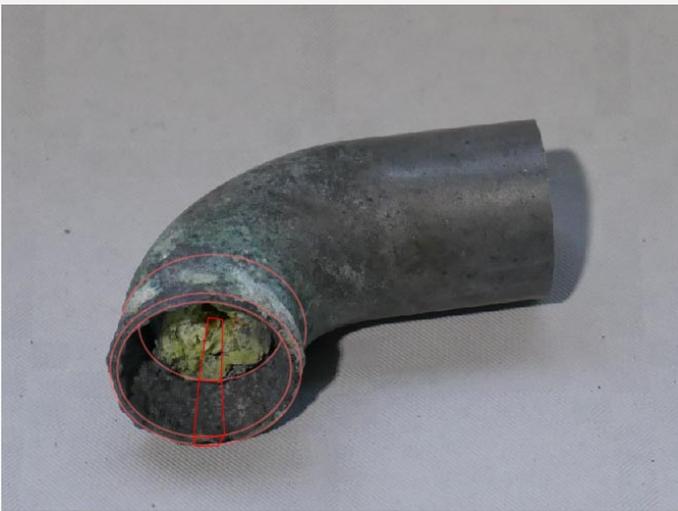
Fig. 3: Heavily corroded side of the Bugatti water pipe showing the sampling area indicated in red,

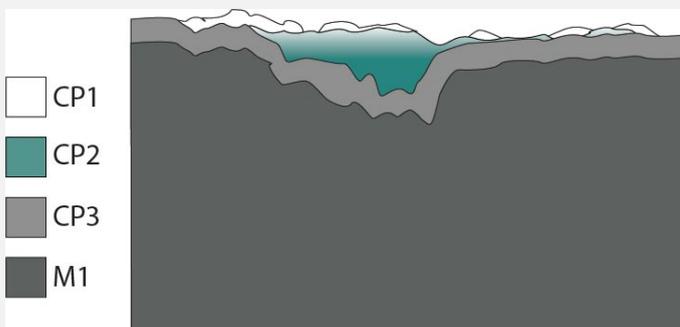
The stratum M is an aluminium alloy. Three CP strata have been identified. CP3 has a greyish mate color and is covering all of the corroded side of the pipe. Scattered over this uniform layer, blue-green (CP2) and white (CP1) spots of corrosion products can be found.

Fig. 4: Stratigraphic representation of the corrosion structure of the external surface of the water pipe from visual macroscopic observation,

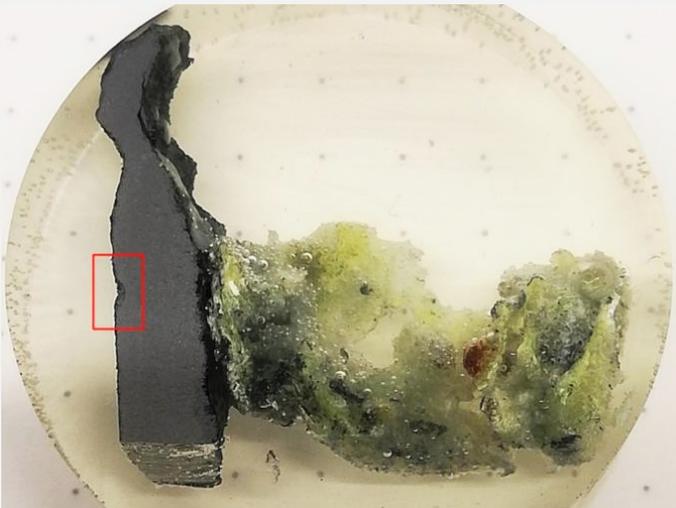
Fig. 6: Micrograph of the sample taken from the corroded exit pipe of the Bugatti water pump (Fig. 3), showing the location of Figs. 7-8 and 11 to 14 in red,

The cross-section shows not only the metal sampled but the accompanying thick yellow deposit that was clugging the pipe. Pitting corrosion develops all along the profile of the sample. A selected area (in red) is further investigated in Figs. 7-8 and 11-14.

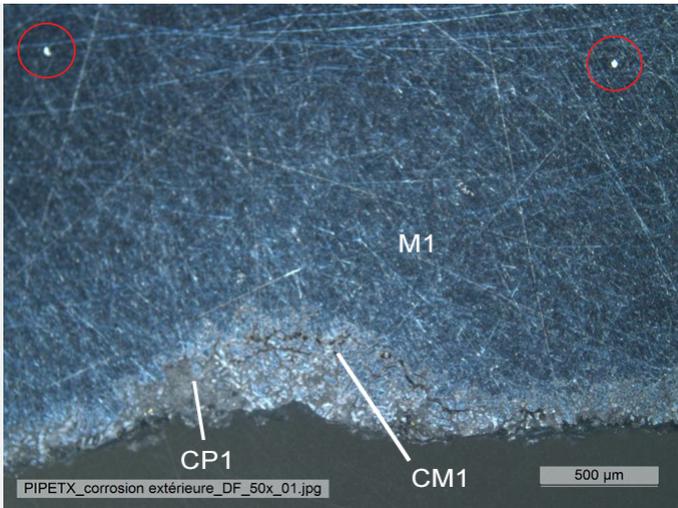
The metal is an aluminium alloy containing both Cu and Zn. It is slightly porous (Fig. 7, red circles). Its dendritic microstructure is revealed by observation in bright field (Fig. 8) and with SEM (Fig. 9).

Fig. 7: Micrograph of the selected area shown on Fig.6 (rotated by 90°), unetched, dark field with indication of pores (red circles),

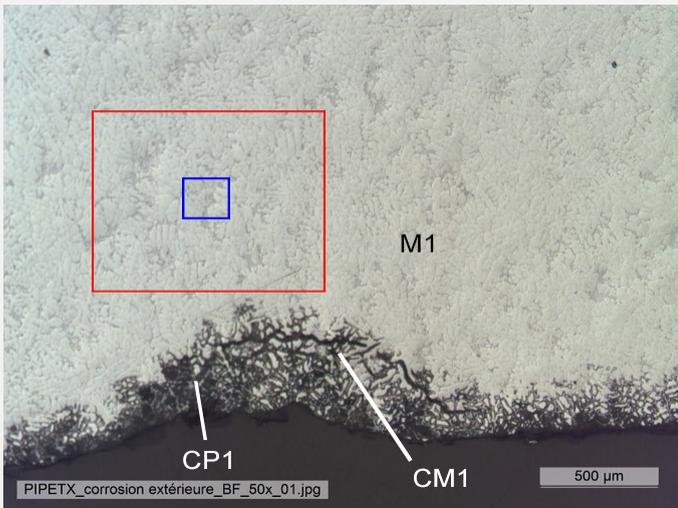
Fig. 8: Micrograph similar to Fig. 7, unetched, bright field showing the locations of Fig. 9 (in red) and Fig. 10 (in blue),

The BF and DF images (Figs. 7 and 8) show a few big cracks at the interface between CM1 and M1. The SEM image shows that they expand in a network of additional microcracks (Fig. 13). The pipe suffers from a uniform interdendritic corrosion. The Al, Cu and Zn phase is oxidising preferentially, developing then aluminium oxides, versus the interdendritic phases. In some places, pits of corrosion formed. SEM cartography showed a concentration of Cl at the base of the pit (Fig. 14: Green).

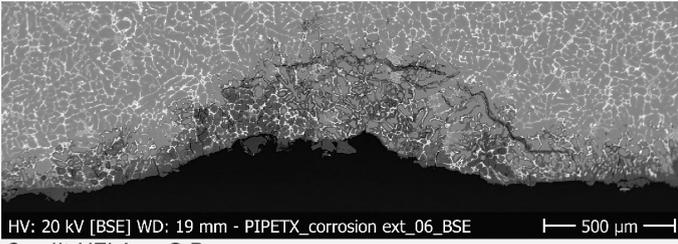
Fig. 13: SEM image of the pitting corrosion of the pipe. BSE, 20kV. Black = Cracks, Dark grey = oxydation, Medium grey = main phase, Light grey = interdendritic phase,

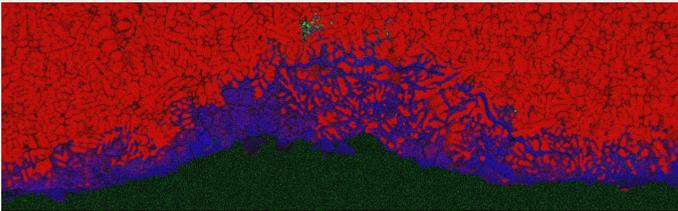
Fig. 14: SEM cartography of a pit of corrosion developing on the pipe. 20kV. Red = Al, Green = Cl, Blue = O,

The external surface shows a uniform interdendritic corrosion preferentially consuming the dendritic phase (Al, Cu, Zn). Pitting corrosion has been identified, with Cl pockets at the base of the pit.

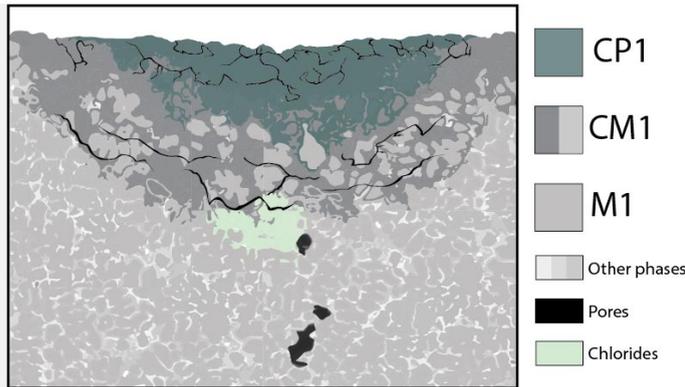
The schematic representation of corrosion layers of Fig. 4 integrating additional information based on the analyses carried out is given in Fig. 15.

Fig. 15: Improved stratigraphic representation of the exit pipe,
