BUGATTI COOLING SYSTEM PIPE – AL ALLOY – UNKNOWN – FRANCE

Artefact name Bugatti cooling system pipe

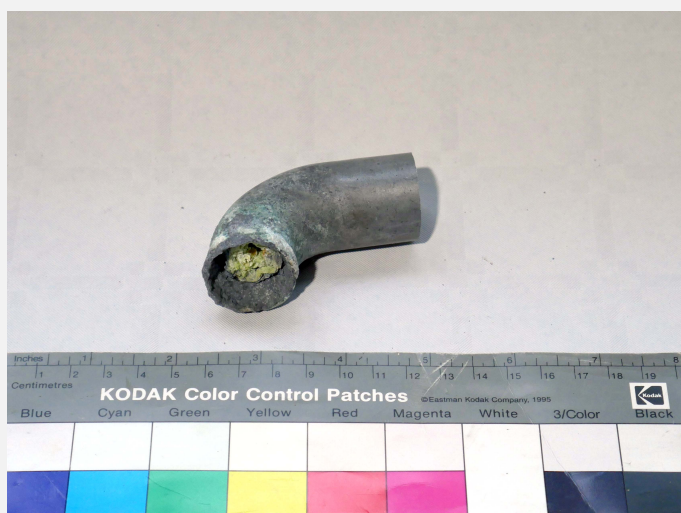
Fig. 1: Bugatti water pipe, unknown model,

Description of the artefact	<p>This section of a pipe was given to the MNAM as study material, without indication of provenance. The pipe is angled, sharply cut on one end and heavily corroded on the other, the inside being clogged by a brittle yellowish deposit.</p> <p>Looking at its shape, it is safe to assume that this is an exit pipe from the upper part of the engine (Fig. 2 and complementary information below).</p>
Type of artefact	Technical object
Origin	MNAM (Musée National de l'Automobile de Mulhouse), Mulhouse, Alsace, France
Recovering date	Unknown
Chronology category	Unknown
chronology tpq	<div>1920</div> <div>A.D. ▾</div>
chronology taq	<div>1930</div> <div>A.D. ▾</div>
Chronology comment	
Burial conditions / environment	Outdoor to indoor atmosphere
Artefact location	MNAM (Musée National de l'Automobile de Mulhouse), Mulhouse, Alsace
Owner	MNAM (Musée National de l'Automobile de Mulhouse), Mulhouse, Alsace

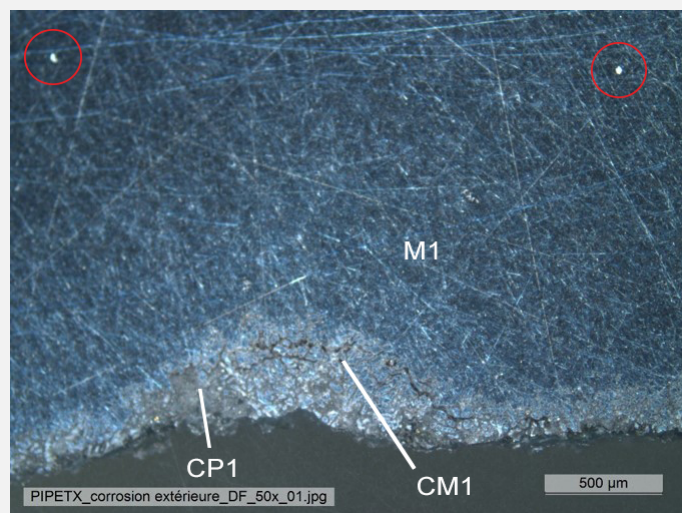
The metal is an aluminium alloy containing both Cu and Zn. It is slightly porous (Fig. 7, red circles). Its dendritic microstructure is revealed by observation in bright field (Fig. 8) and with SEM (Fig. 9).

Fig. 7: Micrograph of the selected area shown on Fig.6 (rotated by 90°), unetched, dark field with indication of pores (red circles),

The BF and DF images (Figs. 7 and 8) show a few big cracks at the interface between CM1 and M1. The SEM image shows that they expand in a network of additional microcracks (Fig. 13). The pipe suffers from a uniform interdendritic corrosion. The Al, Cu and Zn phase is oxidising preferentially, developing then aluminium oxides, versus the interdendritic phases. In some places, pits of corrosion formed. SEM cartography showed a concentration of Cl at the base of the pit (Fig. 14: Green).

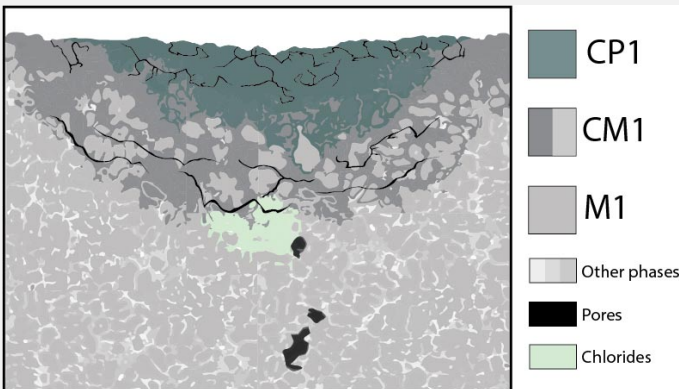
Fig. 15: Improved stratigraphic representation of the exit pipe,
