RING SMRA 16-17285-01 - CU ALLOY - ROMAN TIMES - SWITZERLAND

Artefact name	Ring SMRA 16-17285-01
Authors	Christian. Degrigny (HE-Arc CR, Neuchâtel, Neuchâtel, Switzerland) & Naima. Gutknecht (HE-Arc CR, Neuchâtel, Neuchâtel, Switzerland) & Valentina. Valbi (Laboratoire Métallurgie et Culture LMC-IRAMAT-CNRS-UTBM, Belfort, Franche-Comté, France)
Url	/artefacts/1126/

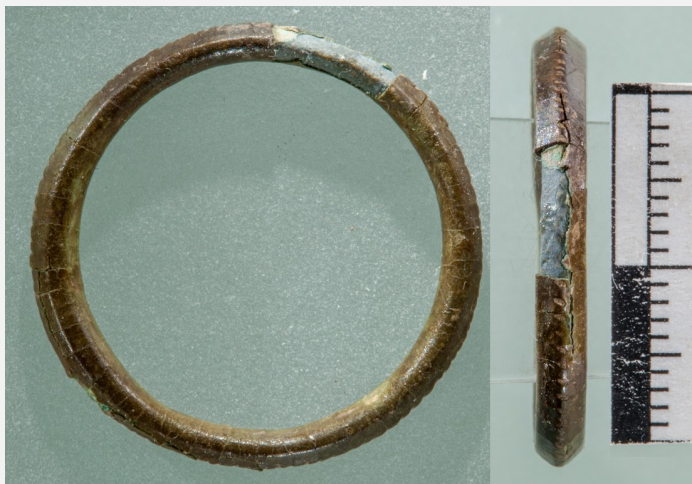
Fig. 1: Ring (face A and side views),

Description of the artefact	Ring with a diamond-shaped cross-section and decorated with ridges on the outside. Its original shape seems to be preserved although the brown corrosion structure is heavily cracked and even has a large lacuna on face A (Fig. 1). Diameter (external) = 2.5cm.
Type of artefact	Jewellery
Origin	Avenches, Switzerland, Avenches, Vaud, Switzerland
Recovering date	2016
Chronology category	Roman Times
chronology tpq	<input type="text"/> ---- ▾
chronology taq	<input type="text"/> ---- ▾
Chronology comment	
Burial conditions / environment	Soil
Artefact location	Site et musée romains Avenches, Avenches, Vaud
Owner	Site et musée romains Avenches, Avenches, Vaud
Inv. number	SMRA 16/17285-01
Recorded conservation data	Cleaning of soil with ethanol and consolidation with resin paraloid B72 in ethyl acetate. Drying at 50°C.

Flaking of the surface was observed before the drying of the object, hence the consolidation with paraloid B72.

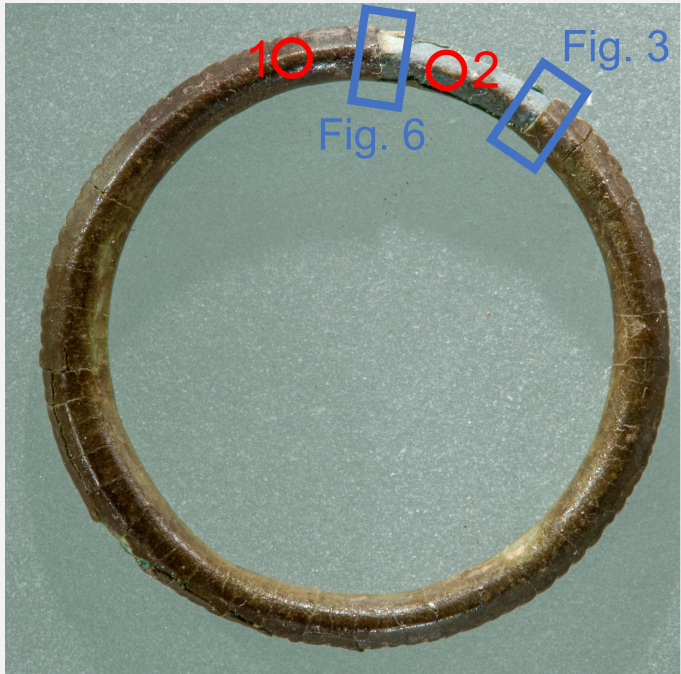
Fig. 2: Location of XRF analyses (red circles), Fig. 3 (blue square) and Fig. 6 (Raman spectroscopy (blue square)) on face A,

XRF analysis was carried out without sampling. For point 1, all strata (soil, corrosion products, and metal) are analyzed at the same time. As for point 2, the analysis was performed where corrosion layers flaked. Therefore, it reflects better the metal composition. The metal is presumably a copper-tin alloy with some lead, while the Si, Fe, Al and P are probably coming from the burial environment. The higher amount of tin on point 1 (with corrosion layers) than on point 2 (corrosion structure flaked, metal visible) is a strong indicator of tin enrichment on the corrosion layers.

Table 2: Chemical composition analysed with handheld XRF at the surface of the ring for two representative points shown in Fig.2. The results are rounded up to the nearest whole number, UR-Arc CR.

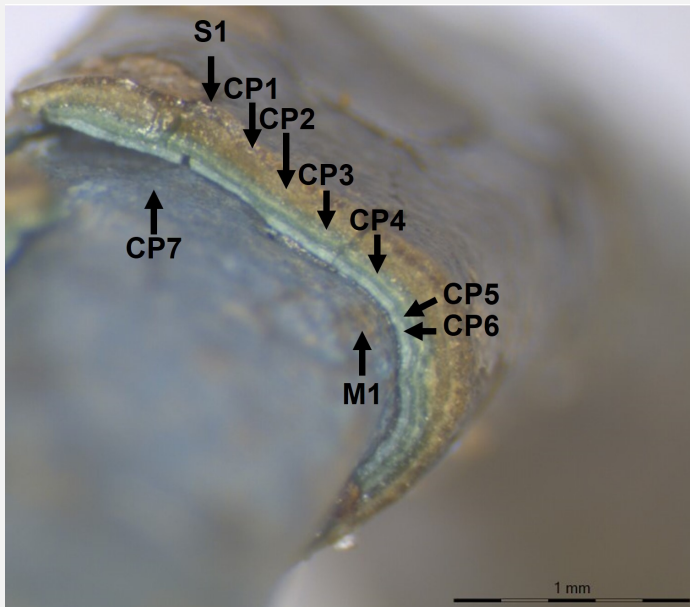
Fig. 3: Description of the corrosion structure,

The schematic representation below gives an overview of the corrosion structure encountered on the ring from a first visual macroscopic observation. There are cracks through CP1 to CP6 that generate the flaking of the layers.

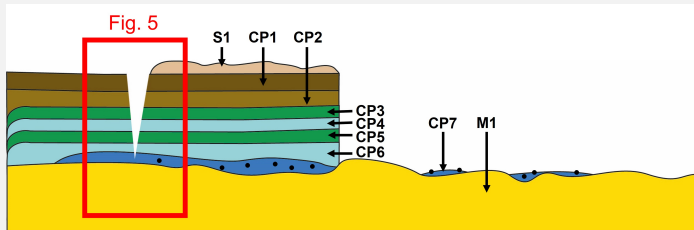
Fig. 4: Stratigraphic representation of the corrosion structure of the ring by macroscopic and binocular observation with indication of the corrosion structure used to build the MiCorr stratigraphy of Fig. 5 (red rectangular),

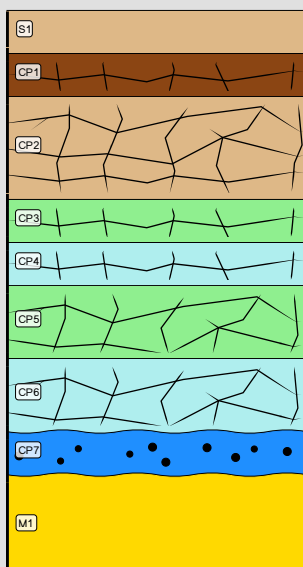
Fig. 5: Stratigraphic representation of the corrosion structure of the ring observed macroscopically under binocular using the MiCorr application with reference to Fig. 4. The characteristics of the strata, such a discontinuity, are accessible by clicking on the drawing that redirects you to the search tool by stratigraphy representation, Credit HE-Arc CR, N.Gutknecht.

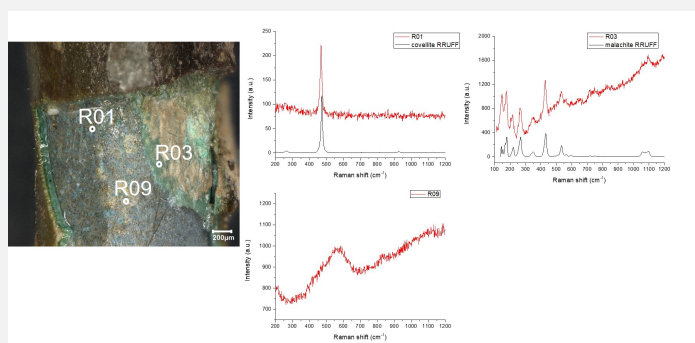
It was not possible to sample this artefact. Therefore, μ -Raman point analyses were performed on the surface of the object in an area where different strata of corrosion products were exposed, as shown in Fig. 6 in a micrograph taken by optical microscopy. The surface of the object appears brown (CP1). It covers a green stratum (CP5) and a blue/golden one (CP7 and M1) with black spots in it. The R01 analysis point was performed on one of the blackspots observed in the blue stratum and can be identified as covellite (CuS) by comparison with a reference spectrum. Point analyses performed on the blue (CP7) and golden stratum showed a spectrum with a large peak at around 560 cm^{-1} (R09) that can be identified as nanocassiterite (SnO₂) by comparison with the work of Ospitali et al. 2012. The R03 point analysis was performed on the green stratum (CP5) and is identified as malachite (Cu₂(CO₃)(OH)₂) by comparison with a reference spectrum.

Fig. 6: Raman points of analysis on the surface of the object and Raman spectra obtained for R01 (together with the covellite reference spectrum RRUFFID=R060306), R03 (together with the malachite reference spectrum RRUFFID=R050508) and R09,

The ring is a tin bronze probably with some lead. The identification of nanocassiterite as the most internal CP shows a phenomenon of decuprification typical of bronze corrosion, accompanied by the formation of copper hydroxycarbonate as a more external CP. The dark inclusions observed in the CP7 and identified as covellite are likely to be residuals of copper sulfide inclusions from the metal microstructure.
