RING SMRA 16-17285-01 – CU ALLOY – ROMAN TIMES – SWITZERLAND

Artefact name	Ring SMRA 16-17285-01
Authors	Christian. Degriigny (HE-Arc CR, Neuchâtel, Neuchâtel, Switzerland) & Naima. Gutknecht (HE-Arc CR, Neuchâtel, Neuchâtel, Switzerland) & Valentina. Valbi (Laboratoire Métallurgie et Culture LMC-IRAMAT-CNRS-UTBM, Belfort, Franche-Comté, France)
Url	/artefacts/1126/

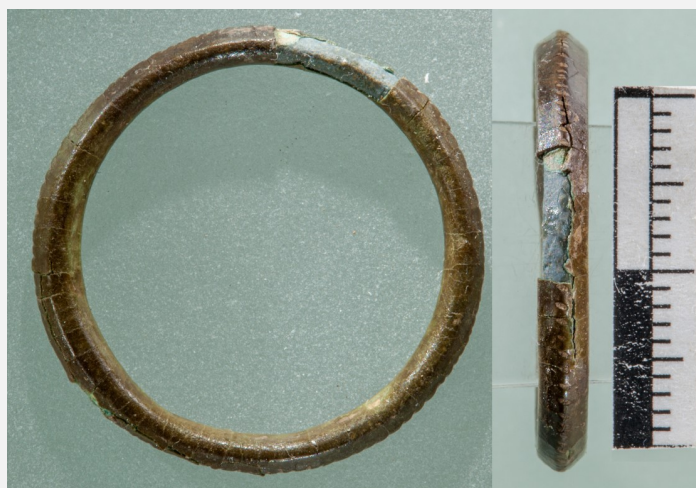
Fig. 1: Ring (face A and side views),

Description of the artefact	Ring with a diamond-shaped cross-section and decorated with ridges on the outside. Its original shape seems to be preserved although the brown corrosion structure is heavily cracked and even has a large lacuna on face A (Fig. 1). Diameter (external) = 2.5cm.
Type of artefact	Jewellery
Origin	Avenches, Switzerland, Avenches, Vaud, Switzerland
Recovering date	2016
Chronology category	Roman Times
chronology tpq	<input type="text"/> ---- ▼
chronology taq	<input type="text"/> ---- ▼
Chronology comment	
Burial conditions / environment	Soil
Artefact location	Site et musée romains Avenches, Avenches, Vaud
Owner	Site et musée romains Avenches, Avenches, Vaud
Inv. number	SMRA 16/17285-01
Recorded conservation data	Cleaning of soil with ethanol and consolidation with resin paraloid B72 in ethyl acetate. Drying at 50°C.

Flaking of the surface was observed before the drying of the object, hence the consolidation with paraloid B72.

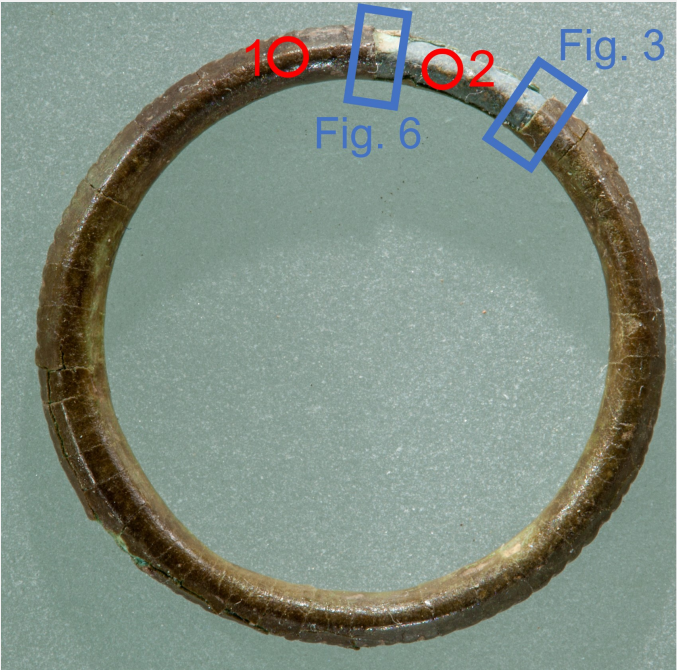
Fig. 2: Location of XRF analyses (red circles), Fig. 3 (blue square) and Fig. 6 (Raman spectroscopy (blue square)) on face A,

XRF analysis was carried out without sampling. For point 1, all strata (soil, corrosion products, and metal) are analyzed at the same time. As for point 2, the analysis was performed where corrosion layers flaked. Therefore, it reflects better the metal composition. The metal is presumably a copper-tin alloy with some lead, while the Si, Fe, Al and P are probably coming from the burial environment. The higher amount of tin on point 1 (with corrosion layers) than on point 2 (corrosion structure flaked, metal visible) is a strong indicator of tin enrichment on the corrosion layers.

Table 2: Chemical composition analysed with handheld XRF at the surface of the ring for two representative points shown in Fig.2. The results are rounded up to the nearest whole number, UR-Arc CR.

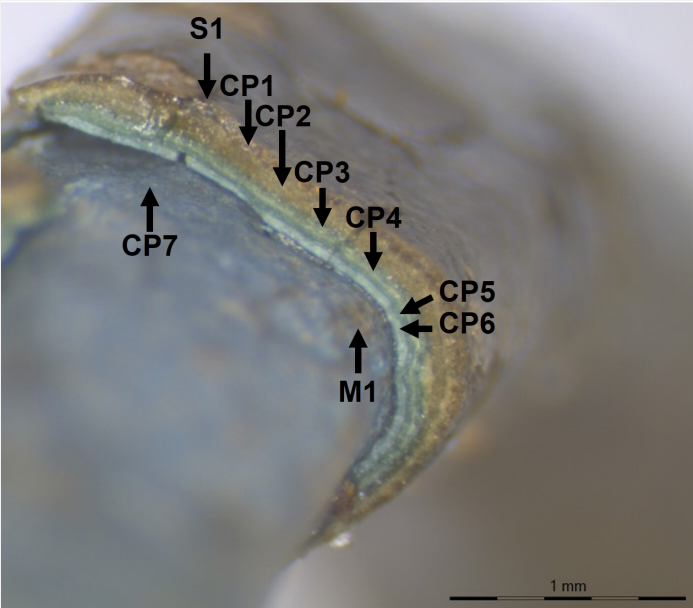
Fig. 3: Description of the corrosion structure,

The schematic representation below gives an overview of the corrosion structure encountered on the ring from a first visual macroscopic observation. There are cracks through CP1 to CP6 that generate the flaking of the layers.

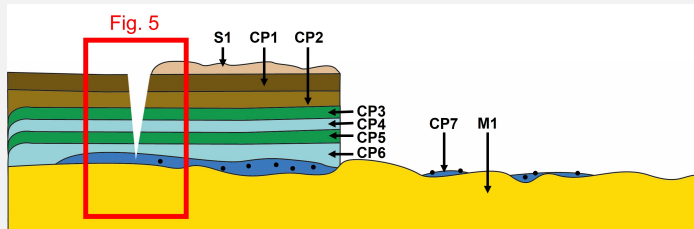
Fig. 4: Stratigraphic representation of the corrosion structure of the ring by macroscopic and binocular observation with indication of the corrosion structure used to build the MiCorr stratigraphy of Fig. 5 (red rectangular),

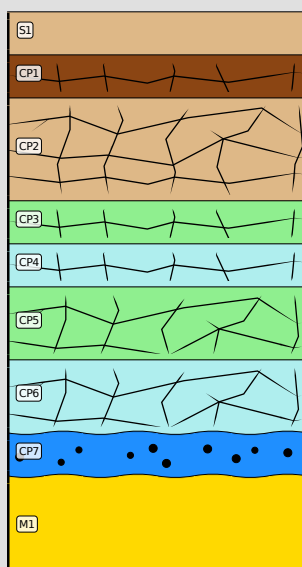
Fig. 5: Stratigraphic representation of the corrosion structure of the ring observed macroscopically under binocular using the MiCorr application with reference to Fig. 4. The characteristics of the strata, such a discontinuity, are accessible by clicking on the drawing that redirects you to the search tool by stratigraphy representation, Credit HE-Arc CR, N.Gutknecht.

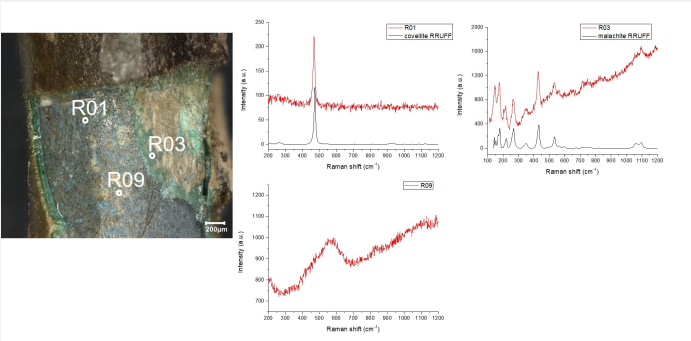
It was not possible to sample this artefact. Therefore, μ -Raman point analyses were performed on the surface of the object in an area where different strata of corrosion products were exposed, as shown in Fig. 6 in a micrograph taken by optical microscopy. The surface of the object appears brown (CP1). It covers a green stratum (CP5) and a blue/golden one (CP7 and M1) with black spots in it. The R01 analysis point was performed on one of the blackpots observed in the blue stratum and can be identified as covellite (CuS) by comparison with a reference spectrum. Point analyses performed on the blue (CP7) and golden stratum showed a spectrum with a large peak at around 560 cm^{-1} (R09) that can be identified as nanocassiterite (SnO_2) by comparison with the work of Ospitali et al. 2012. The R03 point analysis was performed on the green stratum (CP5) and is identified as malachite ($\text{Cu}_2(\text{CO}_3)(\text{OH})_2$) by comparison with a reference spectrum.

Fig. 6: Raman points of analysis on the surface of the object and Raman spectra obtained for R01 (together with the covellite reference spectrum RRUFFID=R060306), R03 (together with the malachite reference spectrum RRUFFID=R050508) and R09,

The ring is a tin bronze probably with some lead. The identification of nanocassiterite as the most internal CP shows a phenomenon of decuprification typical of bronze corrosion, accompanied by the formation of copper hydroxycarbonate as a more external CP. The dark inclusions observed in the CP7 and identified as covellite are likely to be residuals of copper sulfide inclusions from the metal microstructure.
