## RING SMRA 16-17285-01 - CU ALLOY - ROMAN TIMES - SWITZERLAND

<b>Artefact name</b>	Ring SMRA 16-17285-01
<b>Authors</b>	Christian. Degrygn (HE-Arc CR, Neuchâtel, Neuchâtel, Switzerland) & Naima. Gutknecht (HE-Arc CR, Neuchâtel, Neuchâtel, Switzerland) & Valentina. Valbi (Laboratoire Métallurgie et Culture LMC-IRAMAT-CNRS-UTBM, Belfort, Franche-Comté, France)
<b>Url</b>	/artefacts/1126/

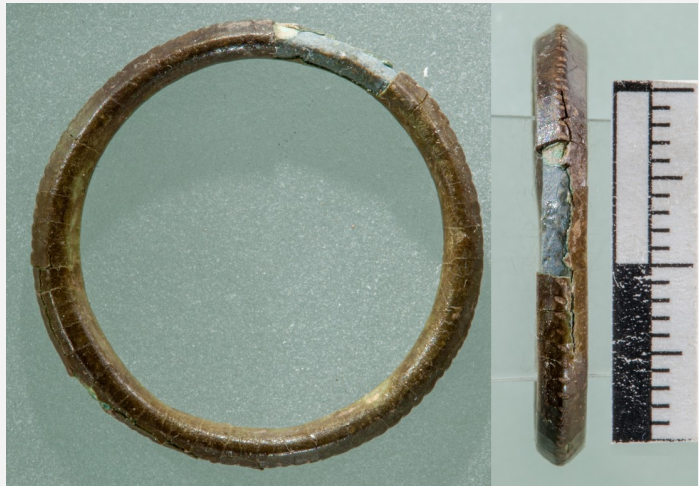
Fig. 1: Ring (face A and side views),

<b>Description of the artefact</b>	Ring with a diamond-shaped cross-section and decorated with ridges on the outside. Its original shape seems to be preserved although the brown corrosion structure is heavily cracked and even has a large lacuna on face A (Fig. 1). Diameter (external) = 2.5cm.
<b>Type of artefact</b>	Jewellery
<b>Origin</b>	Avenches, Switzerland, Avenches, Vaud, Switzerland
<b>Recovering date</b>	2016
<b>Chronology category</b>	Roman Times
<b>chronology tpq</b>	<input type="text"/> ---- ▾
<b>chronology taq</b>	<input type="text"/> ---- ▾
<b>Chronology comment</b>	
<b>Burial conditions / environment</b>	Soil
<b>Artefact location</b>	Site et musée romains Avenches, Avenches, Vaud
<b>Owner</b>	Site et musée romains Avenches, Avenches, Vaud
<b>Inv. number</b>	SMRA 16/17285-01
<b>Recorded conservation data</b>	Cleaning of soil with ethanol and consolidation with resin paraloid B72 in ethyl acetate. Drying at 50°C.

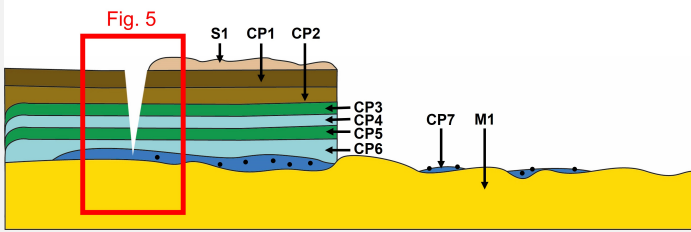
Fig. 4: Stratigraphic representation of the corrosion structure of the ring by macroscopic and binocular observation with indication of the corrosion structure used to build the MiCorr stratigraphy of Fig. 5 (red rectangular),

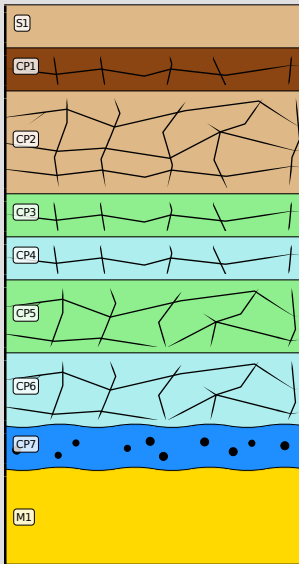
Fig. 5: Stratigraphic representation of the corrosion structure of the ring observed macroscopically under binocular using the MiCorr application with reference to Fig. 4. The characteristics of the strata, such a discontinuity, are accessible by clicking on the drawing that redirects you to the search tool by stratigraphy representation, Credit HE-Arc CR, N.Gutknecht.

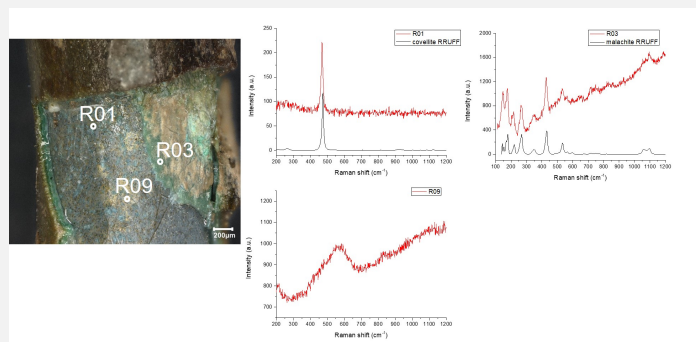
It was not possible to sample this artefact. Therefore,  $\mu$ -Raman point analyses were performed on the surface of the object in an area where different strata of corrosion products were exposed, as shown in Fig. 6 in a micrograph taken by optical microscopy. The surface of the object appears brown (CP1). It covers a green stratum (CP5) and a blue/golden one (CP7 and M1) with black spots in it. The R01 analysis point was performed on one of the blackspots observed in the blue stratum and can be identified as covellite (CuS) by comparison with a reference spectrum. Point analyses performed on the blue (CP7) and golden stratum showed a spectrum with a large peak at around 560  $\text{cm}^{-1}$  (R09) that can be identified as nanocassiterite (SnO<sub>2</sub>) by comparison with the work of Ospitali et al. 2012. The R03 point analysis was performed on the green stratum (CP5) and is identified as malachite (Cu<sub>2</sub>(CO<sub>3</sub>)(OH)<sub>2</sub>) by comparison with a reference spectrum.

Fig. 6: Raman points of analysis on the surface of the object and Raman spectra obtained for R01 (together with the covellite reference spectrum RRUFFID=R060306), R03 (together with the malachite reference spectrum RRUFFID=R050508) and R09,

The ring is a tin bronze probably with some lead. The identification of nanocassiterite as the most internal CP shows a phenomenon of decuprification typical of bronze corrosion, accompanied by the formation of copper hydroxycarbonate as a more external CP. The dark inclusions observed in the CP7 and identified as covellite are likely to be residuals of copper sulfide inclusions from the metal microstructure.
