SETTINGS OF THE GREAT SHRINE OF SAINT MAURICE – AG ALLOY – HIGH MEDIEVAL TIMES

Artefact name Settings of the Great Shrine of saint Maurice

Authors Romain. Jeanneret (Abbaye de St-Maurice, Saint-Maurice, Valais, Switzerland)

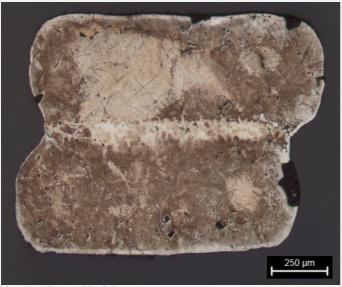
Welding zones are present, in particular for the Bv35.02 and Cv44.02 settings, only visible after etching (Figs. 11, 12 and 15). No clear difference in composition can be seen in these areas (Figs. 13 and 16). The grain structure (large polygonal grains, which may indicate recrystallization of the material(s)) is only visible in the SEM, BSE mode, and by increasing the beam intensity to 10nA (Figs. 8 and 10). Smaller grains are observed in the welding zones (Fig. 8).

Fig.11: Micrograph of Bv35.02 sample etched (to compare to Fig. 8),

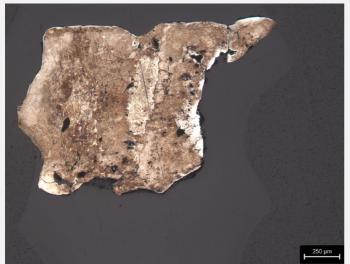
Fig.15: Micrograph of Cv44.02 sample etched (to compare to Fig. 10),
