SETTINGS OF THE GREAT SHRINE OF SAINT MAURICE – AG ALLOY – HIGH MEDIEVAL TIMES

Artefact name	Settings of the Great Shrine of saint Maurice
Authors	Romain. Jeanneret (Abbaye de St-Maurice, Saint-Maurice, Valais, Switzerland)
Url	/artefacts/1175/

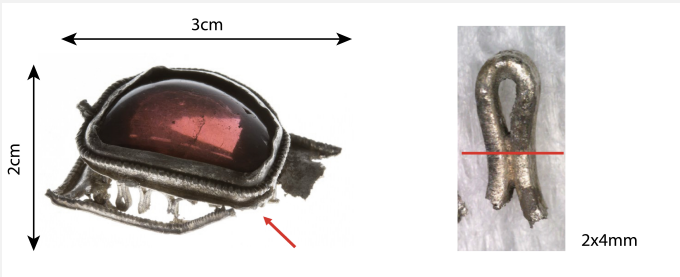
Fig. 3: Location of the analyzed fragments (3) of setting Bv35.02 and of the sampling area on the arcature tarnished fragment soldered on itself. Dimensions: 4 x 2 mm,

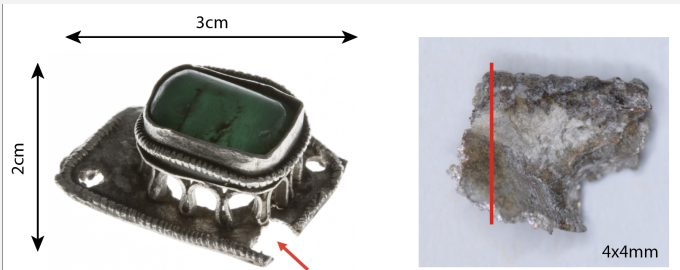
Fig. 4: Location of the analyzed tarnished fragment covered with deposits of cleaning products of setting Bv49.07 and of the sampling area. Assembly by solder between the bottom plate and the twisted wire. Dimensions: 4 x 4 mm,

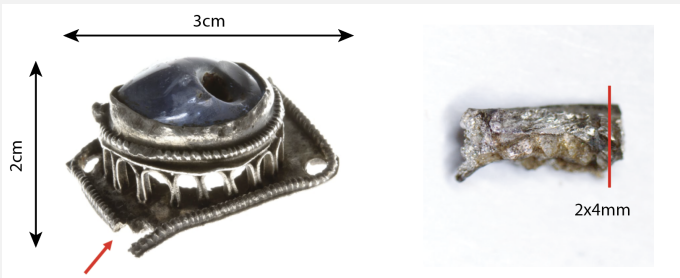
Fig. 5: Location of the analyzed tarnished fragment of setting Cv44.02 and of the sampling area. Assembly by solder between the bottom plate and the twisted wire. Dimensions: 4 x 2 mm,

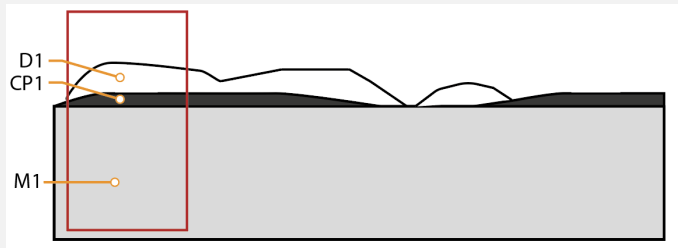
The schematic representation of Fig. 6 gives an overview of the corrosion structures encountered on the arcature settings from a first visual macroscopic observation.

Fig. 6: Stratigraphic representation of the corrosion structures of both settings Bv35.02, Bv49.07 and Cv44.02 by macroscopic and binocular observation with indication of the corrosion structure used to build the MiCorr stratigraphy of Fig. 7 (red rectangular),

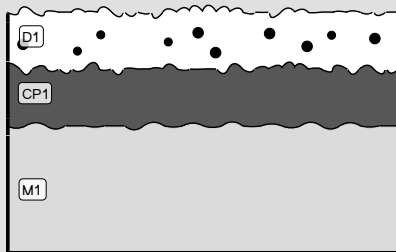
Fig.7: Stratigraphic representation of the corrosion structures of the Bv35.02, Bv49.07 & Cv44.02 settings observed macroscopically under binocular microscope using the MiCorr application with reference to Fig. 6. The characteristics of the strata are only accessible by clicking on the drawing that redirects you to the search tool by stratigraphy representation. Credit HE-Arc CR, N. Gutknecht.

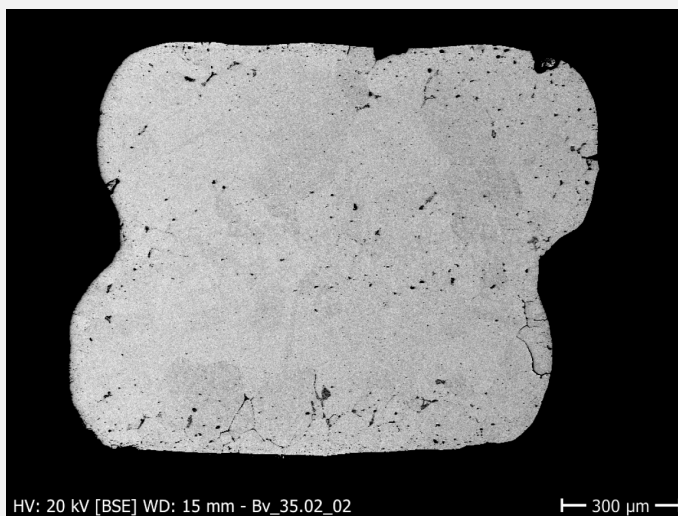
Fig.8: SEM image (BSE mode, current 10nA) of the cross-section of the sample taken from setting Bv35.02 revealing partly the microstructure,

Welding zones are present, in particular for the Bv35.02 and Cv44.02 settings, only visible after etching (Figs. 11, 12 and 15). No clear difference in composition can be seen in these areas (Figs. 13 and 16). The grain structure (large polygonal grains, which may indicate recrystallization of the material(s)) is only visible in the SEM, BSE mode, and by increasing the beam intensity to 10nA (Figs. 8 and 10). Smaller grains are observed in the welding zones (Fig. 8).

The metal is covered with a thin layer of greyish and yellowish tarnish (CP1) on which residues of cleaning products are detected (D1). This tarnish has not been analyzed, but other work shows that the silver tarnish of the objects in the Treasury of the Abbey of Saint-Maurice usually consists of silver sulphide and silver chloride (Degriigny et al. 2015). This type of tarnishing is typical for silver alloys containing low copper content (Costa 2001, Graedel 1992 and Tissot et al. 2016). The metal of the settings is the site of intergranular corrosion (Wanhill, 2013) which appears to be limited to a thickness of 150-200 microns (Figs. 8 and 10).

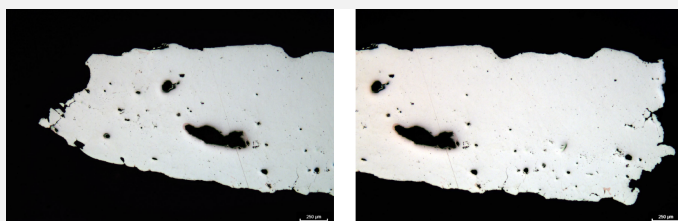
Fig.9: Micrograph of the cross-section of the sample taken from setting Bv49.07,

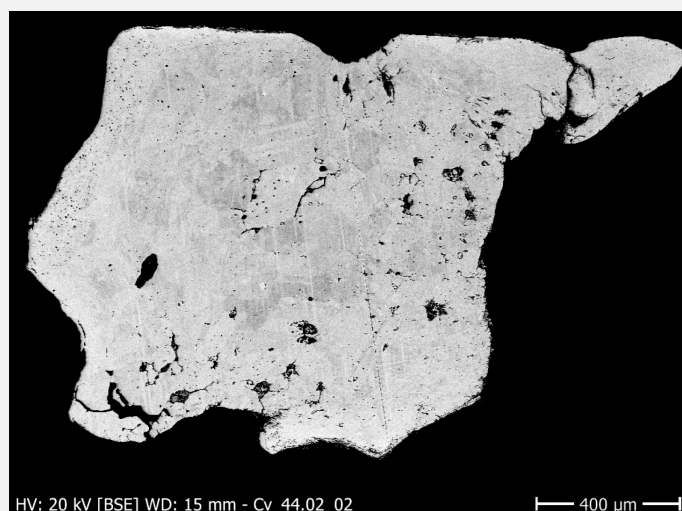
Fig. 10: SEM image (BSE mode, current 10nA) of the cross-section of the sample taken from setting Cv44.02 revealing partly the microstructure,

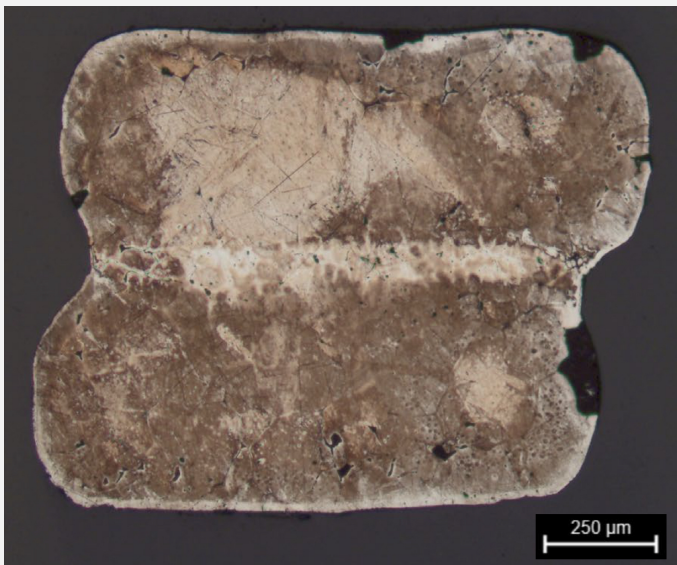
Fig.11: Micrograph of Bv35.02 sample etched (to compare to Fig. 8),

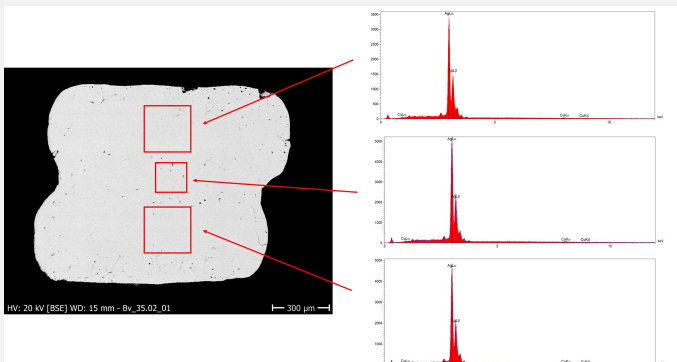
Fig.13: Location of EDS analyses on the cross-section of the Bv35.02 setting with associated spectra,

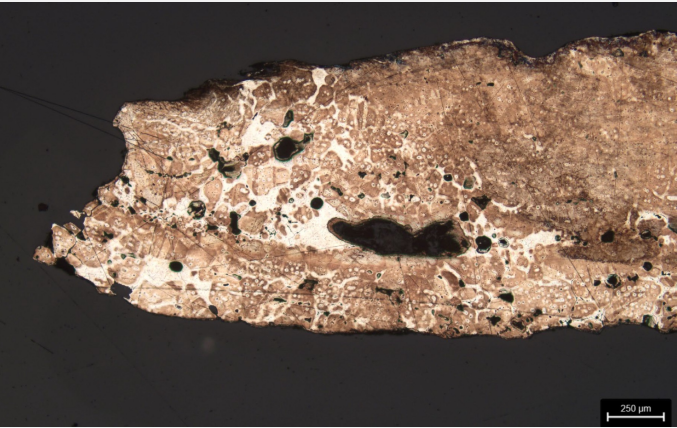
Fig.14: Micrograph of Bv49.07 sample etched. No EDS analysis was made,

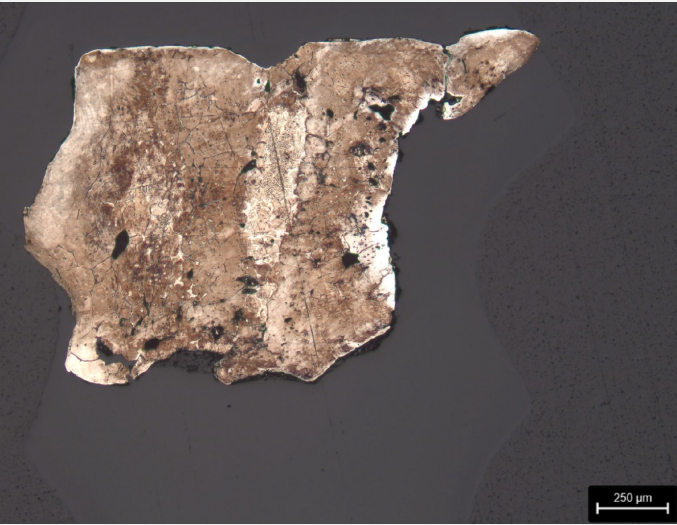
Fig.15: Micrograph of Cv44.02 sample etched (to compare to Fig. 10),

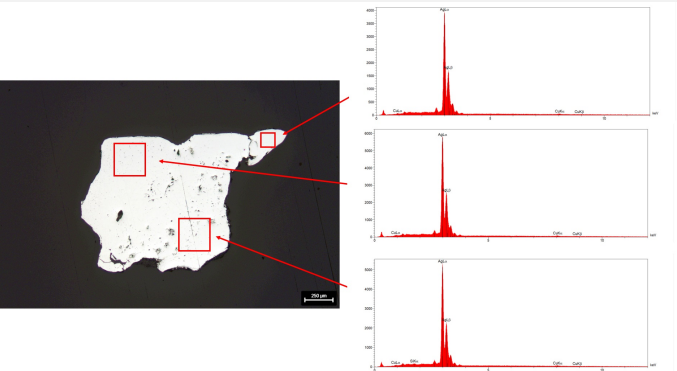
Fig.16: Location of EDS analyses on the cross-section of the Cv44.02 setting with associated spectra,

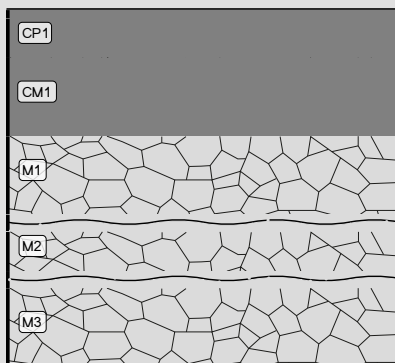
Fig.19: Stratigraphic representation of the sample taken from Bv35.02 in cross-section using the MiCorr application. The characteristics of the strata are only accessible by clicking on the drawing that redirects you to the search tool by stratigraphy representation. This representation can be compared to Fig. 8. Credit ABSM, R. Jeanneret.
