SETTINGS OF THE GREAT SHRINE OF SAINT MAURICE – AG ALLOY – HIGH MEDIEVAL TIMES

Artefact name	Settings of the Great Shrine of saint Maurice
Authors	Romain. Jeanneret (Abbaye de St-Maurice, Saint-Maurice, Valais, Switzerland)
Url	/artefacts/1175/

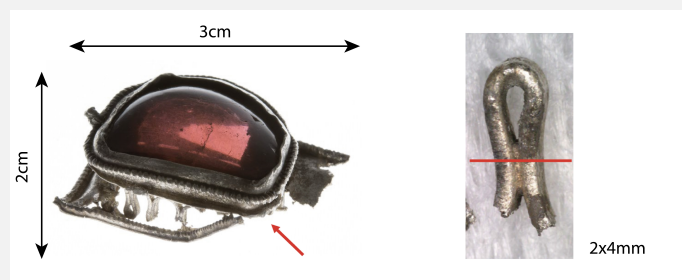
Fig. 3: Location of the analyzed fragments (3) of setting Bv35.02 and of the sampling area on the arcature tarnished fragment soldered on itself. Dimensions: 4 x 2 mm,

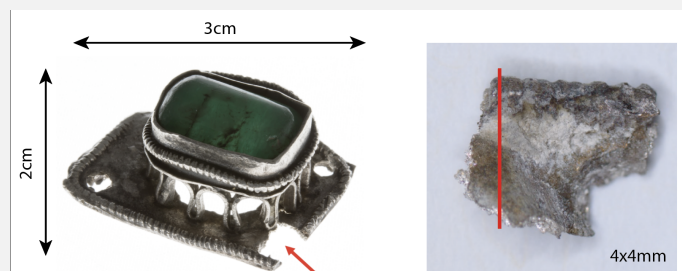
Fig. 4: Location of the analyzed tarnished fragment covered with deposits of cleaning products of setting Bv49.07 and of the sampling area. Assembly by solder between the bottom plate and the twisted wire. Dimensions: 4 x 4 mm,

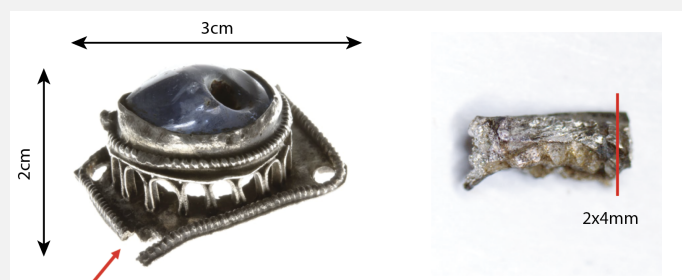
Fig. 5: Location of the analyzed tarnished fragment of setting Cv44.02 and of the sampling area. Assembly by solder between the bottom plate and the twisted wire. Dimensions: 4 x 2 mm,

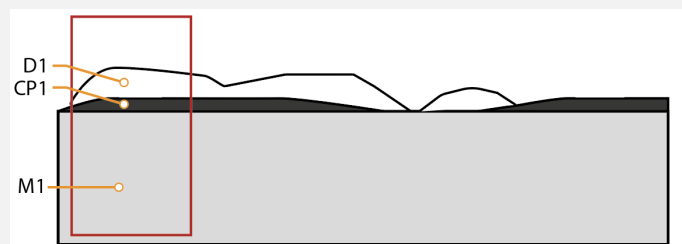
The schematic representation of Fig. 6 gives an overview of the corrosion structures encountered on the arcature settings from a first visual macroscopic observation.

Fig. 6: Stratigraphic representation of the corrosion structures of both settings Bv35.02, Bv49.07 and Cv44.02 by macroscopic and binocular observation with indication of the corrosion structure used to build the MiCorr stratigraphy of Fig. 7 (red rectangular),

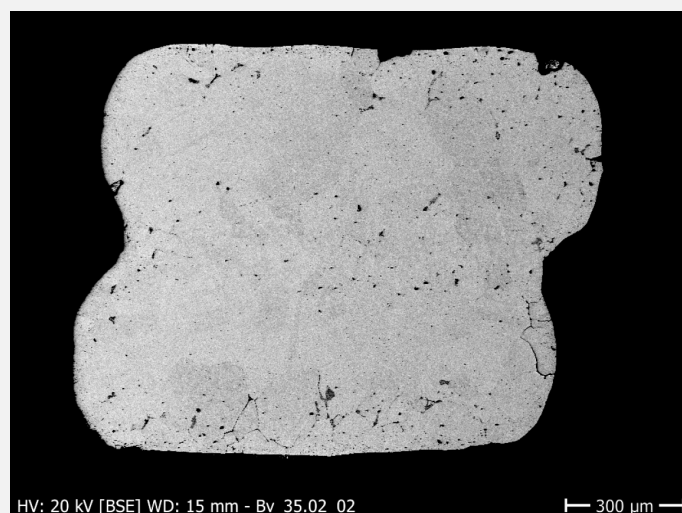
Fig.8: SEM image (BSE mode, current 10nA) of the cross-section of the sample taken from setting Bv35.02 revealing partly the microstructure,

Welding zones are present, in particular for the Bv35.02 and Cv44.02 settings, only visible after etching (Figs. 11, 12 and 15). No clear difference in composition can be seen in these areas (Figs. 13 and 16). The grain structure (large polygonal grains, which may indicate recrystallization of the material(s)) is only visible in the SEM, BSE mode, and by increasing the beam intensity to 10nA (Figs. 8 and 10). Smaller grains are observed in the welding zones (Fig. 8).

The metal is covered with a thin layer of greyish and yellowish tarnish (CP1) on which residues of cleaning products are detected (D1). This tarnish has not been analyzed, but other work shows that the silver tarnish of the objects in the Treasury of the Abbey of Saint-Maurice usually consists of silver sulphide and silver chloride (Degrigny et al. 2015). This type of tarnishing is typical for silver alloys containing low copper content (Costa 2001, Graedel 1992 and Tissot et al. 2016). The metal of the settings is the site of intergranular corrosion (Wanhill, 2013) which appears to be limited to a thickness of 150-200 microns (Figs. 8 and 10).

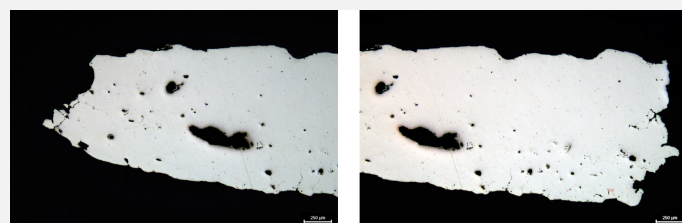
Fig.9: Micrograph of the cross-section of the sample taken from setting Bv49.07,

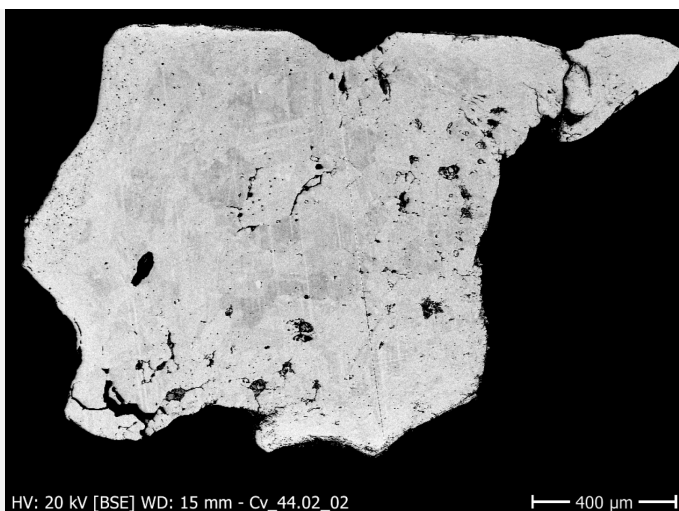
Fig. 10: SEM image (BSE mode, current 10nA) of the cross-section of the sample taken from setting Cv44.02 revealing partly the microstructure,

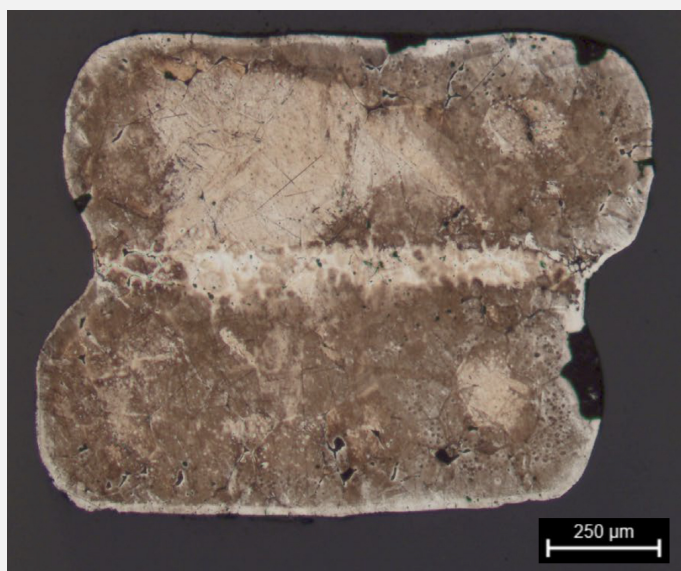
Fig.11: Micrograph of Bv35.02 sample etched (to compare to Fig. 8),

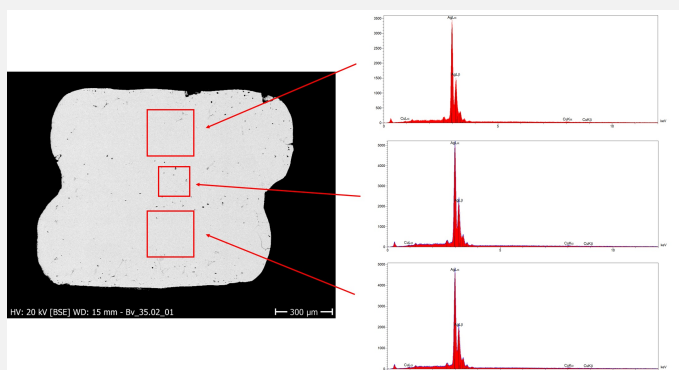
Fig.13: Location of EDS analyses on the cross-section of the Bv35.02 setting with associated spectra,

The elemental analysis by EDS does not seem to show a more pronounced presence of copper in the soldered parts. This result goes against the hypothesis that the different parts of the settings would be assembled by soldering with copper salts or brazing by adding a silver pebble whose alloy would be close to the eutectic. Does this mean that the soldering is done without adding copper or silver flakes? This would indicate that the parts are pre-assembled by gluing and then fired at a temperature that places the alloy in a physical situation where welding takes place at the contact points without melting the rest.

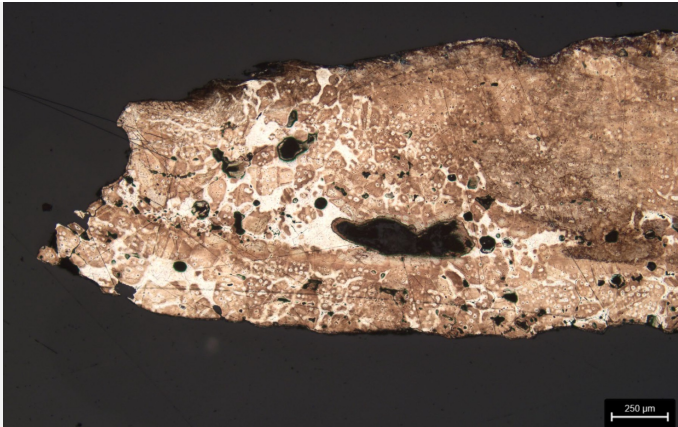
Fig.14: Micrograph of Bv49.07 sample etched. No EDS analysis was made,

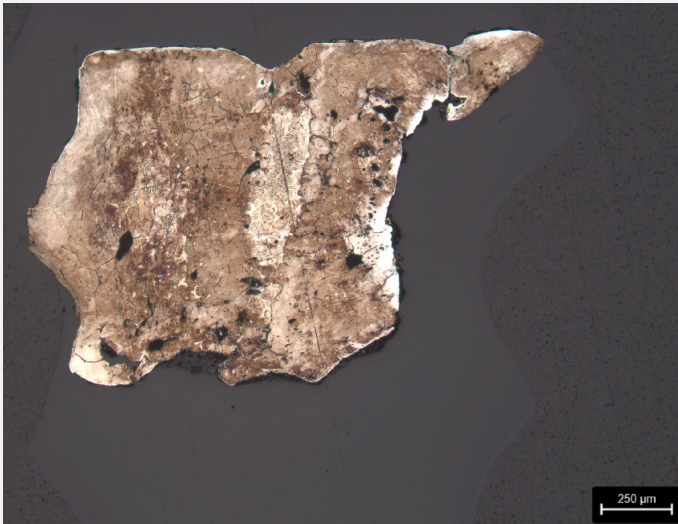
Fig.15: Micrograph of Cv44.02 sample etched (to compare to Fig. 10),

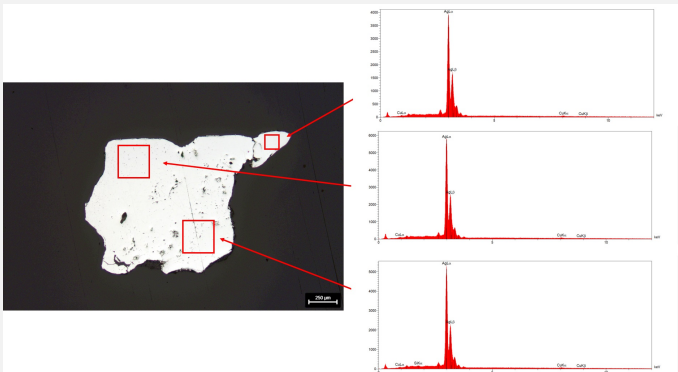
Fig.16: Location of EDS analyses on the cross-section of the Cv44.02 setting with associated spectra,

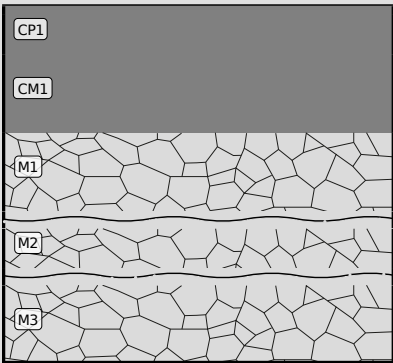
Fig.19: Stratigraphic representation of the sample taken from Bv35.02 in cross-section using the MiCorr application. The characteristics of the strata are only accessible by clicking on the drawing that redirects you to the search tool by stratigraphy representation. This representation can be compared to Fig. 8. Credit ABSM, R. Jeanneret.

The CM1 layer, which corresponds to intergranular corrosion, is only visible in cross-section.
