# GILDED SILVER PLATES OF THE GREAT SHRINE OF ST MAURICE – AG ALLOY – HIGH MEDIEVAL TIMES

Artefact name	Gilded silver plates of the Great Shrine of st Maurice
Authors	Romain. Jeanneret (Abbaye de St-Maurice, Saint-Maurice, Valais, Switzerland)
Url	/artefacts/1176/

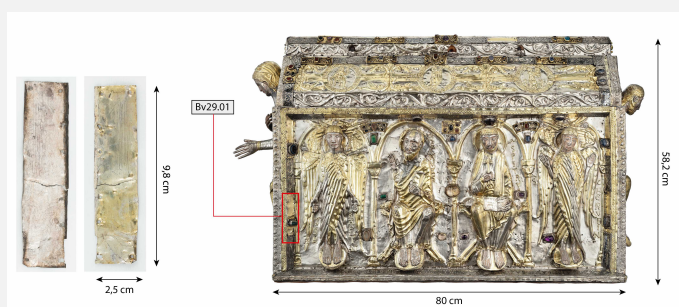
Fig.1: Front and reverse sides of the gilded plate Bv29.01 and its location on the Great Shrine of saint Maurice,

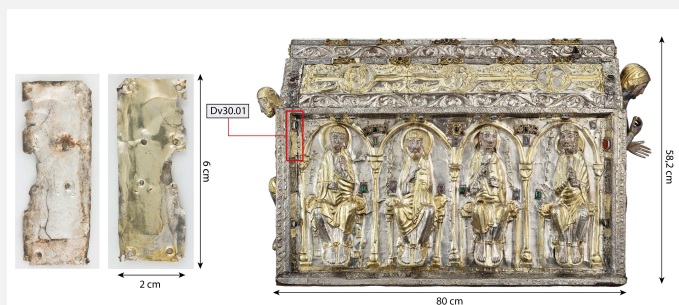
Fig.2: Front and reverse sides of the gilded plate Dv30.01 and its location on the Great Shrine of saint Maurice,

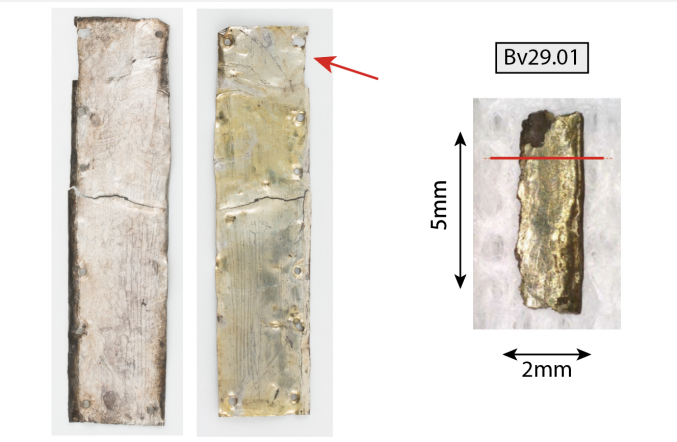
Fig. 3: Location of the loose analysed fragment of gilded plate Bv29.01 and its sampling area. Size of the sample: 5 x 2 mm,

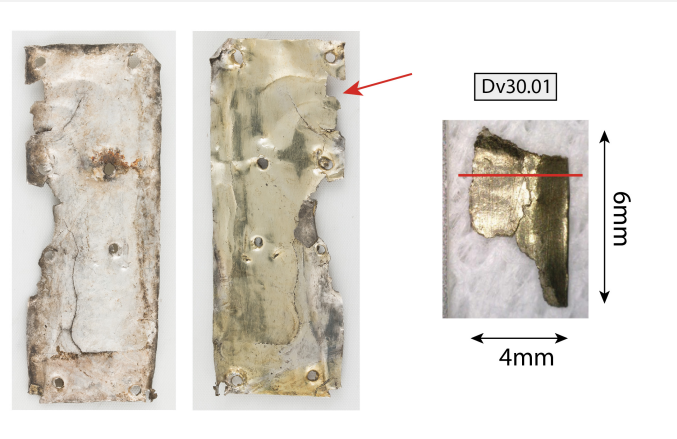
Fig. 4: Location of the loose analysed fragments of gilded plate Dv30.01 and its sampling area. Size of the sample: 6 x 4 mm,

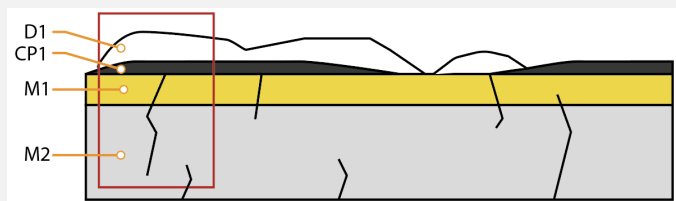
Fig. 5: Stratigraphic representation of the corrosion structures of both gilded plates Bv29.01 and Dv30.01 by macroscopic and binocular observation with indication of the corrosion structure (before conservation treatment) used to build the MiCorr stratigraphy of Fig. 6 (red rectangular),

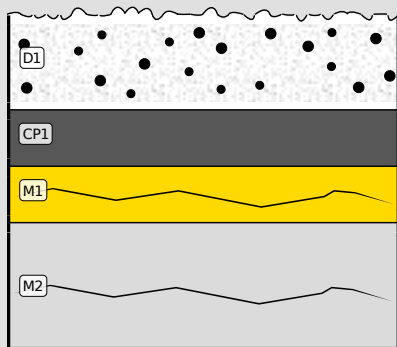
Fig.6: Stratigraphic representation of the corrosion structures of the both Bv29.01 and Dv30.01 gilded plates (before conservation treatment) observed macroscopically under binocular microscope using the MiCorr application with reference to Fig. 5. The characteristics of the strata are only accessible by clicking on the drawing that redirects you to the search tool by stratigraphy representation. Credit ABSM, R.Jeanneret.

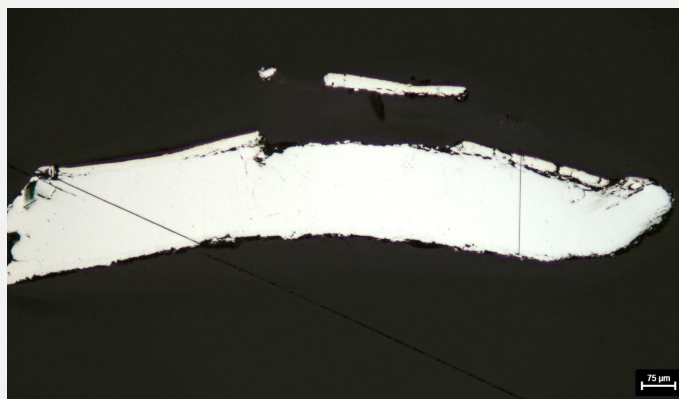
Fig.7: Micrograph of the cross-section of the sample taken from gilded plate Bv29.01 (Fig.3),

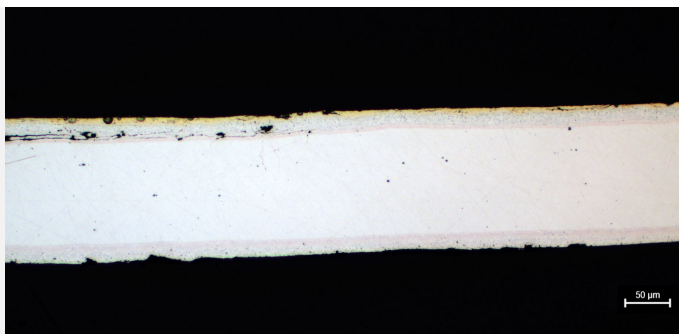
Fig.8: Micrograph of the cross-section of the sample taken from gilded plate Dv30.01 (Fig.4),

Under the Dv30.01 gilding, there is a pink layer about 10um thick visible on the micrograph (Fig.8). While this may appear to be a highly enriched copper layer, it is not confirmed by composition line analysis. This layer is also found on the non-gilded side, indicating that it is maybe related to the gilding process. This is not clearly visible on plate Bv29.01.

The pinkish stratum (M3) and porous layer (M2) are clearly visible on the micrograph (Fig. 8) but compositional line analysis did not demonstrate any difference from the metal.

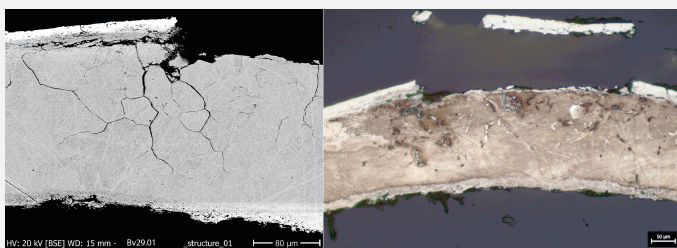
SEM images (Figs. 10 and 12) show that the metal surface of the underlying metal is slightly porous. This suggests a surface enrichment due to the repoussé work and successive annealing. This is reinforced by the etching of the two samples (Figs 9 & 11) indicating a very different reaction between the first 25 microns and the core of the alloys. Despite these differences, the composition line (Figs 10 & 12) analysis shows no variation in copper content.

The grain structure of the silver core (large polygonal grains, which may indicate recrystallization of the material(s)) is only visible in the SEM, BSE mode, and by increasing the beam intensity to 10nA (Figs. 9 and 11).

Fig. 9: SEM image (BSE mode, current 10nA) and micrograph of sample etched of the cross-section of the sample taken from gilded plate Bv29. 01 revealing partly the microstructure,

The majority of cracks are due to cold work. It is possible that this phenomenon was amplified and/or followed by intergranular corrosion. Nevertheless, the mercury-enriched interface seems to have suffered the most from cold working leading to loss of local adhesion of the gilding. This could be explained by differences in the ductility of the different metal layers. Some of the cracks reach the center of the metal (Figs. 9 & 11).

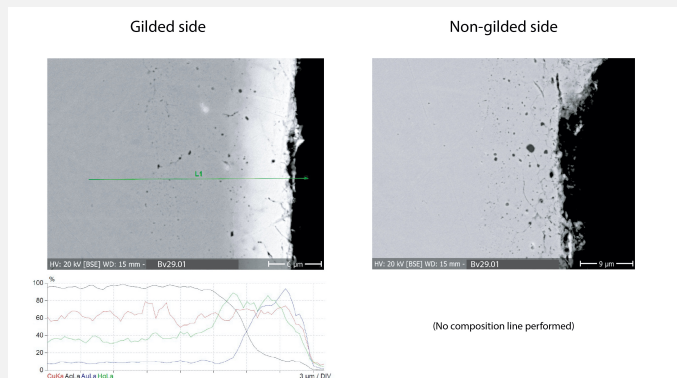
The metal of the plates is silver with a low percentage of copper (about 1-2wt%). The plates are gilded only on their visible side (Figs. 7 and 8). The gilding was studied in cross-section by EDS analysis using a composition line (Figs. 10 & 12). The results are similar for both plates and indicate a presence of mercury bound to both gold and silver and decreasing as we get away from the interface. These results are consistent with what has been studied by Kilian Anhauser on mercury gilding samples reproduced in the laboratory (Anhauser, 1999) and on medieval gilded silver (Schweizer & Degli Agosti, 2007).

Fig.10: SEM images (BSE mode) and EDS analysis by line of composition of the cross-section of the sample (gilded side only) taken from the gilded plate Bv29.01,

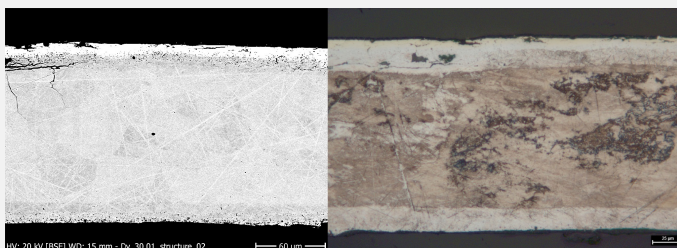
Fig. 11: SEM image (BSE mode, current 10nA) and micrograph of sample etched of the cross-section of the sample taken from gilded plate Dv30.01 revealing partly the microstructure,

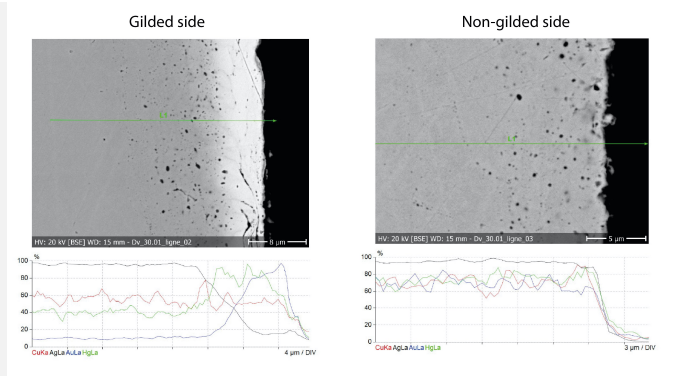
Fig.12: SEM images (BSE mode) and EDS analyses by line of composition of the cross-section of the sample (both sides) taken from the gilded plate Dv30.01,

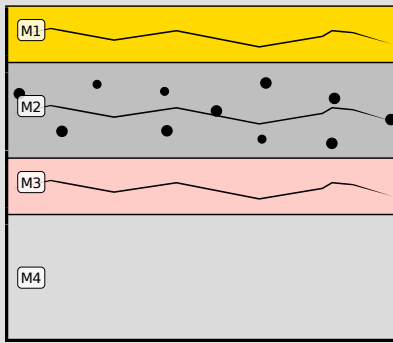
Fig.13: Stratigraphic representation of the sample taken from Dv30.01 in cross-section using the MiCorr application. The characteristics of the strata are only accessible by clicking on the drawing that redirects you to the search tool by stratigraphy representation. Credit ABSM, R. Jeanneret.
