# GILDED SILVER PLATES OF THE GREAT SHRINE OF ST MAURICE – AG ALLOY – HIGH MEDIEVAL TIMES

Artefact name	Gilded silver plates of the Great Shrine of st Maurice
Authors	Romain. Jeanneret (Abbaye de St-Maurice, Saint-Maurice, Valais, Switzerland)
Url	/artefacts/1176/

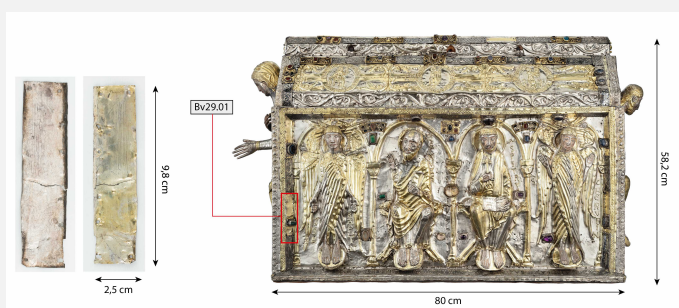
Fig.1: Front and reverse sides of the gilded plate Bv29.01 and its location on the Great Shrine of saint Maurice,

The plates Bv29.01 and Dv 30.01 are from the same decoration as the genesis reliefs. Intact examples of this can be found on the Great Shrine's roofs (Figs. 1 and 2). The plates have been cut out of the gilded areas and cold worked for reuse as gilded plates under gemstones and filigrees.

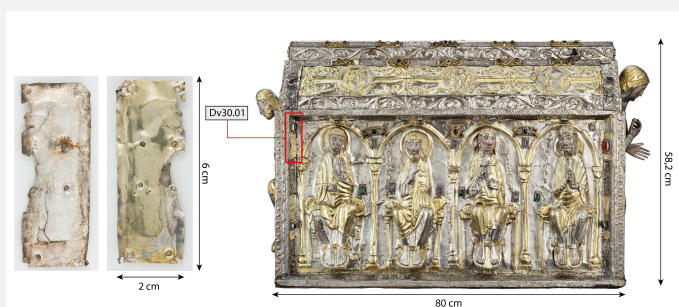
Fig.2: Front and reverse sides of the gilded plate Dv30.01 and its location on the Great Shrine of saint Maurice,

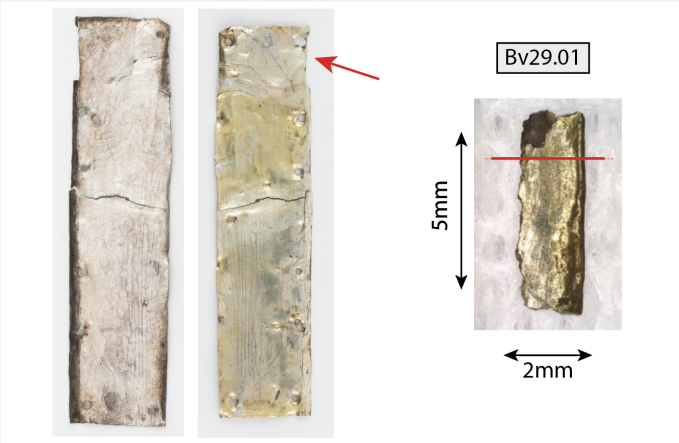
Fig. 3: Location of the loose analysed fragment of gilded plate Bv29.01 and its sampling area. Size of the sample: 5 x 2 mm,

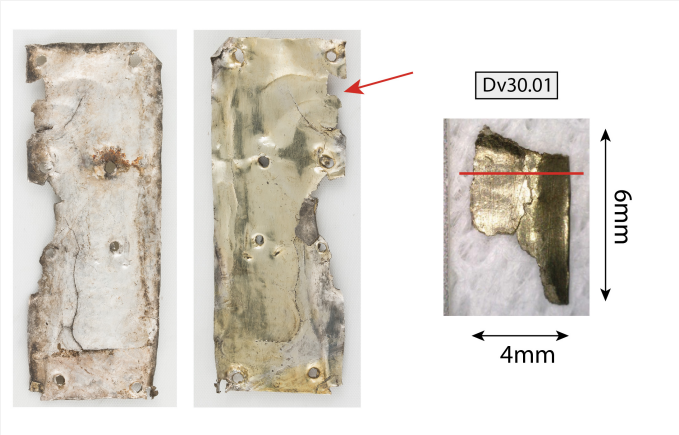
Fig. 4: Location of the loose analysed fragments of gilded plate Dv30.01 and its sampling area. Size of the sample: 6 x 4 mm,

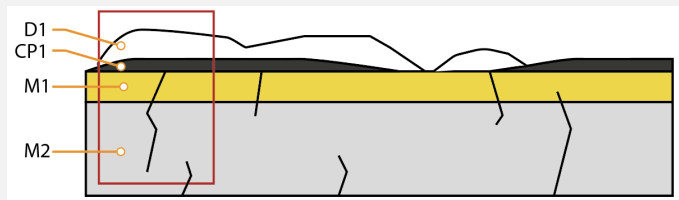
Fig. 5: Stratigraphic representation of the corrosion structures of both gilded plates Bv29.01 and Dv30.01 by macroscopic and binocular observation with indication of the corrosion structure (before conservation treatment) used to build the MiCorr stratigraphy of Fig. 6 (red rectangular),

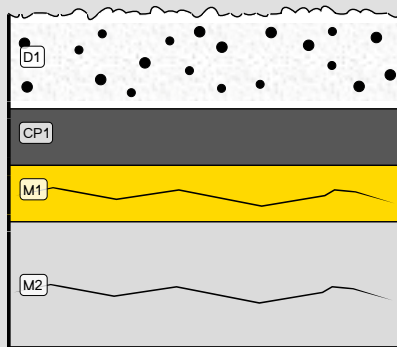
Fig.6: Stratigraphic representation of the corrosion structures of the both Bv29.01 and Dv30.01 gilded plates (before conservation treatment) observed macroscopically under binocular microscope using the MiCorr application with reference to Fig. 5. The characteristics of the strata are only accessible by clicking on the drawing that redirects you to the search tool by stratigraphy representation. Credit ABSM, R.Jeanneret.

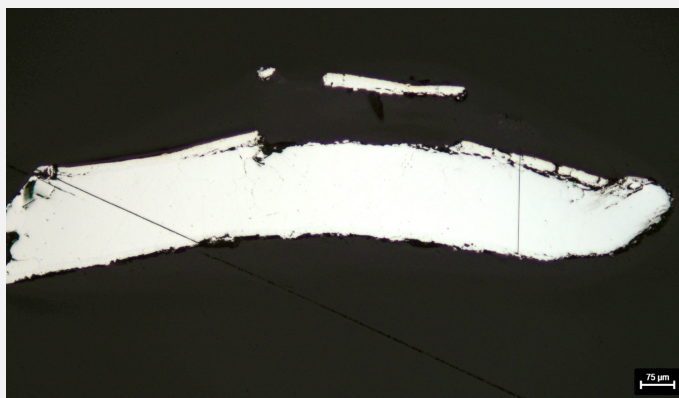
Fig.7: Micrograph of the cross-section of the sample taken from gilded plate Bv29.01 (Fig.3),

The metal of the plates is silver with a low percentage of copper (about 1-2wt%). The plates are gilded only on their visible side (Figs. 7 and 8). The gilding was studied in cross-section by EDS analysis using a composition line (Figs. 10 & 12). The results are similar for both plates and indicate a presence of mercury bound to both gold and silver and decreasing as we get away from the interface. These results are consistent with what has been studied by Kilian Anhauser on mercury gilding samples reproduced in the laboratory (Anhauser, 1999) and on medieval gilded silver (Schweizer & Degli Agosti, 2007).

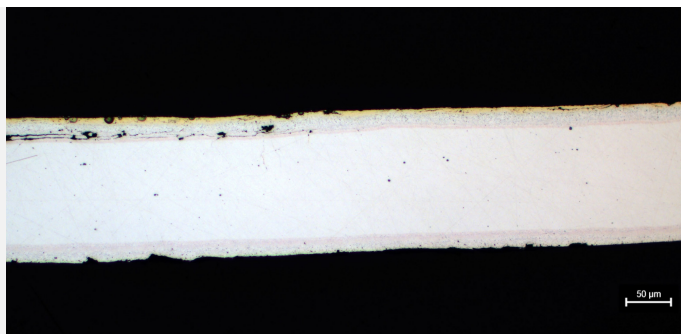
Fig.8: Micrograph of the cross-section of the sample taken from gilded plate Dv30.01 (Fig.4),

Under the Dv30.01 gilding, there is a pink layer about 10um thick visible on the micrograph (Fig.8). While this may appear to be a highly enriched copper layer, it is not confirmed by composition line analysis. This layer is also found on the non-gilded side, indicating that it is maybe related to the gilding process. This is not clearly visible on plate Bv29.01.

The pinkish stratum (M3) and porous layer (M2) are clearly visible on the micrograph (Fig. 8) but compositional line analysis did not demonstrate any difference from the metal.

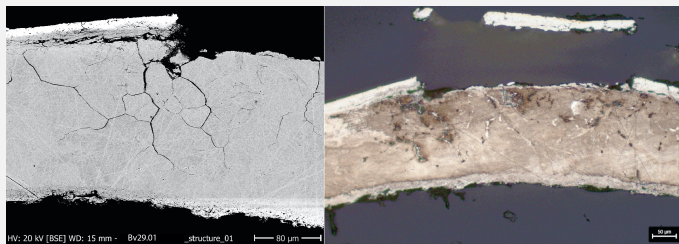
SEM images (Figs. 10 and 12) show that the metal surface of the underlying metal is slightly porous. This suggests a surface enrichment due to the repoussé work and successive annealing. This is reinforced by the etching of the two samples (Figs 9 & 11) indicating a very different reaction between the first 25 microns and the core of the alloys. Despite these differences, the composition line (Figs 10 & 12) analysis shows no variation in copper content.

The grain structure of the silver core (large polygonal grains, which may indicate recrystallization of the material(s)) is only visible in the SEM, BSE mode, and by increasing the beam intensity to 10nA (Figs. 9 and 11).

Fig. 9: SEM image (BSE mode, current 10nA) and micrograph of sample etched of the cross-section of the sample taken from gilded plate Bv29. 01 revealing partly the microstructure,

The majority of cracks are due to cold work. It is possible that this phenomenon was amplified and/or followed by intergranular corrosion. Nevertheless, the mercury-enriched interface seems to have suffered the most from cold working leading to loss of local adhesion of the gilding. This could be explained by differences in the ductility of the different metal layers. Some of the cracks reach the center of the metal (Figs. 9 & 11).

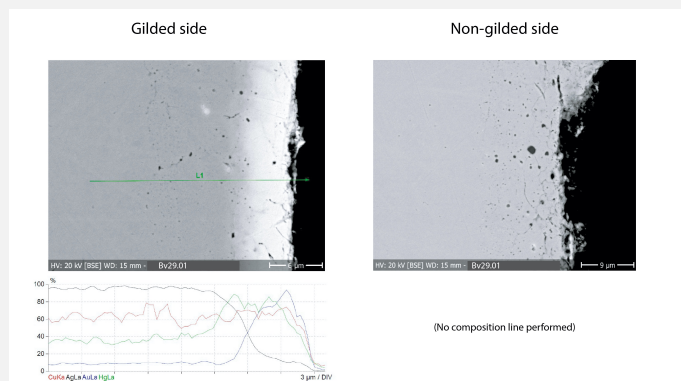
Fig.10: SEM images (BSE mode) and EDS analysis by line of composition of the cross-section of the sample (gilded side only) taken from the gilded plate Bv29.01,

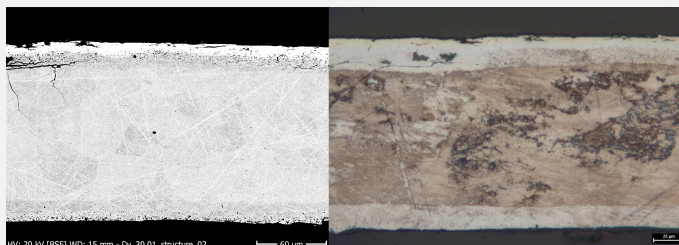
Fig. 11: SEM image (BSE mode, current 10nA) and micrograph of sample etched of the cross-section of the sample taken from gilded plate Dv30.01 revealing partly the microstructure,

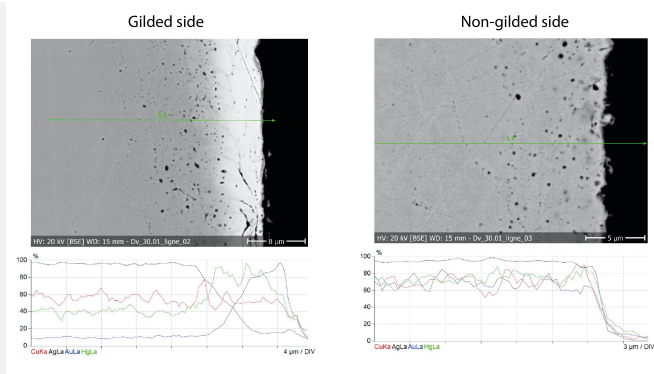
Fig.12: SEM images (BSE mode) and EDS analyses by line of composition of the cross-section of the sample (both sides) taken from the gilded plate Dv30.01,

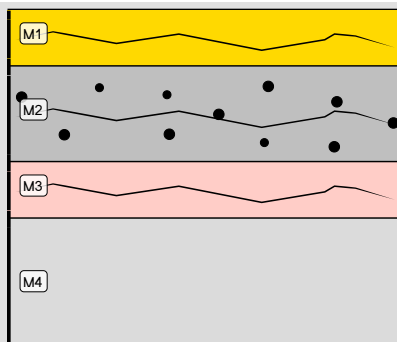
Fig.13: Stratigraphic representation of the sample taken from Dv30.01 in cross-section using the MiCorr application. The characteristics of the strata are only accessible by clicking on the drawing that redirects you to the search tool by stratigraphy representation. Credit ABSM, R. Jeanneret.
