GILDED SILVER PLATES OF THE GREAT SHRINE OF ST MAURICE – AG ALLOY – HIGH MEDIEVAL TIMES

Artefact name Gilded silver plates of the Great Shrine of st Maurice

Authors Romain. Jeanneret (Abbaye de St-Maurice, Saint-Maurice, Valais, Switzerland)

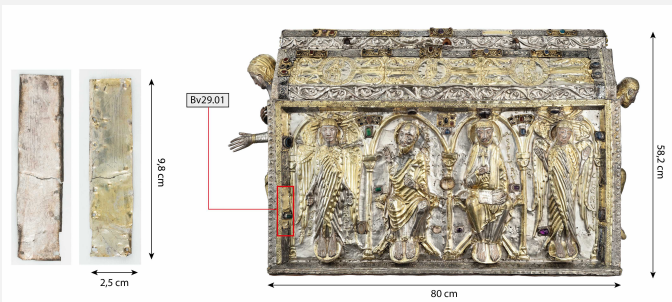
Fig.1: Front and reverse sides of the gilded plate Bv29.01 and its location on the Great Shrine of saint Maurice,

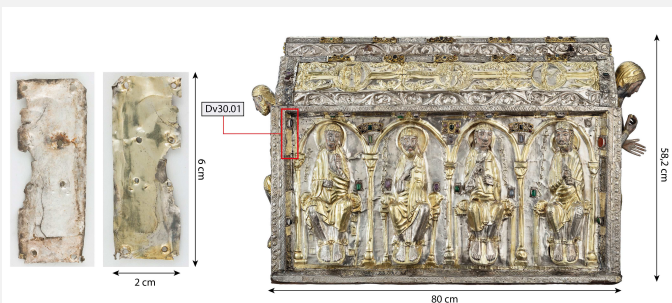
Fig.2: Front and reverse sides of the gilded plate Dv30.01 and its location on the Great Shrine of saint Maurice,

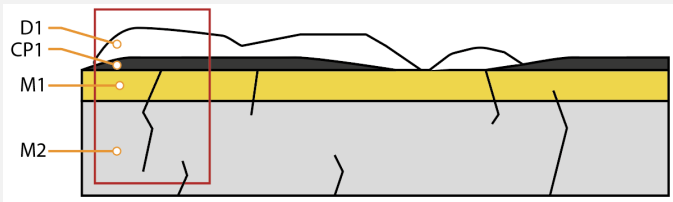
Fig. 5: Stratigraphic representation of the corrosion structures of both gilded plates Bv29.01 and Dv30.01 by macroscopic and binocular observation with indication of the corrosion structure (before conservation treatment) used to build the MiCorr stratigraphy of Fig. 6 (red rectangular),

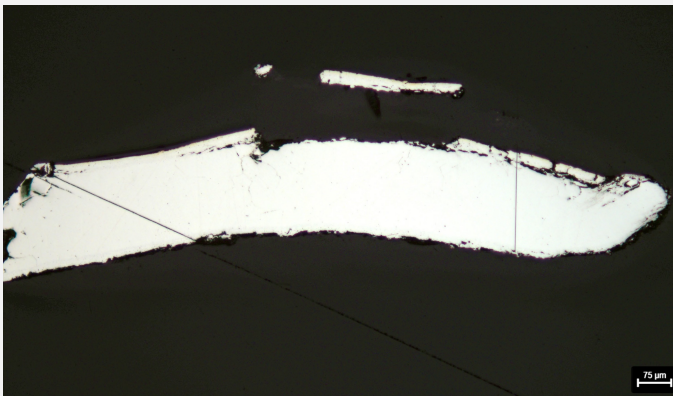
Fig.7: Micrograph of the cross-section of the sample taken from gilded plate Bv29.01 (Fig.3),

Under the Dv30.01 gilding, there is a pink layer about 10um thick visible on the micrograph (Fig.8). While this may appear to be a highly enriched copper layer, it is not confirmed by composition line analysis. This layer is also found on the non-gilded side, indicating that it is maybe related to the gilding process. This is not clearly visible on plate Bv29.01.

The pinkish stratum (M3) and porous layer (M2) are clearly visible on the micrograph (Fig. 8) but compositional line analysis did not demonstrate any difference from the metal.

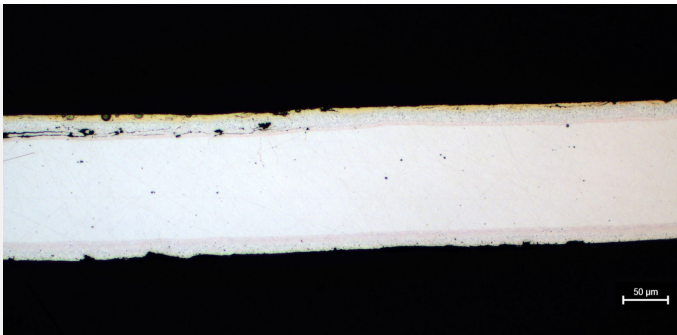
Fig.8: Micrograph of the cross-section of the sample taken from gilded plate Dv30.01 (Fig.4),

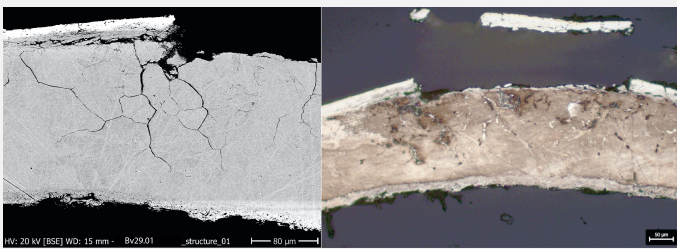
SEM images (Figs. 10 and 12) show that the metal surface of the underlying metal is slightly porous. This suggests a surface enrichment due to the repoussé work and successive annealing. This is reinforced by the etching of the two samples (Figs 9 & 11) indicating a very different reaction between the first 25 microns and the core of the alloys. Despite these differences, the composition line (Figs 10 & 12) analysis shows no variation in copper content.

The grain structure of the silver core (large polygonal grains, which may indicate recrystallization of the material(s)) is only visible in the SEM, BSE mode, and by increasing the beam intensity to 10nA (Figs. 9 and 11).

Fig. 9: SEM image (BSE mode, current 10nA) and micrograph of sample etched of the cross-section of the sample taken from gilded plate Bv29.01 revealing partly the microstructure,

The majority of cracks are due to cold work. It is possible that this phenomenon was amplified and/or followed by intergranular corrosion. Nevertheless, the mercury-enriched interface seems to have suffered the most from cold working leading to loss of local adhesion of the gilding. This could be explained by differences in the ductility of the different metal layers. Some of the cracks reach the center of the metal (Figs. 9 & 11).

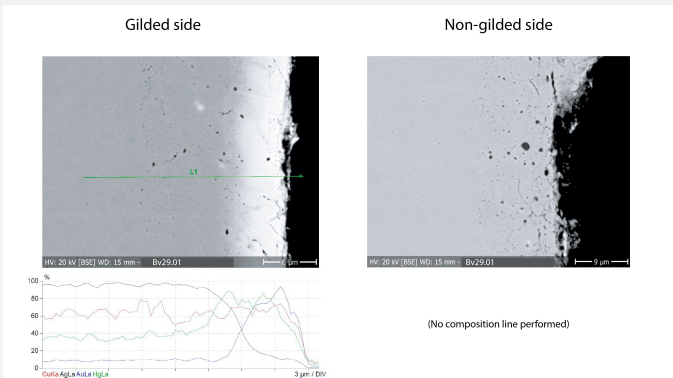
The metal of the plates is silver with a low percentage of copper (about 1-2wt%). The plates are gilded only on their visible side (Figs. 7 and 8). The gilding was studied in cross-section by EDS analysis using a composition line (Figs. 10 & 12). The results are similar for both plates and indicate a presence of mercury bound to both gold and silver and decreasing as we get away from the interface. These results are consistent with what has been studied by Kilian Anhauser on mercury gilding samples reproduced in the laboratory (Anhauser, 1999) and on medieval gilded silver (Schweizer & Degli Agosti, 2007).

Fig.10: SEM images (BSE mode) and EDS analysis by line of composition of the cross-section of the sample (gilded side only) taken from the gilded plate Bv29.01,

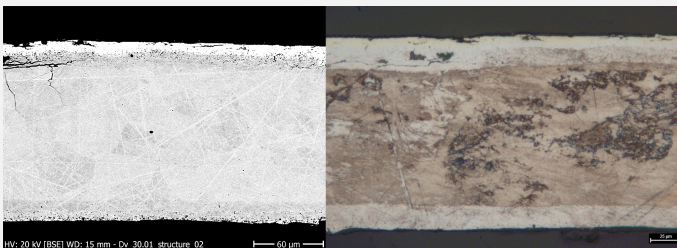
Fig. 11: SEM image (BSE mode, current 10nA) and micrograph of sample etched of the cross-section of the sample taken from gilded plate Dv30.01 revealing partly the microstructure,

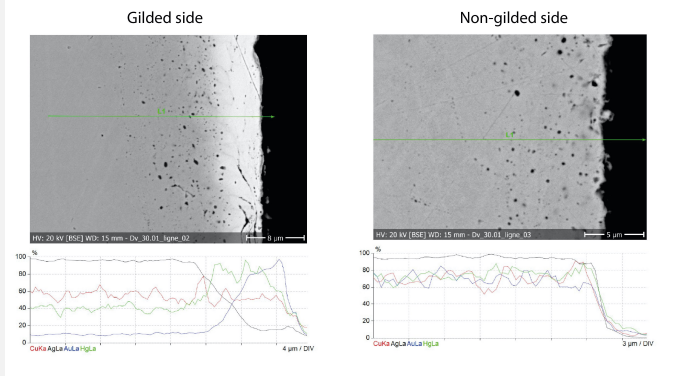
Fig.12: SEM images (BSE mode) and EDS analyses by line of composition of the cross-section of the sample (both sides) taken from the gilded plate Dv30.01,
