GILDED SILVER PLATES OF THE GREAT SHRINE OF ST MAURICE – AG ALLOY – HIGH MEDIEVAL TIMES

Artefact name Gilded silver plates of the Great Shrine of st Maurice

Authors Romain. Jeanneret (Abbaye de St-Maurice, Saint-Maurice, Valais, Switzerland)

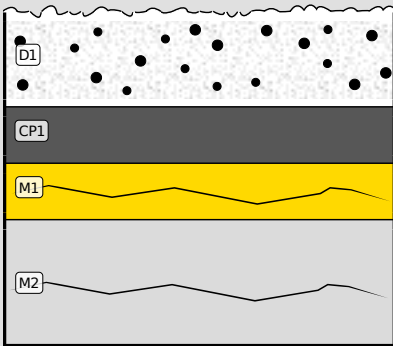
Fig.6: Stratigraphic representation of the corrosion structures of the both Bv29.01 and Dv30.01 gilded plates (before conservation treatment) observed macroscopically under binocular microscope using the MiCorr application with reference to Fig. 5. The characteristics of the strata are only accessible by clicking on the drawing that redirects you to the search tool by stratigraphy representation. Credit ABSM, R.Jeanneret.

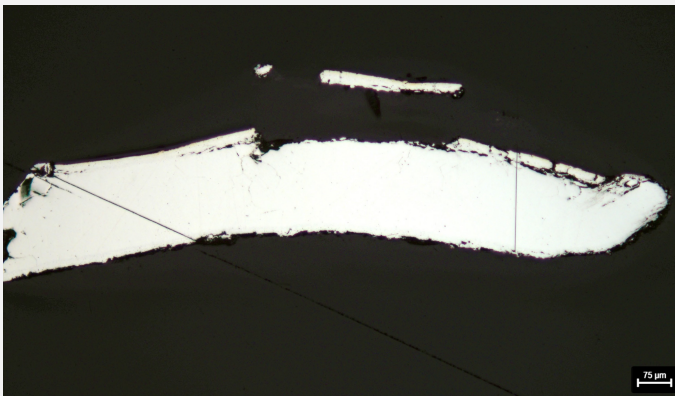
Fig.7: Micrograph of the cross-section of the sample taken from gilded plate Bv29.01 (Fig.3),

Fig.8: Micrograph of the cross-section of the sample taken from gilded plate Dv30.01 (Fig.4),

Under the Dv30.01 gilding, there is a pink layer about 10um thick visible on the micrograph (Fig.8). While this may appear to be a highly enriched copper layer, it is not confirmed by composition line analysis. This layer is also found on the non-gilded side, indicating that it is maybe related to the gilding process. This is not clearly visible on plate Bv29.01.

The pinkish stratum (M3) and porous layer (M2) are clearly visible on the micrograph (Fig. 8) but compositional line analysis did not demonstrate any difference from the metal.

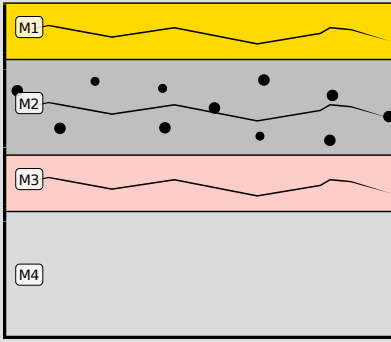
Fig.13: Stratigraphic representation of the sample taken from Dv30.01 in cross-section using the MiCorr application. The characteristics of the strata are only accessible by clicking on the drawing that redirects you to the search tool by stratigraphy representation. Credit ABSM, R. Jeanneret.
