# AIRCRAFT REAR FASTENING PLATE VHS-497 – AL ALLOY – MODERN TIMES

**Artefact name** Aircraft rear fastening plate VHS-497

**Authors** Marianne. Senn (Empa, Dübendorf, Zurich, Switzerland) & Christian. Degrigny (HE-Arc CR, Neuchâtel, Neuchâtel, Switzerland)

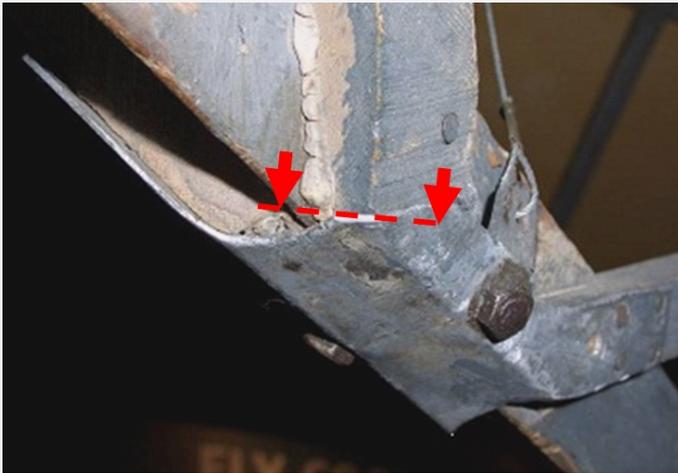
Fig. 2: Location of sampling area,

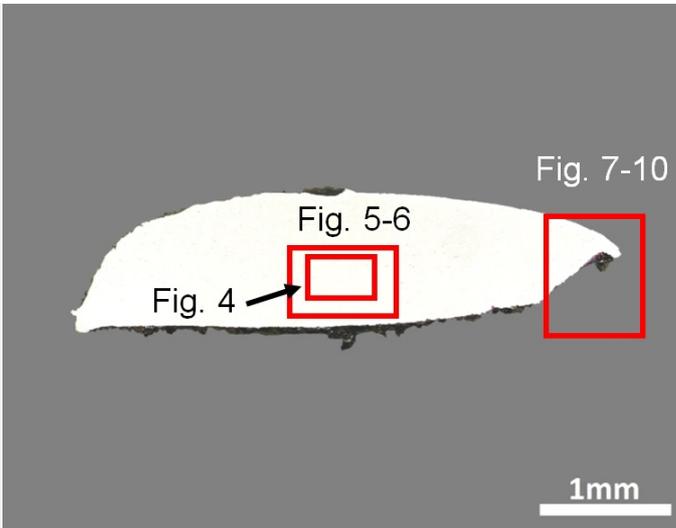
Fig. 3: Micrograph of the cross-section of the sample taken from the back fastening plate showing the location of Figs. 4 to 10,

<b>Description of sample</b>	Sample cut from the corner of the fastening plate (Fig. 2). Dimensions: L = 4mm ; W = 1.2mm.
<b>Alloy</b>	Al Alloy
<b>Technology</b>	Hot rolled and annealed
<b>Lab number of sample</b>	DUF-12
<b>Sample location</b>	HE-Arc CR, Neuchâtel, Neuchâtel
<b>Responsible institution</b>	Swiss Museum of Transport, Luzern, Lucerne
<b>Date and aim of sampling</b>	September 2007, metallography and alloy composition

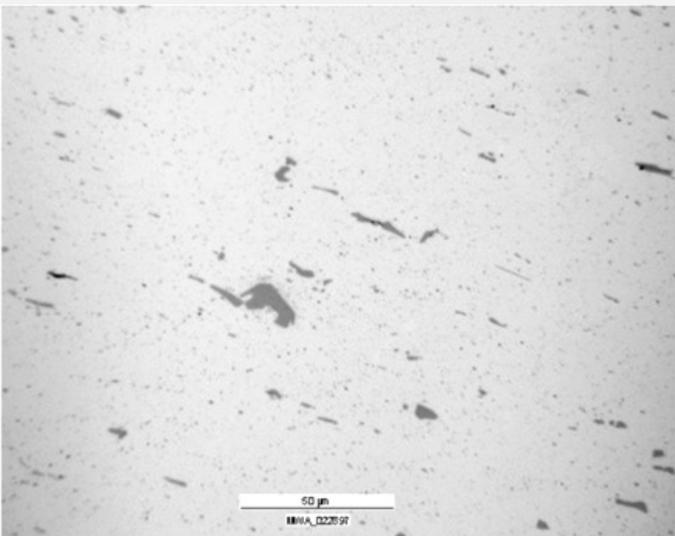
The metal is a relatively pure aluminium alloy with numerous inclusions (Table 1). From the chemical composition of the inclusions they can be interpreted as alpha-AlFeSi intermetallic compounds. In bright field we observe elongated inclusions indicating that the metal was rolled (Fig. 4). The alloy composition is similar to an unalloyed primary aluminium (Al content between 99 and 99.8 mass%). The O content reflects the immediate oxidation of the metal and is not part of the alloy. After etching the organisation of inclusions in rows is more easily seen (Fig. 5). The SEM image shows large grains formed after annealing (Fig. 6). The average hardness of the metal is HV1 40.

Fig. 4: Micrograph of the metal sample from Fig. 3 (detail), unetched, bright field. The metal matrix is in white, the elongated inclusions in grey,

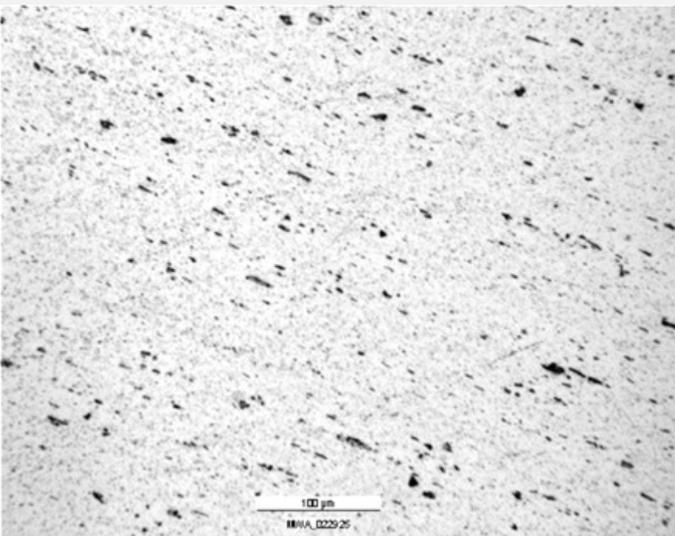
Fig. 5: Micrograph of the metal sample from Fig. 3 (detail), etched, bright field. The metal matrix is in white, the elongated inclusions in dark-grey and black,

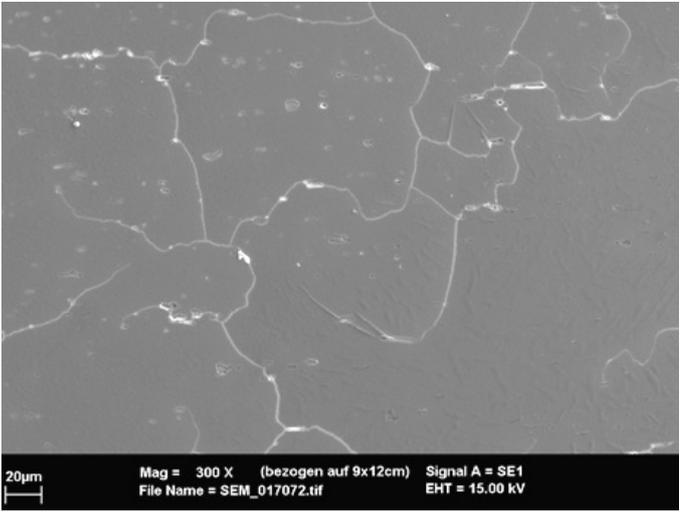
Fig. 6: SEM image of the metal sample from Fig. 3 (detail), SE-mode, etched. We observe the presence of large grains and numerous elongated inclusions,

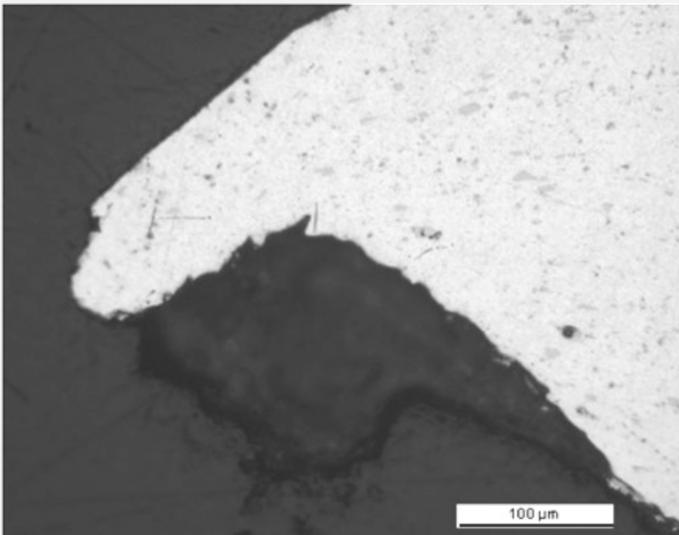
The metal is covered by a very thin corrosion layer (CP1). In addition to this, locally thicker adhering materials can be observed (NMM1, appearing as dark-grey area in Fig. 7). Under polarized light, they appear blue-brown (Fig. 8). Analysis by SEM-EDS indicates that the metal is, as expected, covered by a very thin Al and O-rich layer whereas the particles in the adherent material contain C, O, Si, Ca, Fe, Zn, S and even Ti (Figs. 9 and 10). The location of the adherent material and the presence of both Zn and Ti suggest that it is a residue of a paint coating.

Fig. 7: Micrograph showing the metal - adhering material interface from Fig. 3 (reversed picture, detail), unetched, bright field. We observe in white the metal matrix and dark-grey the adhering material,

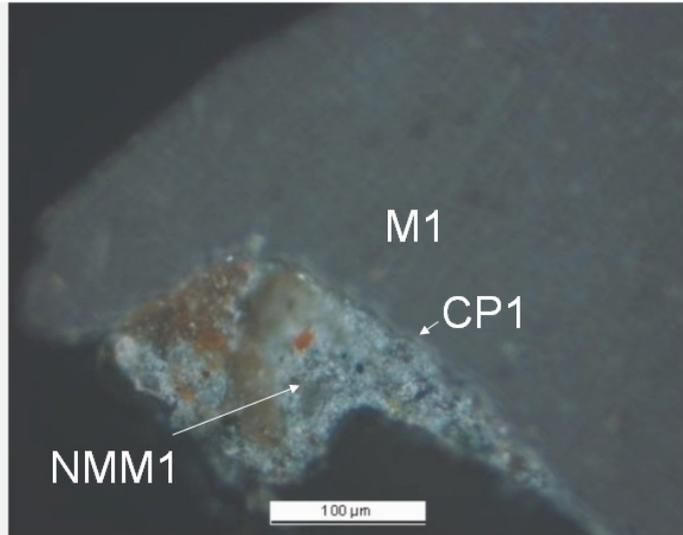
Fig. 8: Micrograph (same as Fig. 7) and corresponding to the stratigraphy of Fig. 11, unetched, polarised light. We observe

in grey the metal matrix and blue-brown the adhering material,

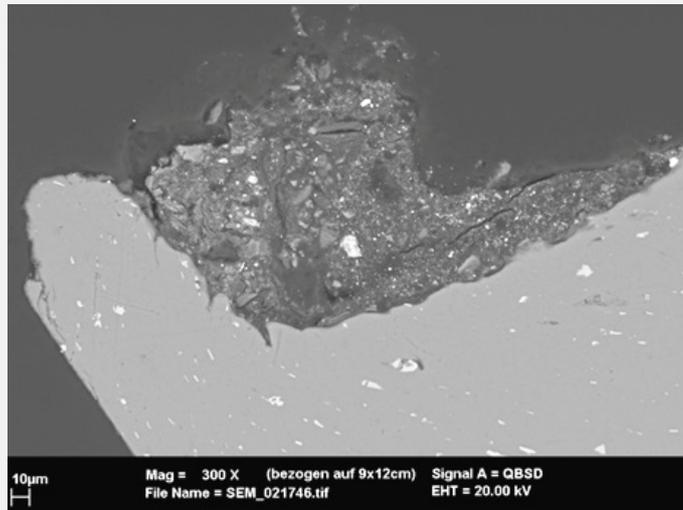
Fig. 9: SEM image (same as Fig. 7, inverted picture, detail), BSE-mode, unetched,

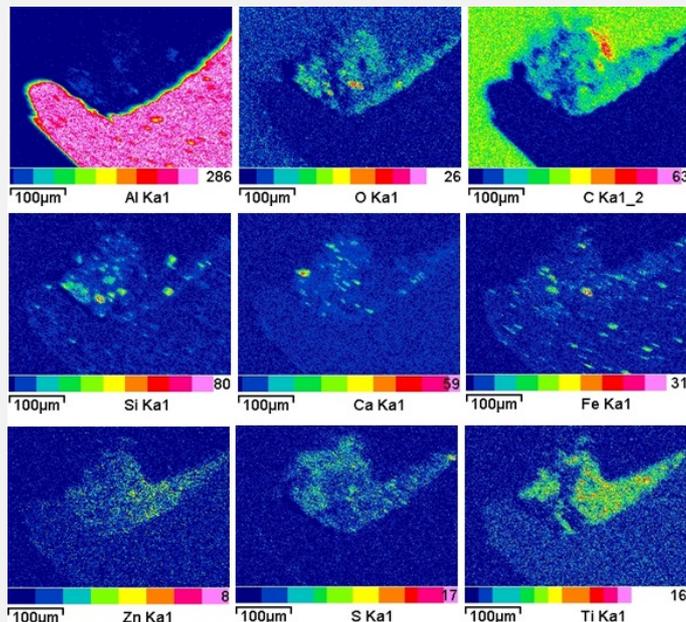
Fig. 10: Elemental chemical distribution of the selected area from Fig. 9. Method of examination: SEM/EDS, Laboratory of Analytical Chemistry, Empa,

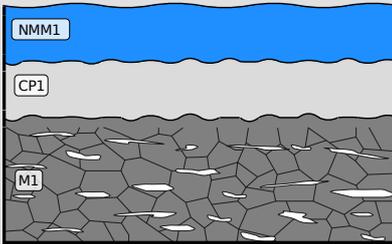
Fig. 11: Stratigraphic representation of the sample taken from the back fastening plate in cross-section (dark field) using the MiCorr application. The characteristics of the strata are only accessible by clicking on the drawing that redirects you to the search tool by stratigraphy representation. This representation can be compared to Fig. 8, Credit HE-Arc CR.
