AIRCRAFT FRONT FASTENING PLATE VHS-497 (2) – AL CU SN ZN SI ALLOY – MODERN TIMES

Artefact name	Aircraft front fastening plate VHS-497 (2)
Authors	Marianne. Senn (Empa, Dübendorf, Zurich, Switzerland) & Christian. Degryny (HE-Arc CR, Neuchâtel, Neuchâtel, Switzerland)
Url	/artefacts/1213/

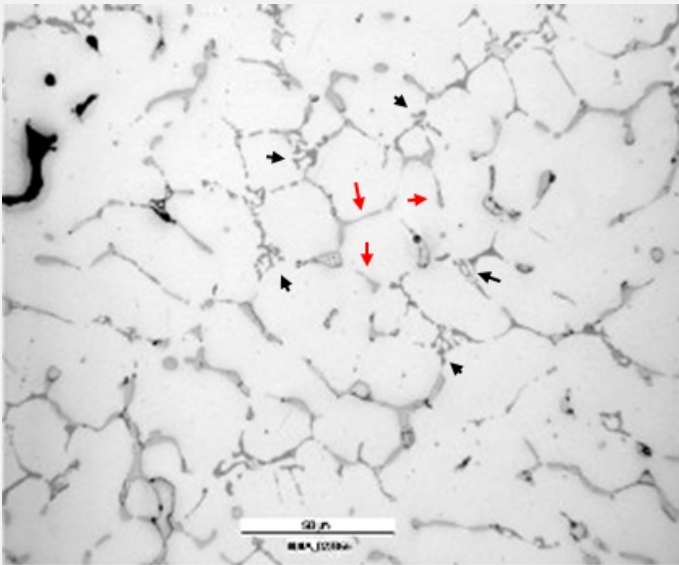
The metal is an aluminium alloy containing Cu, Sn, Zn and Si (Table 1). The unetched metal shows an as-cast structure consisting of the aluminium matrix with Sn (not soluble in Al) inclusions (Figs. 4 and 5), intermetallic compounds such as Al₂Cu (Fig. 4, red arrows) and clusters of Al,Fe,Cu & Si phases (Fig. 4, black arrows). There are porosities in the metal (Figs. 3 and 5). The average hardness of the metal is HV1 80.

Fig. 4: Micrograph of the metal sample from Fig. 3 (detail), unetched, bright field. The cast structure is revealed by light grey intermetallic compounds (Al₂Cu, red arrows), dark-grey Al,Fe,Si & Cu phase clusters (black arrows) and Sn inclusions (nodules). On the top left some pores can be seen,

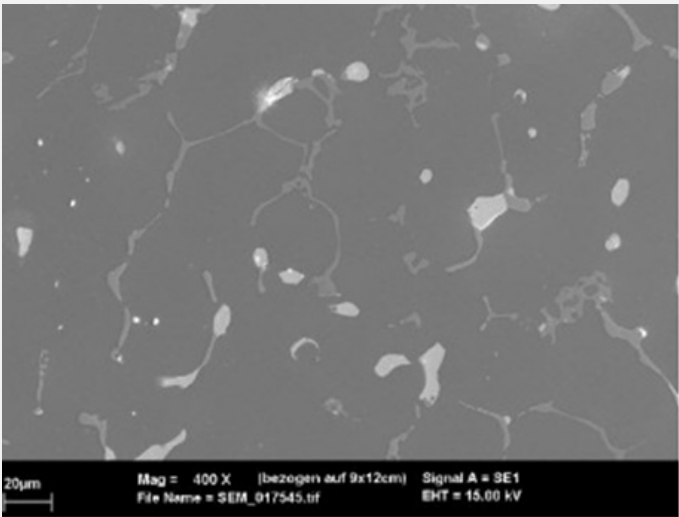
Table 1: Chemical composition (mass %) of the metal and inclusions (from Fig. 5). Method of analysis: SEM/EDS, Laboratory of Analytical Chemistry, Empa.

Fig. 5: SEM image of the metal sample from Fig. 3 (detail), SE-mode, unetched. We observe in dark-grey the metal matrix, in medium-grey the intermetallic compound Al₂Cu as well as Al,Fe,Si & Cu phase clusters and in light-grey the Sn inclusions,

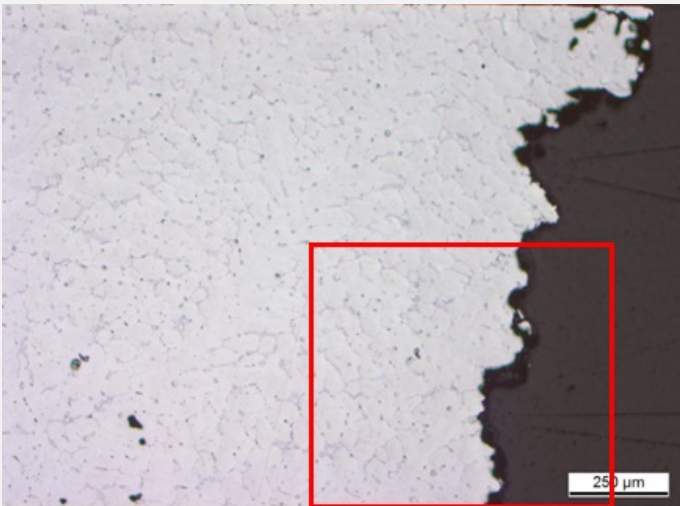
No corrosion layer can be seen on the metal surface (Figs. 3 and 6). Under polarized light small white and brown particles are visible on the broken edge (D1, Fig. 7). Their analysis reveals the presence of silica particles surrounded by dirt (Table 2 and Fig. 8). The metal surface is covered by a thin oxygen bearing skin (CP1, Fig. 8).

Fig. 6: Micrograph showing the metal - "corrosion products" interface from Fig. 3 (reversed picture, detail), unetched, bright field. We observe in white the metal matrix, in dark-grey Al,Fe, Si & Cu phase and light-grey Al₂Cu intermetallic compounds. The micrograph of Fig. 7 is marked by a rectangle,

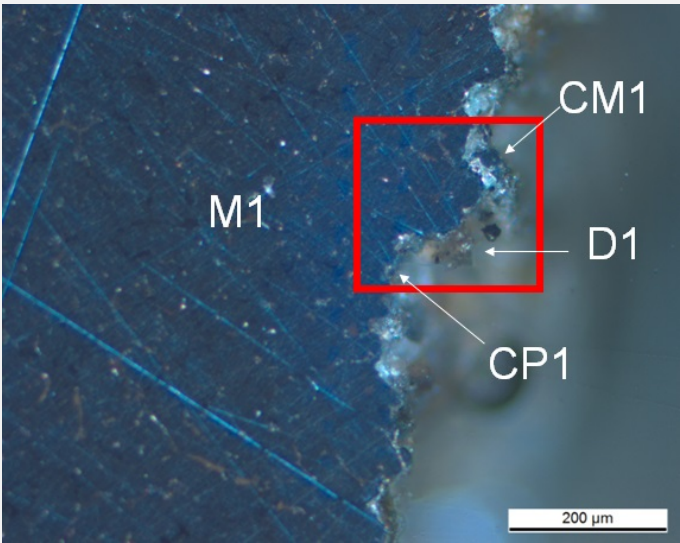
Fig. 7: Micrograph from Fig. 6 (detail) and corresponding to the stratigraphy of Fig. 9, unetched, polarised light. We observe in dark blue the metal matrix and blue-brown the adherent material. The area selected for elemental chemical distribution (Fig. 8) is marked by a rectangle,

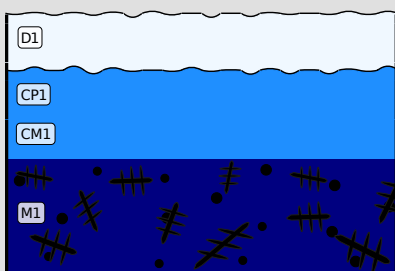
Fig. 9: Stratigraphic representation of the sample taken from the front fastening plate in cross-section (dark field) using the MiCorr application. The characteristics of the strata are only accessible by clicking on the drawing that redirects you to the search tool by stratigraphy representation. This representation can be compared to Fig. 7, Credit HE-Arc CR.
