# CHISEL POINT DEV 995 1069 PR – EUTECTOID TO HYPEREUTECTOID STEEL – EARLY MEDIEVAL TIMES – SWITZERLAND

**Artefact name** Chisel point DEV 995 1069 PR

**Authors** Marianne. Senn (Empa, Dübendorf, Zurich, Switzerland) & Christian. Degryny (HE-Arc CR, Neuchâtel, Neuchâtel, Switzerland)

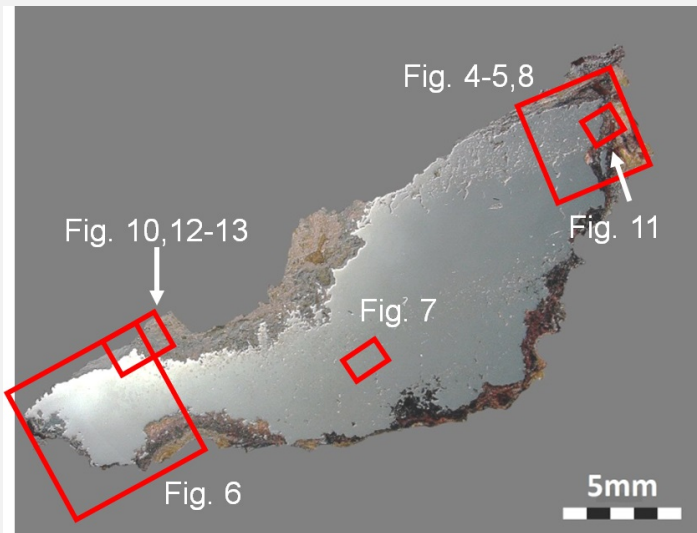
Fig. 3: Micrograph of the cross-section of the chisel point showing the location of Figs. 4 to 8 and 10 to 13,

A longitudinal cut from a chisel point (Figs. 2 and 3) after restoration. Dimensions: L = 30mm; W = 11mm (approximately).

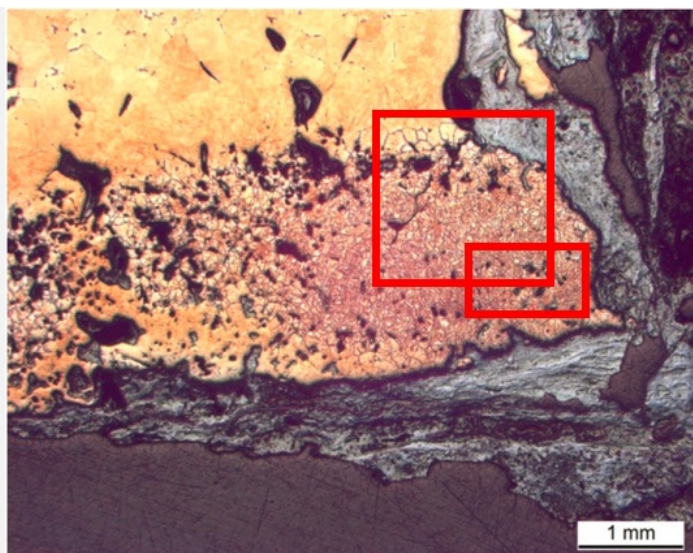
The remaining metal is a eutectoid to hypereutectoid steel (C 0.8-1 mass%) with cracks and porosity (Figs. 4 and 5). Its composition is given in Table 1 (except Fe). Of the trace elements, only Ni reaches a medium concentration (Ni 0.07 mass%). The composition and the high Ni/Co ratio are atypical for iron worked in smithies of the settlement at Develier-Courtételle JU, CH. The few slag inclusions and their chemical composition confirm this (Table 2). The slag is rich in CaO whereas the pisolithic or bean ore worked in the Central Jura smelting district is rich in Al<sub>2</sub>O<sub>3</sub>. The slag inclusions cannot be smithing slag because the artefact is formed from one piece of metal. The slag probably incorporated while refining the bloom or during the bloom smelting process. The ore from which this metal was smelted cannot yet be identified. Intergranular corrosion has developed, penetrating into the metal structure (Fig. 5). The etched metal shows a dominant martensitic structure, typical of quench hardened steel (Figs. 4, 6, 7 and 8). The characteristic forms of the martensite are non-organised needles (Fig. 7). In restricted areas bainite nodules occur (Figs. 6 and 7). In the centre of the point, hypereutectoid steel is composed of cementite in the grain boundaries and in needle like shapes within the grains (Fig. 9). Hypereutectoid regions also occur in the centre of the shaft and on its left surface (Fig. 4). Here the hypereutectoid steel is composed of martensite and cementite in the grain boundaries and in needle form within the grains (Figs. 5 and 8). Nevertheless, most of the chisel is dominated by eutectoid steel. The average hardness of the quench hardened eutectoid steel is about HV1 690. In the bainite nodules the average hardness drops to about HV1 350, the martensite has an average hardness of HV1 750.

Fig. 4: Micrograph of the metal sample from Fig. 3 (inverted picture, detail), etched, bright field. The metal contains porosity and cracks (in black). The micrographs of Figs. 5 and 8 are marked by the top and bottom rectangles respectively,

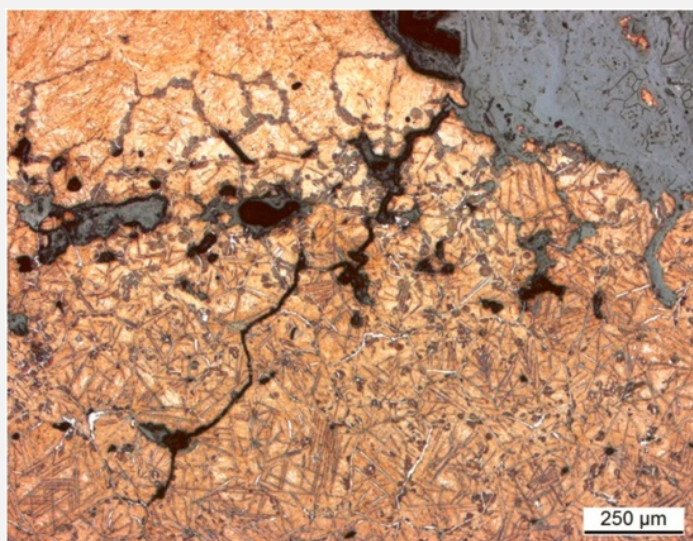
Fig. 5: Micrograph of the metal sample, detail from Fig. 4, etched, bright field. We observe martensite (in orange), cementite (in grey), porosity and intergranular cracks (in black) and corrosion,

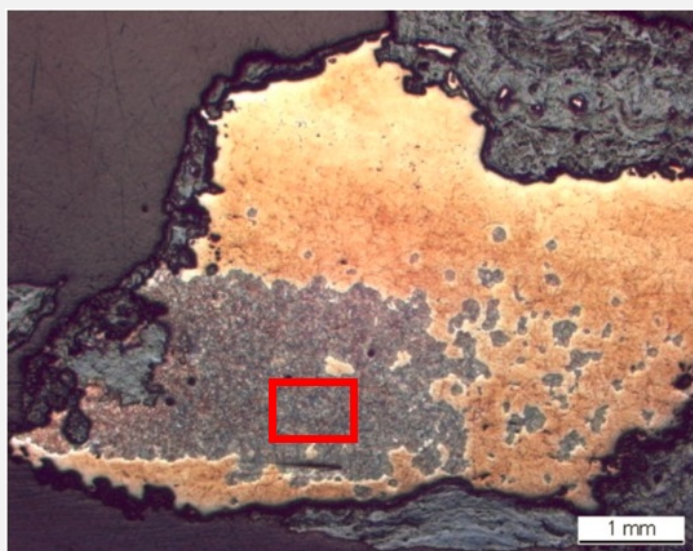
Fig. 6: Micrograph of the metal sample from Fig. 3 (inverted picture, detail), etched, bright field. We observe the metal with martensite (orange) and bainite nodules (blue). The micrograph of Fig. 9 is marked by a rectangle,

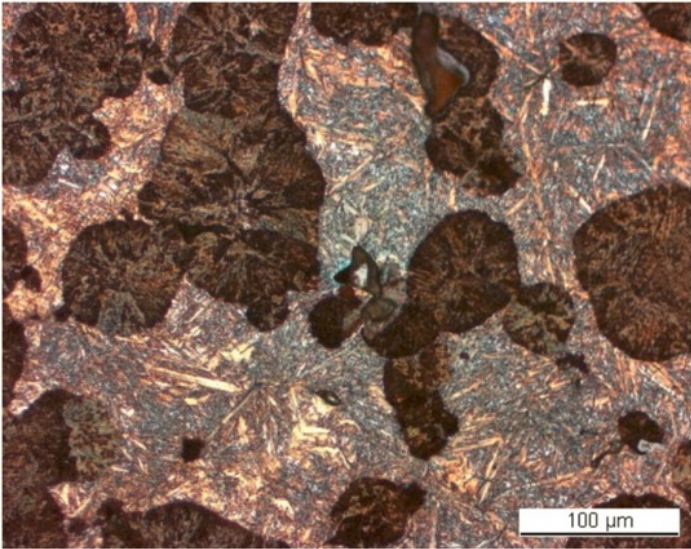
Fig. 7: Micrograph of the metal sample from Fig. 3 (detail), etched, bright field. We observe dark bainite nodules combined with martensite needles,

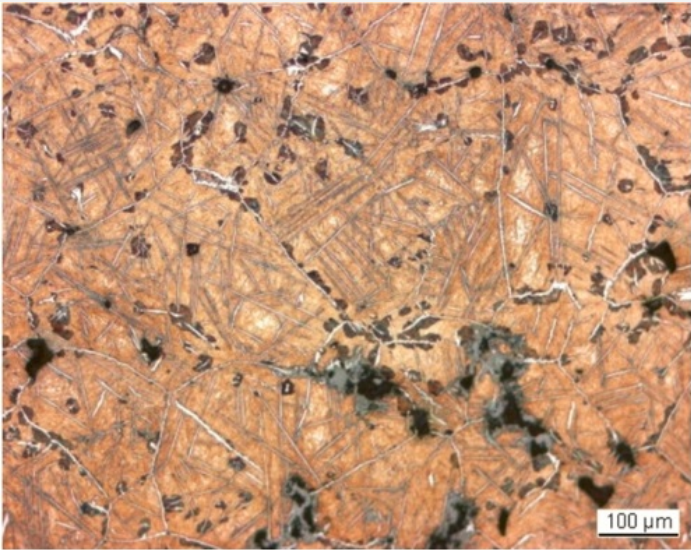
Fig. 8: Micrograph of the metal sample, detail from Fig. 4, etched, bright field. Hypereutectoid steel with a structure of cementite in white in the grain boundaries and in needle form combined with martensite (pink). Some bainite occurs around the grain boundaries,

The tool is made of hard, eutectoid to hypereutectoid steel and was, as a last manufacturing step, entirely quenched. In this state it is too hard and brittle to be used. It is likely that the quenched hypereutectoid structure provoked the breakage of the tool when it was first used. The absence of a tempering process at the end is unclear. The chemical composition of the metal and the slag inclusions indicate that the artefact was imported to the hamlet of Develier-Courtételle JU. The corrosion has, in areas, replaced the metal structure retaining a ghost structure; the outer layer has been mostly removed during surface cleaning. Extensive pitting corrosion has occurred, typical for steel with an elevated C content. The presence of S in the inner layer can be explained by putrefaction processes in the soil. Chlorides are still present at the metal-corrosion interface as no desalination process was attempted. Iron carbonates are present in the centre of a corrosion pit. The corrosion is of terrestrial type.

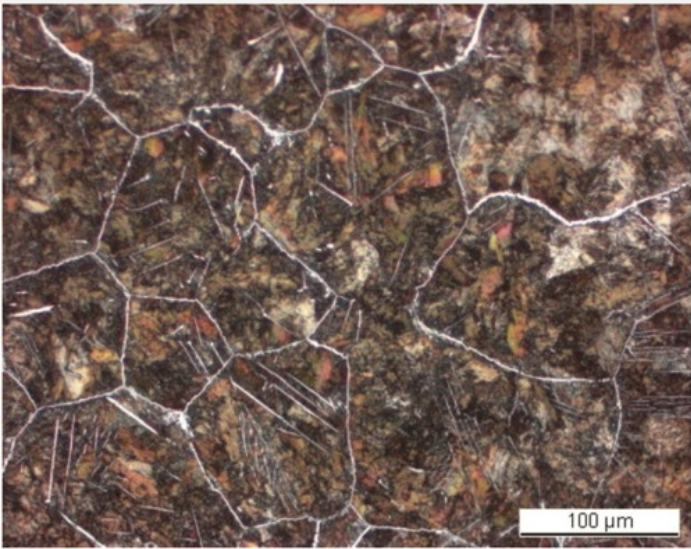
Fig. 9: Micrograph of the metal sample, detail from Fig. 6, etched, bright field. Hypereutectoid steel with a structure of cementite in white in the grain boundaries and in needle form combined with bainite (dark),

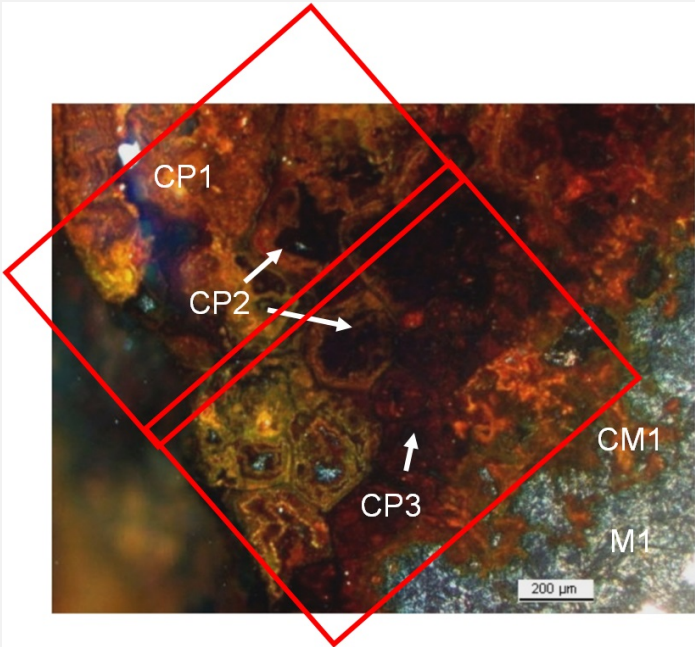
The metal is heavily corroded and the thickness of the corrosion crust is irregular, but averages about 0.5mm. The corrosion products enclose different ghost structures: the corrosion crust has preserved the shape of polygonal grains (Figs. 10 and 12) and cementite needles (Fig. 11). Under polarised light, the corrosion products at the metal - corrosion crust interface are dark-red and form an inner S-rich layer (CP3, Figs. 10 and 12). Cl occurs locally (CP3) and C is present in layers CP2 and CP3 (Fig. 12). The outer layer of the corrosion products (CP1) is orange and contains more O than the inner layer CP3 (Figs. 10 and 13).

Fig. 10: Micrograph showing the metal - corrosion crust interface from Fig. 3 (rotated by 270°, detail) and corresponding to the stratigraphy of Fig. 14, unetched, polarised light. Polygonal grains are visible as ghost structure in the corrosion crust. The selected areas for elemental chemical distribution (Figs. 12 and 13) are marked by two rectangles (bottom: Fig. 12 and top: Fig. 13),

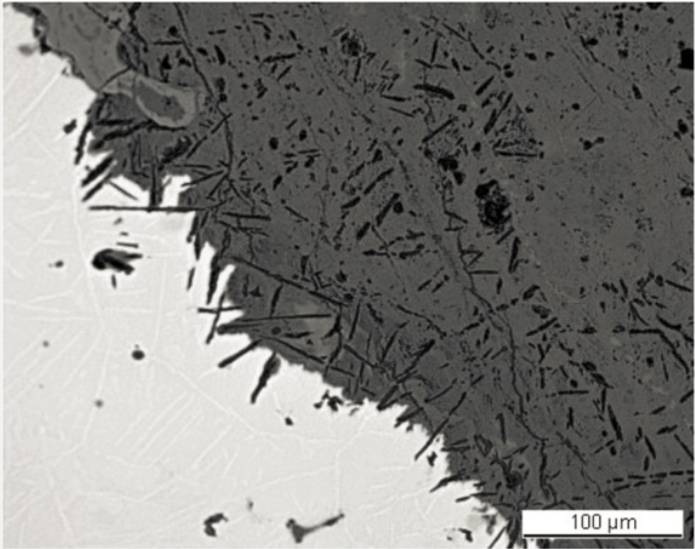
Fig. 11: Micrograph showing the metal - corrosion crust interface from Fig. 3 (detail), unetched, bright field. The cementite is visible as white needles in the metal and its ghost structure as black needles in the corrosion crust,

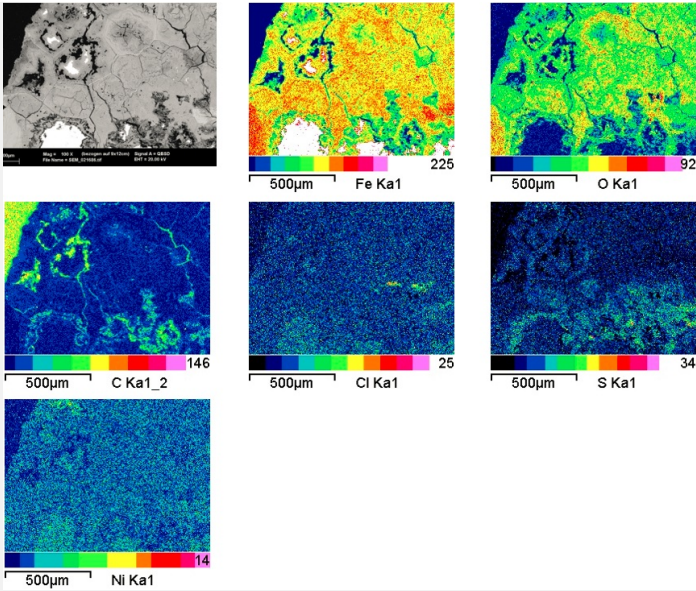
Fig. 12: SEM image, BSE-mode, and elemental chemical distribution of the selected area from Fig. 10 (rotated by 45°). Method of examination: SEM/EDS, Laboratory of Analytical Chemistry, Empa,

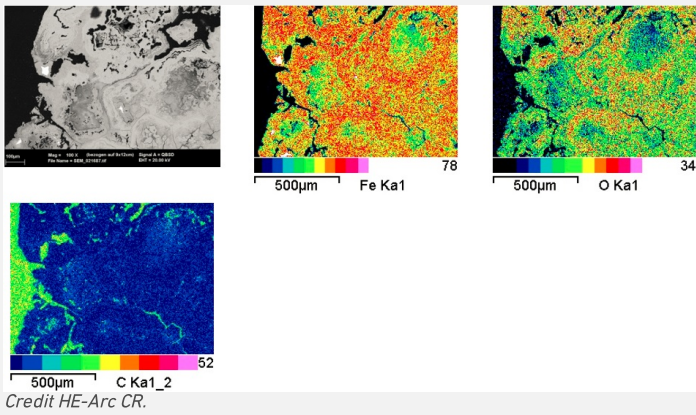
Fig. 13: SEM image, BSE-mode, and elemental chemical distribution of the selected area from Fig. 10 (rotated by 45°). Method of examination: SEM/EDS, Laboratory of Analytical Chemistry, Empa,
