# CHISEL POINT DEV 995 1069 PR – EUTECTOID TO HYPEREUTECTOID STEEL – EARLY MEDIEVAL TIMES – SWITZERLAND

**Artefact name** Chisel point DEV 995 1069 PR

**Authors** Marianne. Senn (Empa, Dübendorf, Zurich, Switzerland) & Christian. Degriigny (HE-Arc CR, Neuchâtel, Neuchâtel, Switzerland)

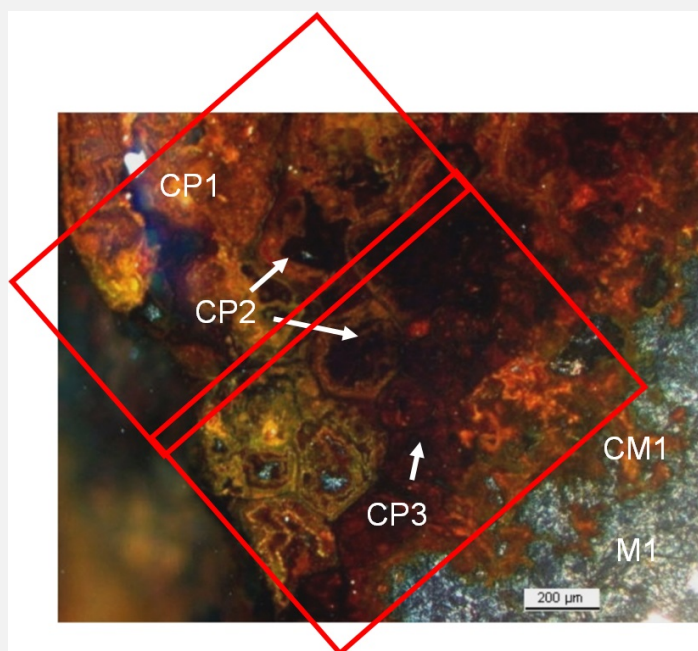
The metal is heavily corroded and the thickness of the corrosion crust is irregular, but averages about 0.5mm. The corrosion products enclose different ghost structures: the corrosion crust has preserved the shape of polygonal grains (Figs. 10 and 12) and cementite needles (Fig. 11). Under polarised light, the corrosion products at the metal - corrosion crust interface are dark-red and form an inner S-rich layer (CP3, Figs. 10 and 12). Cl occurs locally (CP3) and C is present in layers CP2 and CP3 (Fig. 12). The outer layer of the corrosion products (CP1) is orange and contains more O than the inner layer CP3 (Figs. 10 and 13).

Fig. 10: Micrograph showing the metal - corrosion crust interface from Fig. 3 (rotated by 270°, detail) and corresponding to the stratigraphy of Fig. 14, unetched, polarised light. Polygonal grains are visible as ghost structure in the corrosion crust. The selected areas for elemental chemical distribution (Figs. 12 and 13) are marked by two rectangles (bottom: Fig. 12 and top: Fig. 13),

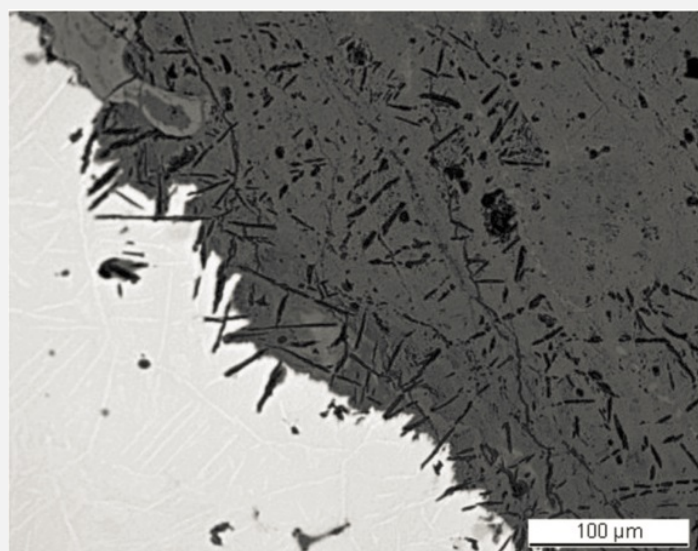
Fig. 11: Micrograph showing the metal - corrosion crust interface from Fig. 3 (detail), unetched, bright field. The cementite is visible as white needles in the metal and its ghost structure as black needles in the corrosion crust,

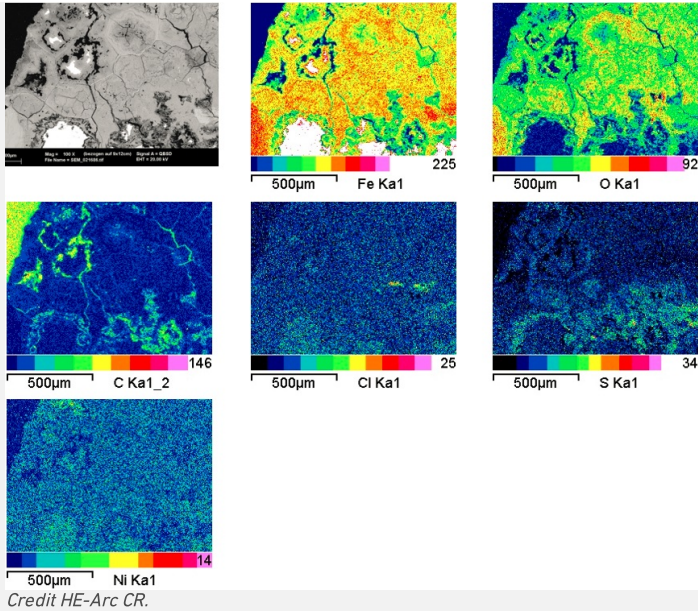
Fig. 12: SEM image, BSE-mode, and elemental chemical distribution of the selected area from Fig. 10 (rotated by 45°). Method of examination: SEM/EDS, Laboratory of Analytical Chemistry, Empa,

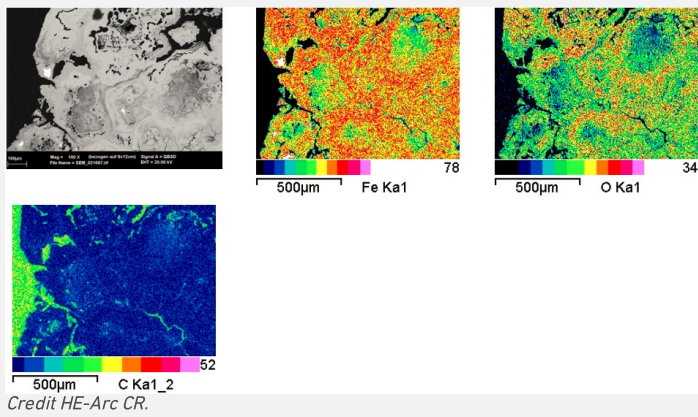
Fig. 13: SEM image, BSE-mode, and elemental chemical distribution of the selected area from Fig. 10 (rotated by 45°). Method of examination: SEM/EDS, Laboratory of Analytical Chemistry, Empa,

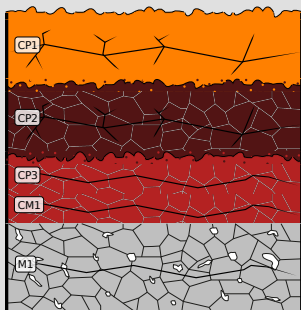
Fig. 14: Stratigraphic representation of the chisel point in cross-section (dark field) using the MiCorr application. The characteristics of the strata are only accessible by clicking on the drawing that redirects you to the search tool by stratigraphy representation. This representation can be compared to Fig. 10, Credit HE-Arc CR.
