SACRIFICIAL ANODE VHS-8339 – ZN ALLOY – MODERN TIMES

Artefact name	Sacrificial anode VHS-8339
Authors	Marianne. Senn (Empa, Dübendorf, Zurich, Switzerland) & Christian. Degriigny (HE-Arc CR, Neuchâtel, Neuchâtel, Switzerland)
Url	/artefacts/1218/

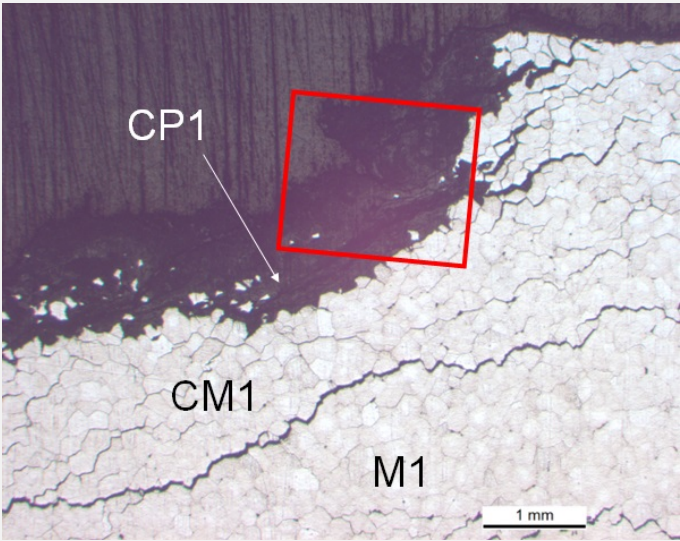
Fig. 4: Micrograph of the metal sample from Fig. 3 (reversed picture, detail), unetched, bright field. Extensive intergranular corrosion is visible. The rectangle marks Fig. 6,

Extensive intergranular corrosion / cracking has developed in the metal structure (Figs. 4, 5). The metal is covered by a corrosion crust that is hardly visible in bright field and which contains remnant metal (Fig. 4). On most of the sample the corrosion crust is uniform. In areas we see cracks (Fig. 6) appearing as brown lines separating the corrosion crust (Fig. 7). In bright field the corrosion crust appears grey containing dark-grey zones (Fig. 6). Under polarized light, the corrosion crust appears white with darker parts including remnant metal (Fig. 7). It contains Zn and O as well as S along some cracks (Table 2 and Fig. 8).

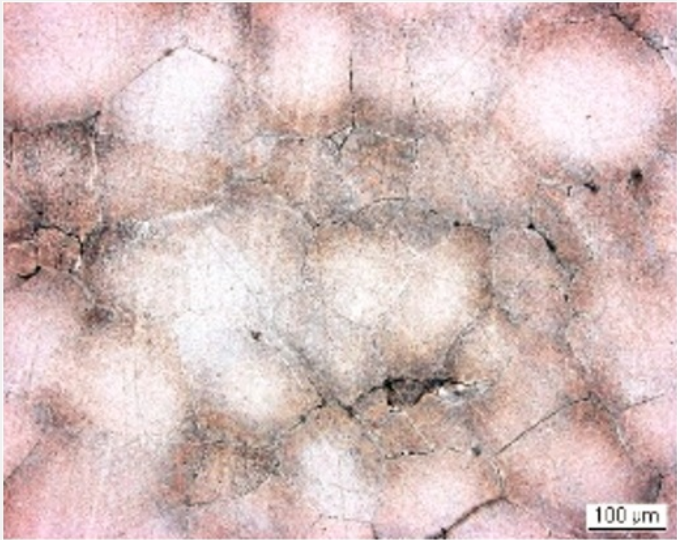
The remaining metal is an almost pure zinc alloy (Table 1). The oxygen content is not from the original alloy, but is due to secondary corrosion. The metal grains are visible without etching and present a polygonal structure (Figs. 4 and 5). The structure is recrystallised after annealing. The recrystallization of zinc alloys begins at room temperature.

Fig. 5: Micrograph of the metal sample from Fig. 3 (detail), etched,

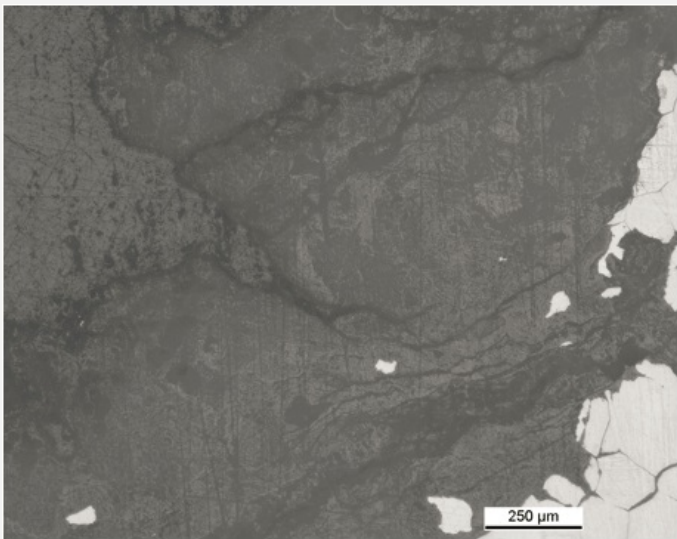
Table 2. Chemical composition (mass %, <: below the detection limit) of the corrosion layer from Figs. 6 and 8. Method of analysis: SEM/EDS, Laboratory of Analytical Chemistry, Empa.

Fig. 6: Micrograph showing the metal - corrosion products interface from Fig. 5 (detail), unetched, bright field,

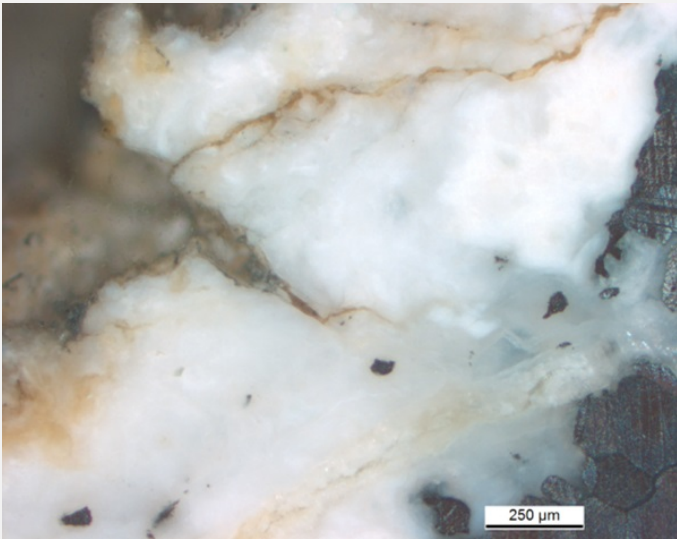
Fig. 7: Micrograph (same as Fig. 6) corresponding to the stratigraphy of Fig. 4, unetched, polarised light. We observe in dark-grey the metal, in white the corrosion crust separated by brown cracks including remnant metal,
