# SACRIFICIAL ANODE VHS-8339 – ZN ALLOY – MODERN TIMES

**Artefact name** Sacrificial anode VHS-8339

**Authors** Marianne. Senn (Empa, Dübendorf, Zurich, Switzerland) & Christian. Degrigny (HE-Arc CR, Neuchâtel, Neuchâtel, Switzerland)

**Origin** Submarine "Mesoscaph" from Auguste Piccard

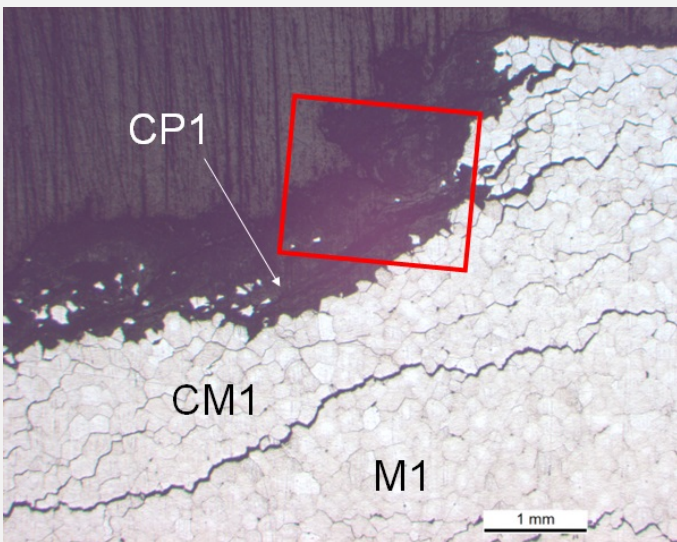
The remaining metal is an almost pure zinc alloy (Table 1). The oxygen content is not from the original alloy, but is due to secondary corrosion. The metal grains are visible without etching and present a polygonal structure (Figs. 4 and 5). The structure is recrystallised after annealing. The recrystallization of zinc alloys begins at room temperature.

Fig. 4: Micrograph of the metal sample from Fig. 3 (reversed picture, detail), unetched, bright field. Extensive intergranular corrosion is visible. The rectangle marks Fig. 6,

Extensive intergranular corrosion / cracking has developed in the metal structure (Figs. 4, 5). The metal is covered by a corrosion crust that is hardly visible in bright field and which contains remnant metal (Fig. 4). On most of the sample the corrosion crust is uniform. In areas we see cracks (Fig. 6) appearing as brown lines separating the corrosion crust (Fig. 7). In bright field the corrosion crust appears grey containing dark-grey zones (Fig. 6). Under polarized light, the corrosion crust appears white with darker parts including remnant metal (Fig. 7). It contains Zn and O as well as S along some cracks (Table 2 and Fig. 8).

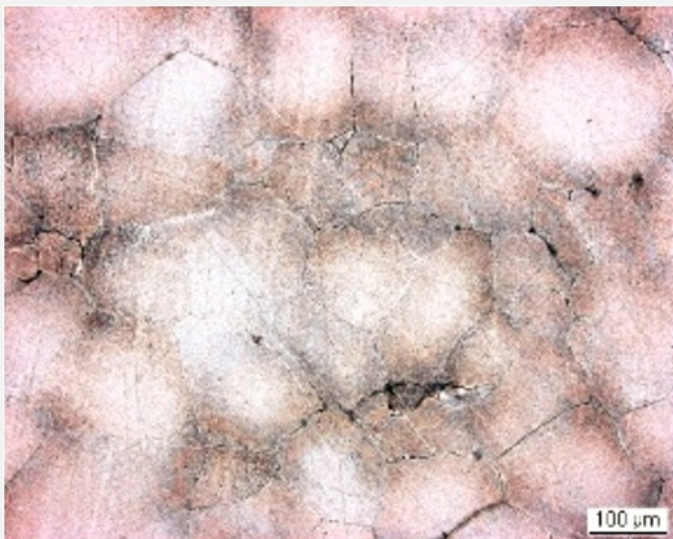
Fig. 5: Micrograph of the metal sample from Fig. 3 (detail), etched,

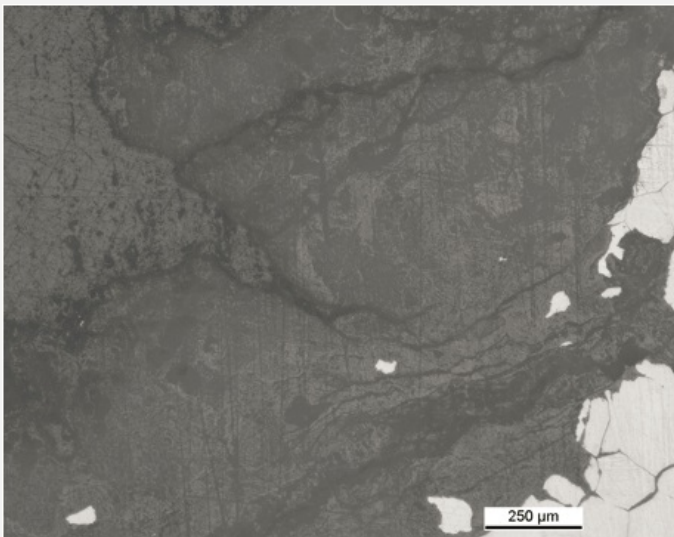
Table 2. Chemical composition (mass %, <: below the detection limit) of the corrosion layer from Figs. 6 and 8. Method of analysis: SEM/EDS, Laboratory of Analytical Chemistry, Empa.

Fig. 6: Micrograph showing the metal - corrosion products interface from Fig. 5 (detail), unetched, bright field,

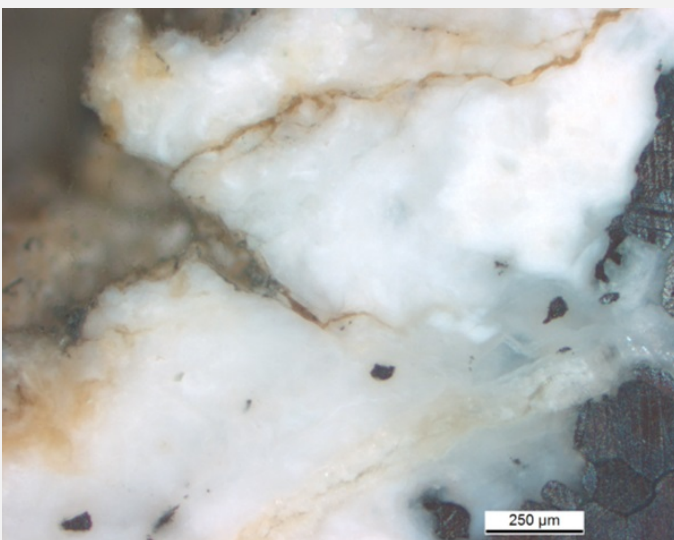
Fig. 7: Micrograph (same as Fig. 6) corresponding to the stratigraphy of Fig. 4, unetched, polarised light. We observe in dark-grey the metal, in white the corrosion crust separated by brown cracks including remnant metal,

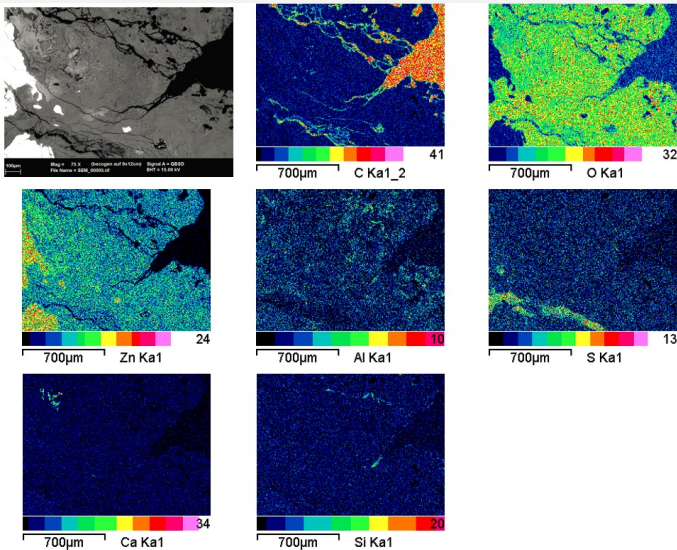
Fig. 8: SEM image, BSE-mode, and elemental chemical distribution of most of the area of Fig. 6 (reversed picture). Method of examination: SEM/EDS, Laboratory of Analytical Chemistry, Empa,
