# SACRIFICIAL ANODE VHS-8339 – ZN ALLOY – MODERN TIMES

<b>Artefact name</b>	Sacrificial anode VHS-8339
<b>Authors</b>	Marianne. Senn (Empa, Dübendorf, Zurich, Switzerland) & Christian. Degryny (HE-Arc CR, Neuchâtel, Neuchâtel, Switzerland)
<b>Url</b>	/artefacts/1218/

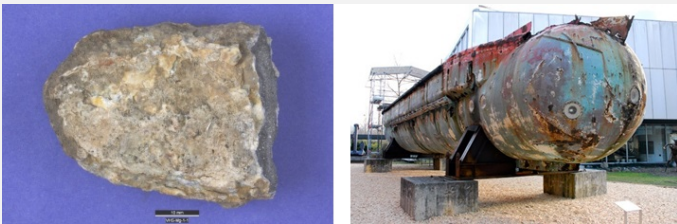
Fig. 1: Sacrificial anode (left) from submarine "Mesoscaph" (right) ([www.verkehrshaus.ch](http://www.verkehrshaus.ch)),

<b>Description of the artefact</b>	The artefact could be a weight or sacrificial anode of a submarine (Fig. 1). It is surrounded by a whitish brown-grey corrosion crust. The broken metal has a greyish shiny colour. Dimensions: L = 4.9cm ; WT = 95g.
<b>Type of artefact</b>	Submarine part
<b>Origin</b>	Submarine "Mesoscaph" from Auguste Piccard
<b>Recovering date</b>	The sacrificial anodes (?) might have been added when the submarine was used in the sea.
<b>Chronology category</b>	Modern Times
<b>chronology tpq</b>	<input type="text" value="1970"/> A.D. ▼
<b>chronology taq</b>	<input type="text" value="1974"/> A.D. ▼
<b>Chronology comment</b>	
<b>Burial conditions / environment</b>	Outdoor atmosphere
<b>Artefact location</b>	Swiss Museum of Transport, Luzern, Lucerne
<b>Owner</b>	Swiss Museum of Transport, Luzern, Lucerne

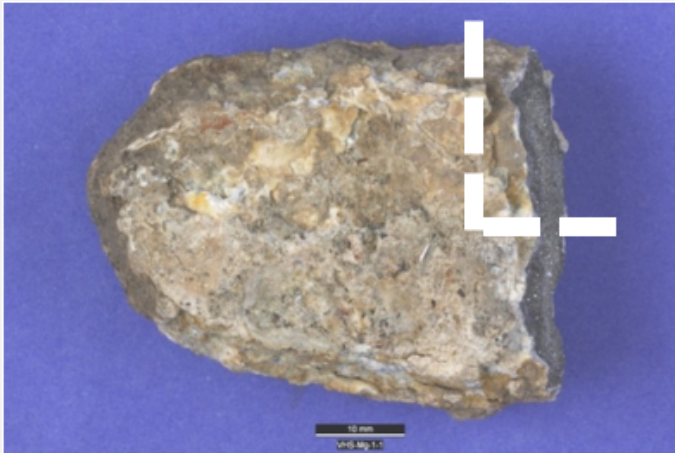
Fig. 2: Location of sampling area,

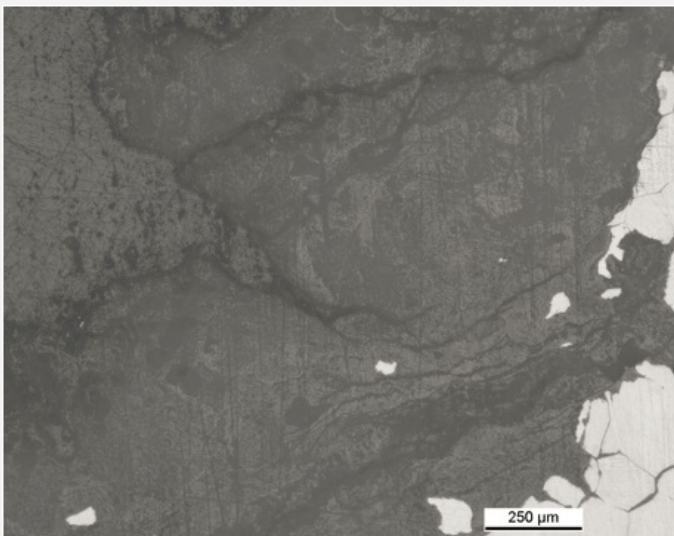
Extensive intergranular corrosion / cracking has developed in the metal structure (Figs. 4, 5). The metal is covered by a corrosion crust that is hardly visible in bright field and which contains remnant metal (Fig. 4). On most of the sample the corrosion crust is uniform. In areas we see cracks (Fig. 6) appearing as brown lines separating the corrosion crust (Fig. 7). In bright field the corrosion crust appears grey containing dark-grey zones (Fig. 6). Under polarized light, the corrosion crust appears white with darker parts including remnant metal (Fig. 7). It contains Zn and O as well as S along some cracks (Table 2 and Fig. 8).

Fig. 6: Micrograph showing the metal - corrosion products interface from Fig. 5 (detail), unetched, bright field,

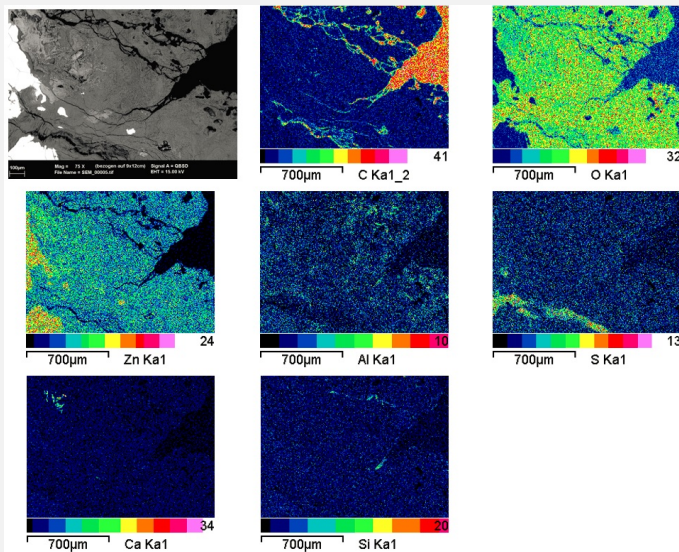
Fig. 8: SEM image, BSE-mode, and elemental chemical distribution of most of the area of Fig. 6 (reversed picture). Method of examination: SEM/EDS, Laboratory of Analytical Chemistry, Empa,
