ARMATURE FROM A CLOCK MOVEMENT MIH IV-212 – ZN AL SN CU ALLOY – MODERN TIMES

Artefact name Armature from a clock movement MIH IV-212

Authors Marianne. Senn (Empa, Dübendorf, Zurich, Switzerland) & Christian. Degriigny (HE-Arc CR, Neuchâtel, Neuchâtel, Switzerland)

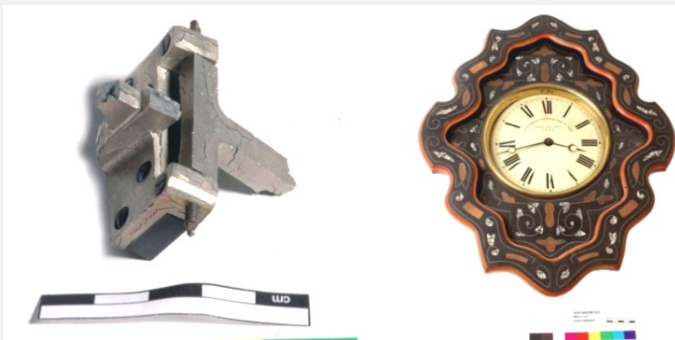
Fig. 1: Broken armature (left) from the clock movement of a wooden wall clock (right) (after Seematter 2009),

Description of the artefact	Armature from the clock movement of a wooden wall clock with electric movement, broken in two elements (Fig. 1 and Fig. 2) with a heavily cracked surface.
Type of artefact	Horological object
Origin	Wooden wall clock
Recovering date	1902-1904
Chronology category	Modern Times
chronology tpq	<input type="text" value="1902"/> A.D. ▼
chronology taq	<input type="text" value="1904"/> A.D. ▼
Chronology comment	
Burial conditions / environment	Indoor atmosphere

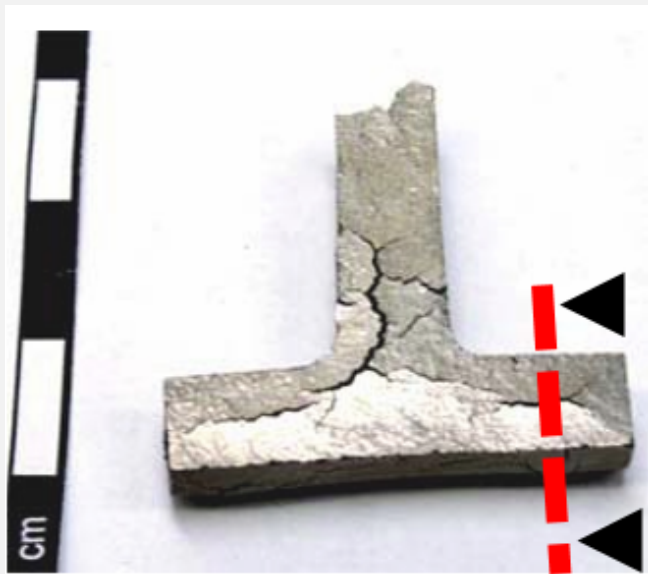
Fig. 2: Location of sampling area on one of the two broken elements of the armature,

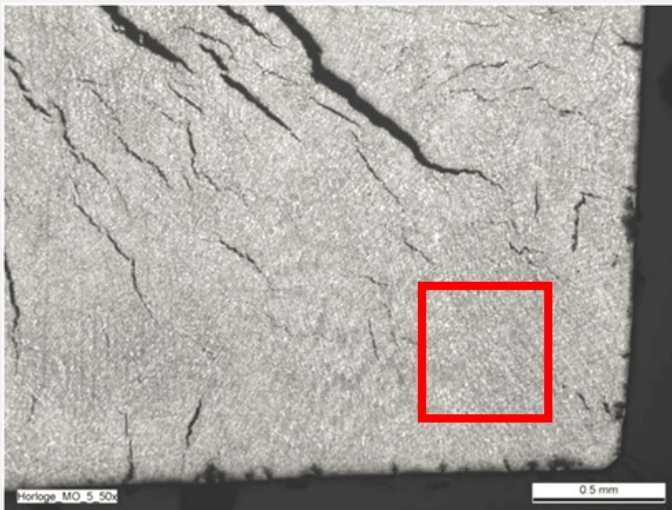
The metal is a Zn-Al-Sn-Cu alloy (Table 1) with an average hardness of HV1 105. A fine dendritic structure is observed (Fig. 4) which consists of clearly separated Zn, Al-Cu and Sn-rich phases (Figs. 5 and 6). Pb is associated with Sn but also forms tiny nodules.

Fig. 4: Micrograph of the metal sample from Fig. 3 (inverted picture, rotated by 270°, detail), unetched, bright field. A dendritic structure is visible. The micrograph of Fig. 5 is marked by a square,

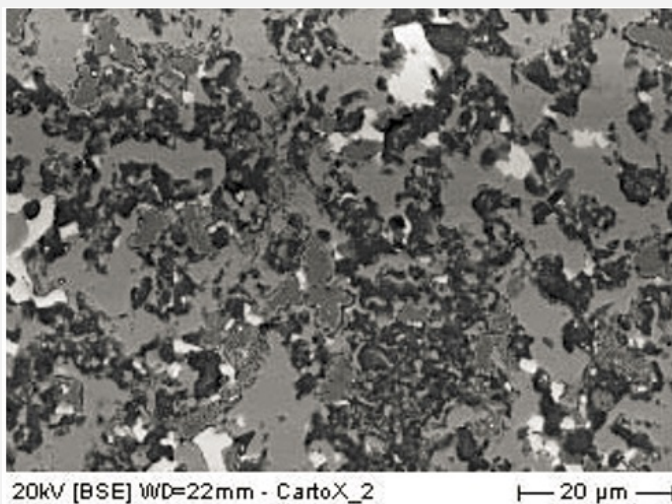
Fig. 5: SEM image, BSE-mode, detail from Fig. 4 (detail), unetched, bright field. Three phases appear: in light-grey the Zn-rich phase, in dark-grey the Al and Cu-rich phase and in white the Sn-rich phase,

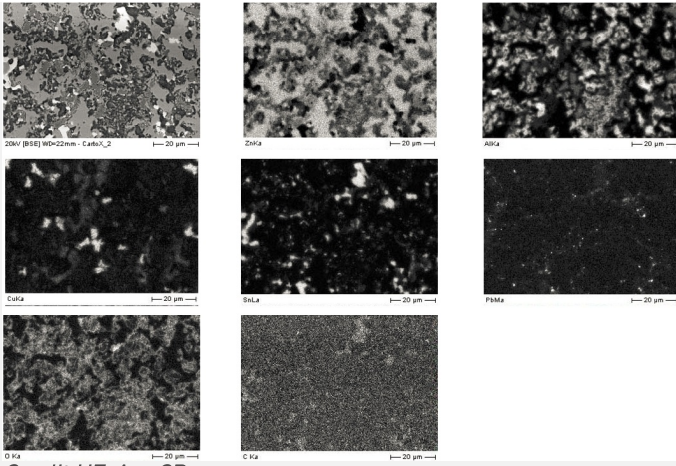
Fig. 6: SEM image, BSE-mode, and elemental chemical distribution of the selected area from Fig. 5. Method of examination: SEM/EDS, Lab of Electronic Microscopy and microanalysis, IMA (Néode), HEI Arc,

The Zn-rich phase is heavily oxidised internally (Fig. 6). The corrosion has developed throughout the entire metal body, generating cracks (Figs. 7 and 8). The cracks are Zn, O and C-rich (Fig. 9) and could be composed of zinc carbonate.

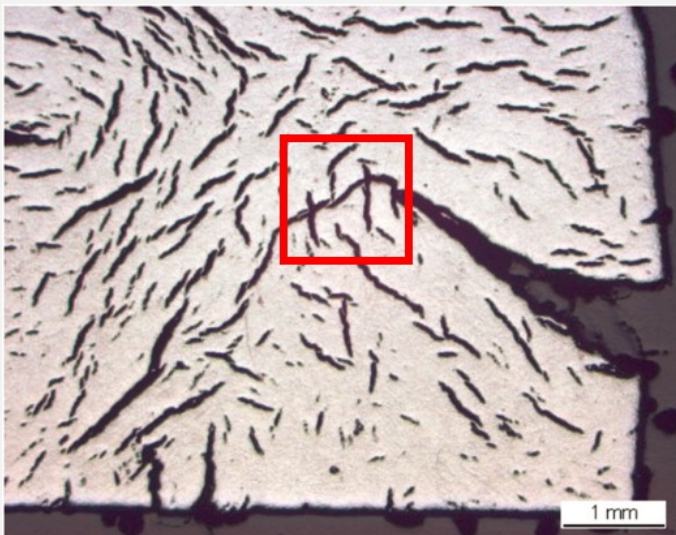
Fig. 7: Micrograph showing the metal - "corrosion products" interface from Fig. 3 (reversed picture, detail), unetched, bright field,

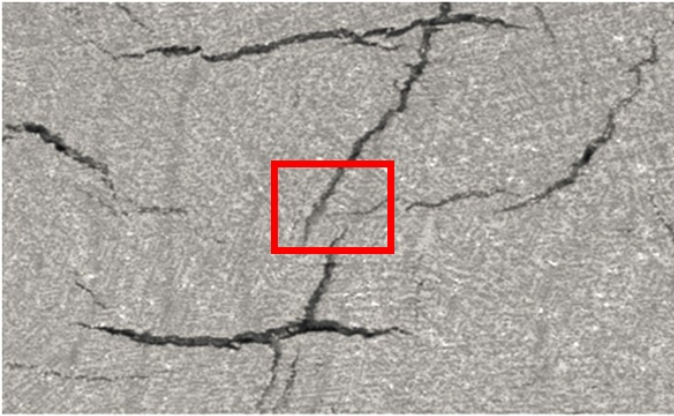
Fig. 8: Micrograph of the metal sample, detail from Fig. 7 (reversed and rotated by 90°), unetched, bright field. A dendritic structure is visible. The area selected for elementary mapping (Fig. 9) is marked by a rectangle. Can be compared to the stratigraphy representation of Fig. 10,

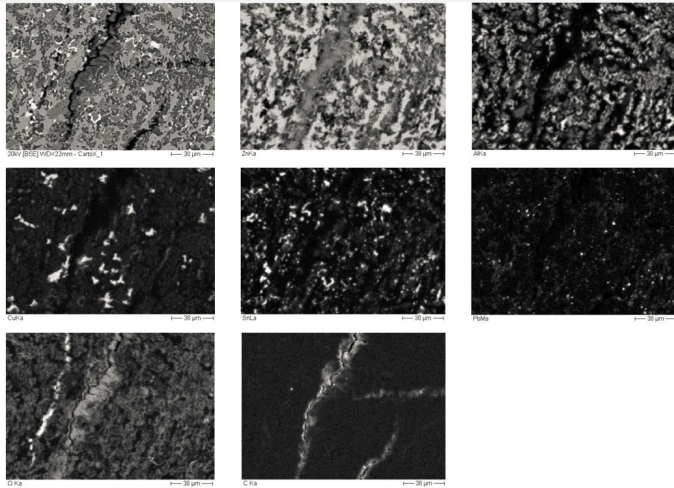
Fig. 9: SEM image, BSE-mode, and elemental chemical distribution of the selected area from Fig. 8 (detail). Method of examination: SEM/EDX, Lab of Electronic Microscopy and microanalysis, IMA (Néode), HEI Arc,

Corrosion form Internal cracking
Corrosion type zinc pest
