# ARMATURE FROM A CLOCK MOVEMENT MIH IV-212 - ZN AL SN CU ALLOY - MODERN TIMES

**Artefact name** Armature from a clock movement MIH IV-212

**Authors** Marianne. Senn (Empa, Dübendorf, Zurich, Switzerland) & Christian. Degriigny (HE-Arc CR, Neuchâtel, Neuchâtel, Switzerland)

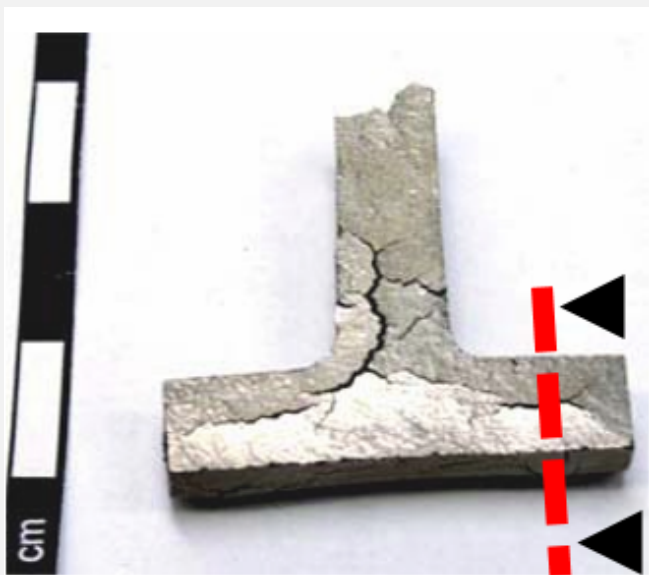
Fig. 2: Location of sampling area on one of the two broken elements of the armature,

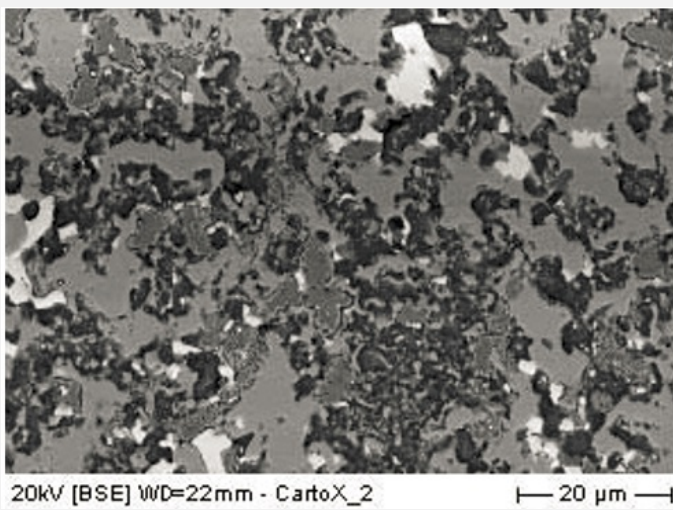
Fig. 5: SEM image, BSE-mode, detail from Fig. 4 (detail), unetched, bright field. Three phases appear: in light-grey the Zn-rich phase, in dark-grey the Al and Cu-rich phase and in white the Sn-rich phase,

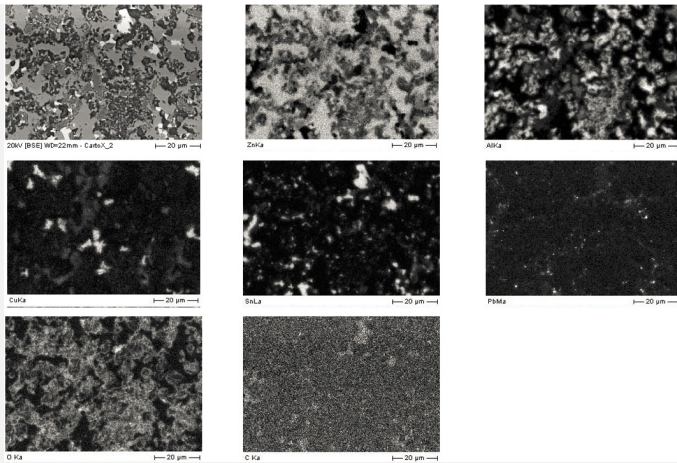
Fig. 6: SEM image, BSE-mode, and elemental chemical distribution of the selected area from Fig. 5. Method of examination: SEM/EDS, Lab of Electronic Microscopy and microanalysis, IMA (Néode), HEI Arc,

The Zn-rich phase is heavily oxidised internally (Fig. 6). The corrosion has developed throughout the entire metal body, generating cracks (Figs. 7 and 8). The cracks are Zn, O and C-rich (Fig. 9) and could be composed of zinc carbonate.

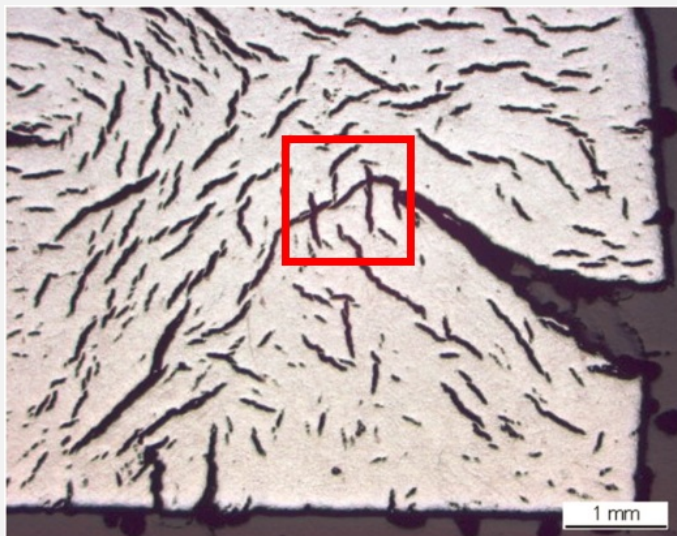
Fig. 7: Micrograph showing the metal - "corrosion products" interface from Fig. 3 (reversed picture, detail), unetched, bright field,

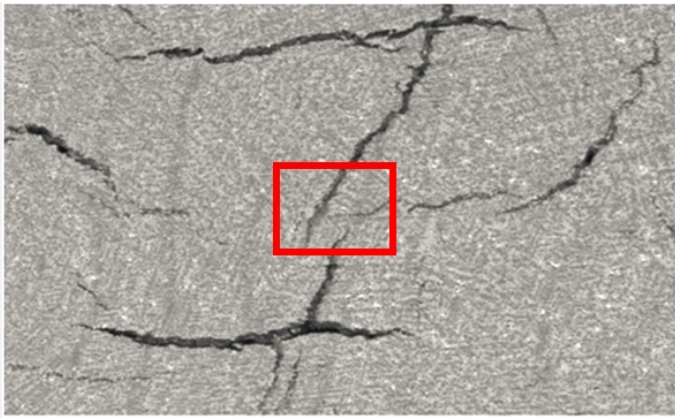
Fig. 8: Micrograph of the metal sample, detail from Fig. 7 (reversed and rotated by 90°), unetched, bright field. A dendritic structure is visible. The area selected for elementary mapping (Fig. 9) is marked by a rectangle. Can be compared to the stratigraphy representation of Fig. 10,

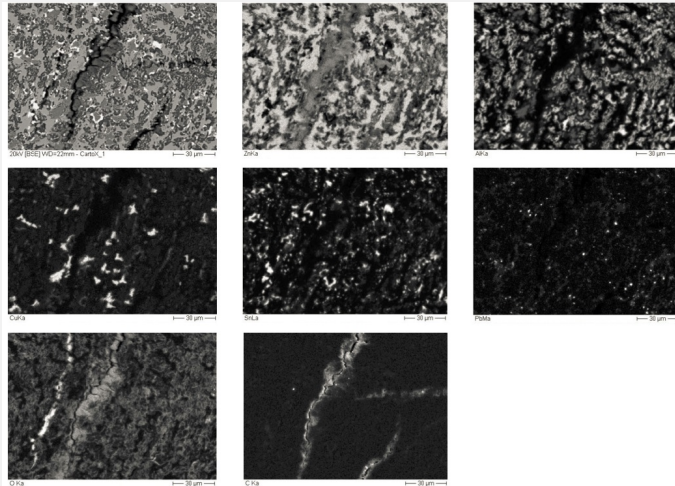
Fig. 9: SEM image, BSE-mode, and elemental chemical distribution of the selected area from Fig. 8 (detail). Method of examination: SEM/EDX, Lab of Electronic Microscopy and microanalysis, IMA (Néode), HEI Arc,

**Corrosion form** Internal cracking  
**Corrosion type** zinc pest
