# ARMATURE FROM A CLOCK MOVEMENT MIH IV-212 – ZN AL SN CU ALLOY – MODERN TIMES

<b>Artefact name</b>	Armature from a clock movement MIH IV-212
<b>Authors</b>	Marianne. Senn (Empa, Dübendorf, Zurich, Switzerland) & Christian. Degrygn (HE-Arc CR, Neuchâtel, Neuchâtel, Switzerland)
<b>Url</b>	/artefacts/1219/

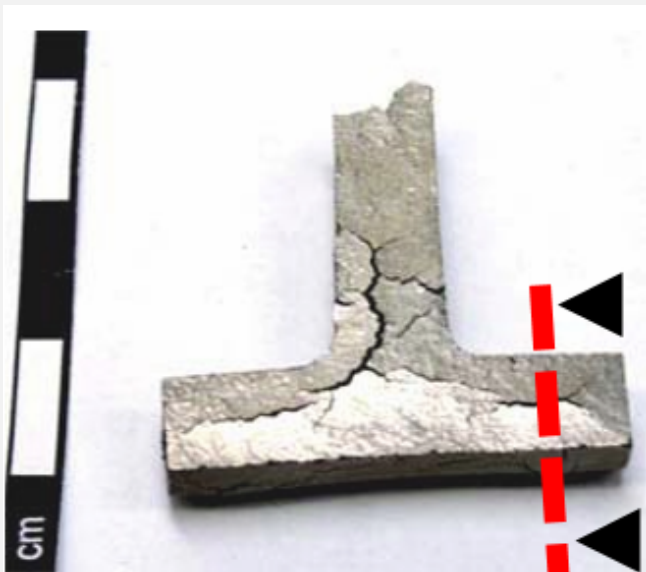
Fig. 2: Location of sampling area on one of the two broken elements of the armature,

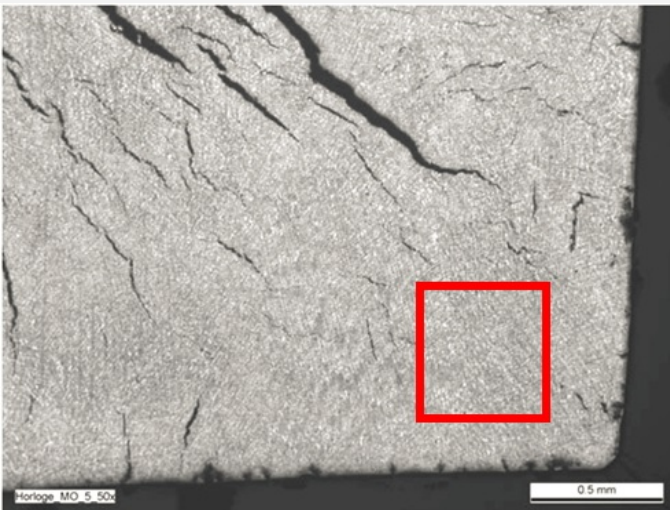
The metal is a Zn-Al-Sn-Cu alloy (Table 1) with an average hardness of HV1 105. A fine dendritic structure is observed (Fig. 4) which consists of clearly separated Zn, Al-Cu and Sn-rich phases (Figs. 5 and 6). Pb is associated with Sn but also forms tiny nodules.

Fig. 4: Micrograph of the metal sample from Fig. 3 (inverted picture, rotated by 270°, detail), unetched, bright field. A dendritic structure is visible. The micrograph of Fig. 5 is marked by a square,

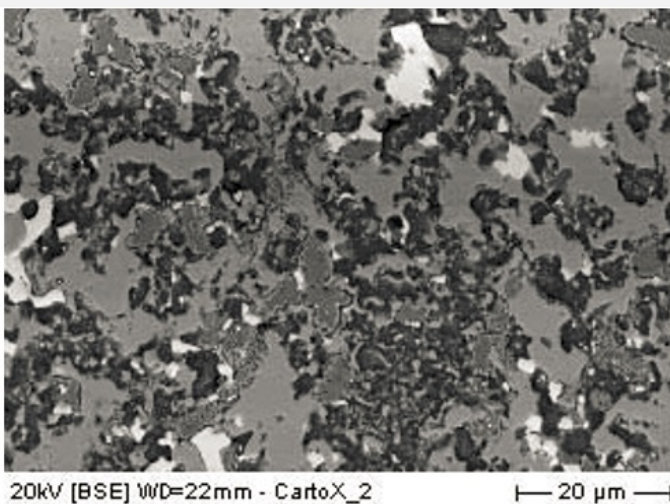
Fig. 5: SEM image, BSE-mode, detail from Fig. 4 (detail), unetched, bright field. Three phases appear: in light-grey the Zn-rich phase, in dark-grey the Al and Cu-rich phase and in white the Sn-rich phase,

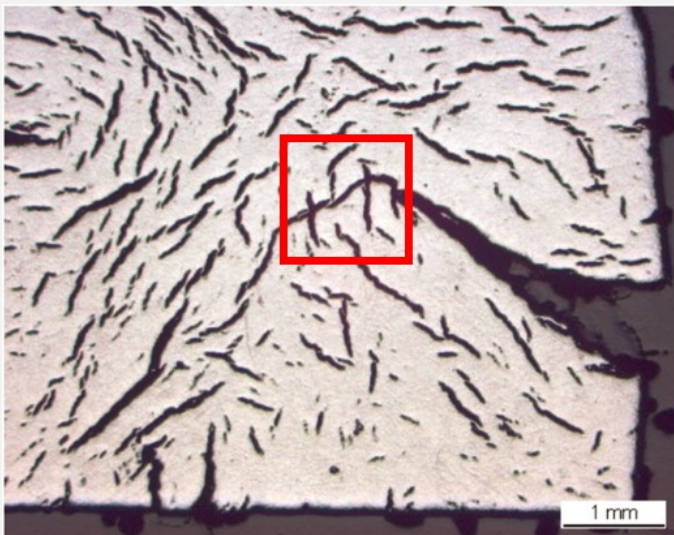
Fig. 7: Micrograph showing the metal - "corrosion products" interface from Fig. 3 (reversed picture, detail), unetched, bright field,
