ARMATURE FROM A CLOCK MOVEMENT MIH IV-212 - ZN AL SN CU ALLOY - MODERN TIMES

Artefact name	Armature from a clock movement MIH IV-212
Authors	Marianne. Senn (Empa, Dübendorf, Zurich, Switzerland) & Christian. Degriigny (HE-Arc CR, Neuchâtel, Neuchâtel, Switzerland)
Url	/artefacts/1219/

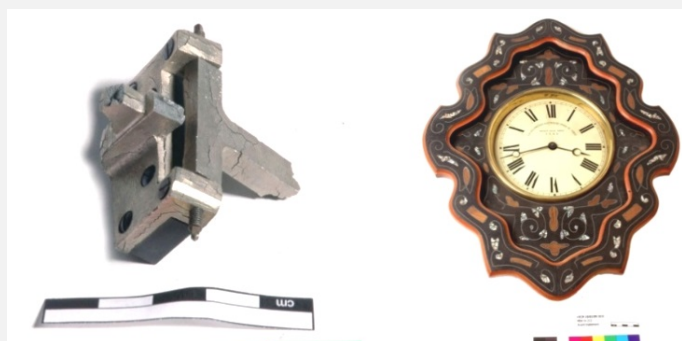
Fig. 1: Broken armature (left) from the clock movement of a wooden wall clock (right) (after Seematter 2009),

Description of the artefact	Armature from the clock movement of a wooden wall clock with electric movement, broken in two elements (Fig. 1 and Fig. 2) with a heavily cracked surface.		
Type of artefact	Horological object		
Origin	Wooden wall clock		
Recovering date	1902-1904		
Chronology category	Modern Times		
chronology tpq	1902	A.D.	∨
chronology taq	1904	A.D.	∨
Chronology comment

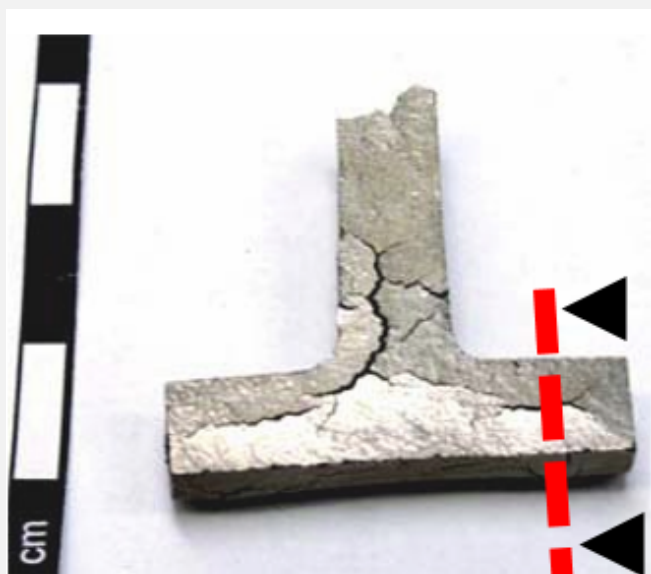
Fig. 2: Location of sampling area on one of the two broken elements of the armature,

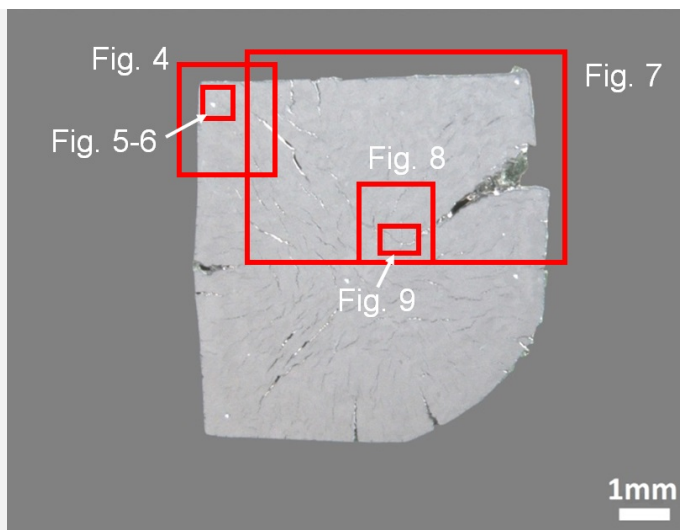
Fig. 3: Micrograph of the cross-section of the fragment sampled from the armature showing the location of Figs. 4 to 9,

Description of sample	This sample is the complete cross-section from one of the two broken elements of the armature (Fig. 2). The metal has large cracks radiating from the centre to the outside which have deformed the armature (Fig. 3).
Alloy	Zn Al Sn Cu Alloy
Technology	As-cast
Lab number of sample	MIH-VI-212
Sample location	HE-Arc CR, Neuchâtel, Neuchâtel
Responsible institution	International museum of horology (IMH), La Chaux-de-Fonds, Neuchâtel
Date and aim of sampling	2009, metal analysis

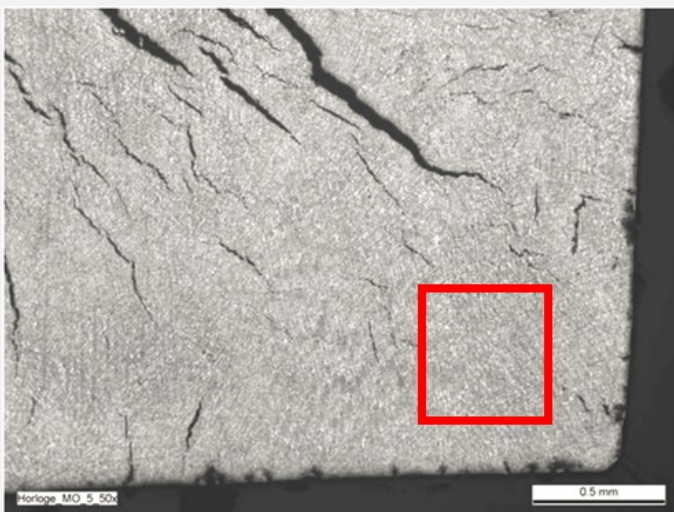
The metal is a Zn-Al-Sn-Cu alloy (Table 1) with an average hardness of HV1 105. A fine dendritic structure is observed (Fig. 4) which consists of clearly separated Zn, Al-Cu and Sn-rich phases (Figs. 5 and 6). Pb is associated with Sn but also forms tiny nodules.

Fig. 4: Micrograph of the metal sample from Fig. 3 (inverted picture, rotated by 270°, detail), unetched, bright field. A dendritic structure is visible. The micrograph of Fig. 5 is marked by a square,

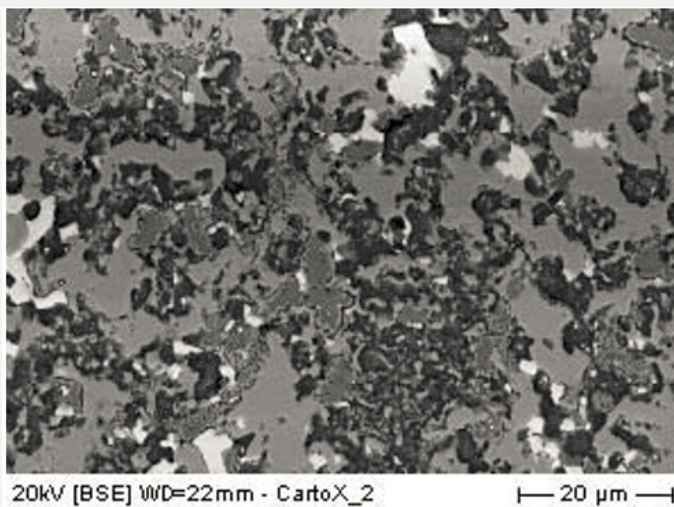
Fig. 5: SEM image, BSE-mode, detail from Fig. 4 (detail), unetched, bright field. Three phases appear: in light-grey the Zn-rich phase, in dark-grey the Al and Cu-rich phase and in white the Sn-rich phase,

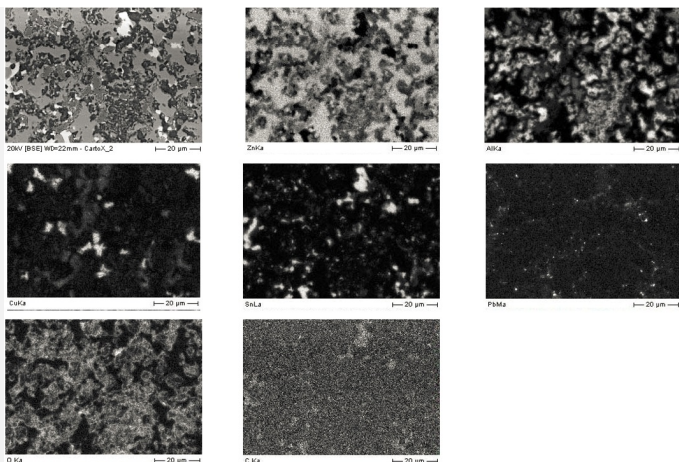
Fig. 6: SEM image, BSE-mode, and elemental chemical distribution of the selected area from Fig. 5. Method of examination: SEM/EDS, Lab of Electronic Microscopy and microanalysis, IMA (Néode), HEI Arc,

The Zn-rich phase is heavily oxidised internally (Fig. 6). The corrosion has developed throughout the entire metal body, generating cracks (Figs. 7 and 8). The cracks are Zn, O and C-rich (Fig. 9) and could be composed of zinc carbonate.

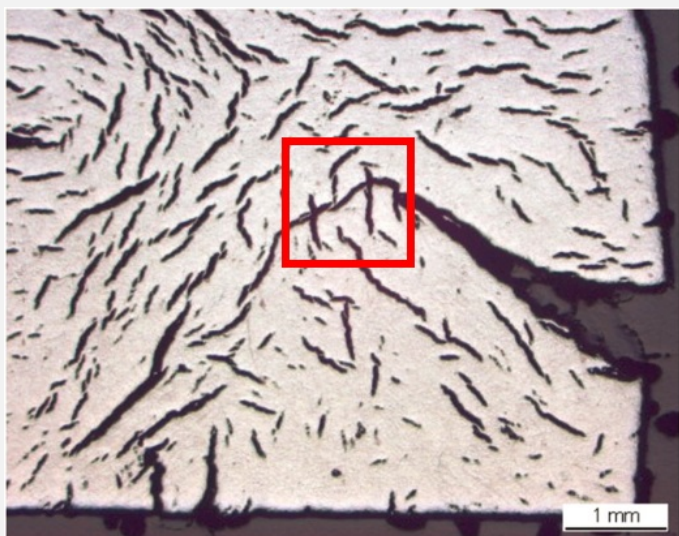
Fig. 7: Micrograph showing the metal - "corrosion products" interface from Fig. 3 (reversed picture, detail), unetched, bright field,

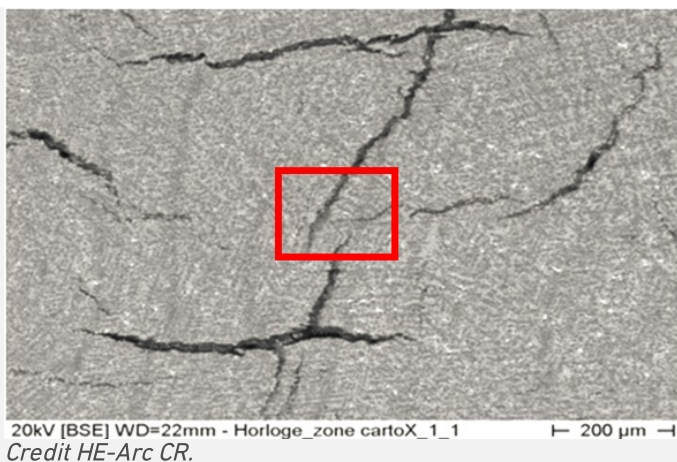
Fig. 8: Micrograph of the metal sample, detail from Fig. 7 (reversed and rotated by 90°), unetched, bright field. A dendritic structure is visible. The area selected for elementary mapping (Fig. 9) is marked by a rectangle. Can be compared to the stratigraphy representation of Fig. 10,

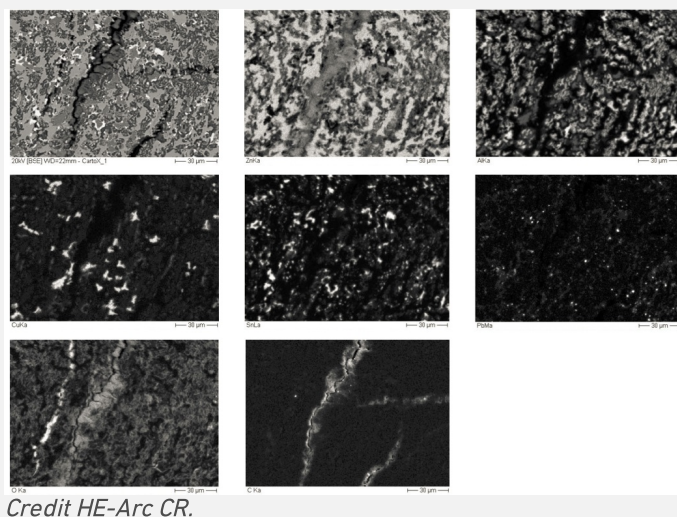
Fig. 9: SEM image, BSE-mode, and elemental chemical distribution of the selected area from Fig. 8 (detail). Method of examination: SEM/EDX, Lab of Electronic Microscopy and microanalysis, IMA (Néode), HEI Arc,
