ARMATURE FROM A CLOCK MOVEMENT MIH IV-212 – ZN AL SN CU ALLOY – MODERN TIMES

Artefact name	Armature from a clock movement MIH IV-212
Authors	Marianne. Senn (Empa, Dübendorf, Zurich, Switzerland) & Christian. Degriigny (HE-Arc CR, Neuchâtel, Neuchâtel, Switzerland)
Url	/artefacts/1219/

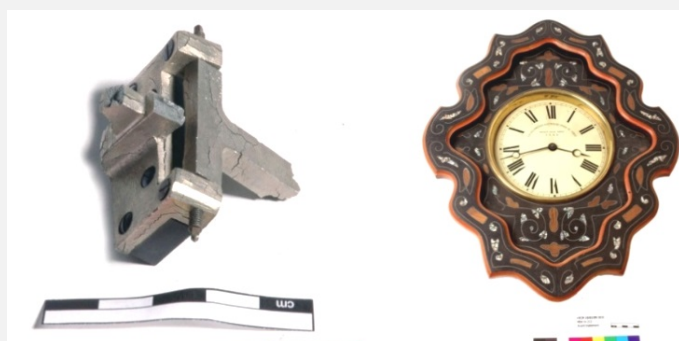
Fig. 1: Broken armature (left) from the clock movement of a wooden wall clock (right) (after Seematter 2009),

Description of the artefact	Armature from the clock movement of a wooden wall clock with electric movement, broken in two elements (Fig. 1 and Fig. 2) with a heavily cracked surface.		
Type of artefact	Horological object		
Origin	Wooden wall clock		
Recovering date	1902-1904		
Chronology category	Modern Times		
chronology tpq	1902	A.D. ▼	
chronology taq	1904	A.D. ▼	
Chronology comment			
Burial conditions / environment	Indoor atmosphere

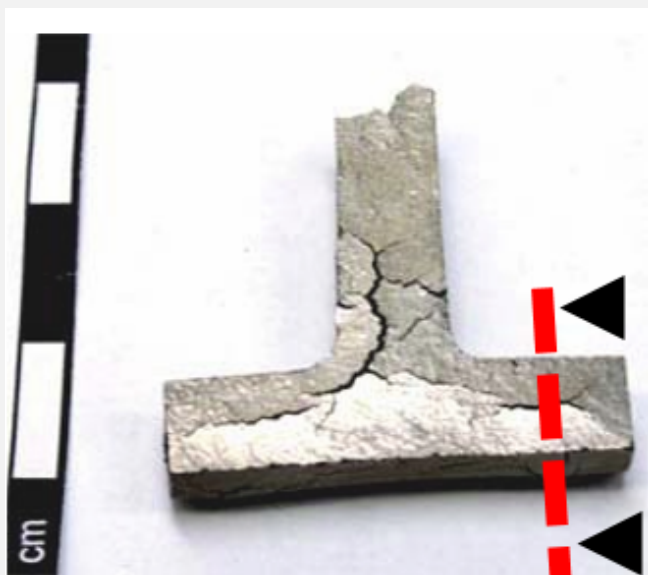
Fig. 2: Location of sampling area on one of the two broken elements of the armature,

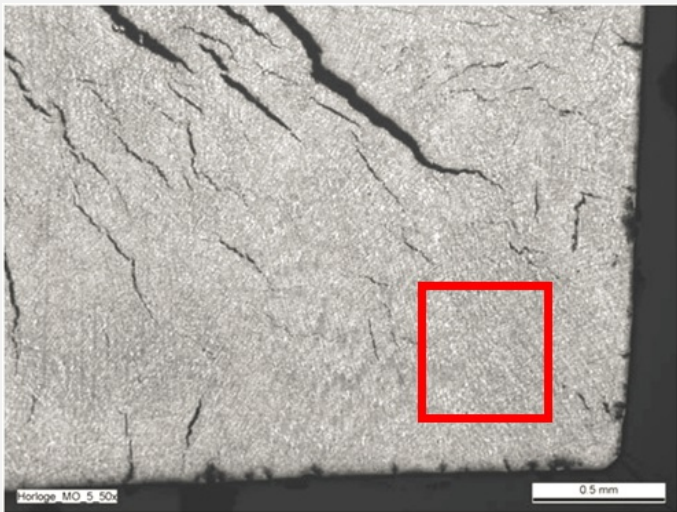
The metal is a Zn-Al-Sn-Cu alloy (Table 1) with an average hardness of HV1 105. A fine dendritic structure is observed (Fig. 4) which consists of clearly separated Zn, Al-Cu and Sn-rich phases (Figs. 5 and 6). Pb is associated with Sn but also forms tiny nodules.

Fig. 4: Micrograph of the metal sample from Fig. 3 (inverted picture, rotated by 270°, detail), unetched, bright field. A dendritic structure is visible. The micrograph of Fig. 5 is marked by a square,

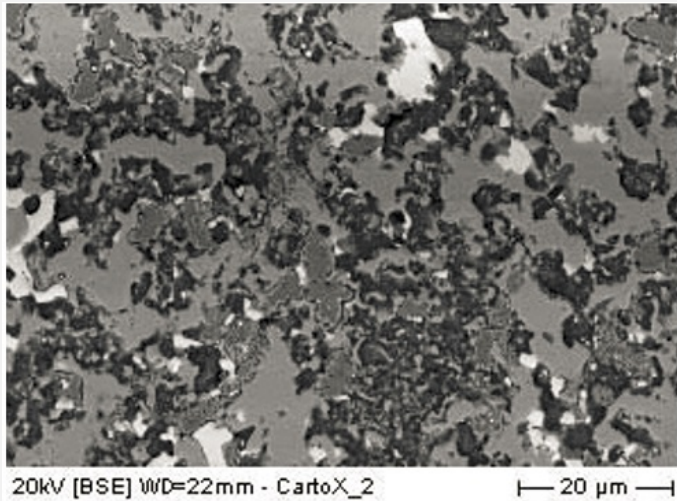
Fig. 5: SEM image, BSE-mode, detail from Fig. 4 (detail), unetched, bright field. Three phases appear: in light-grey the Zn-rich phase, in dark-grey the Al and Cu-rich phase and in white the Sn-rich phase,

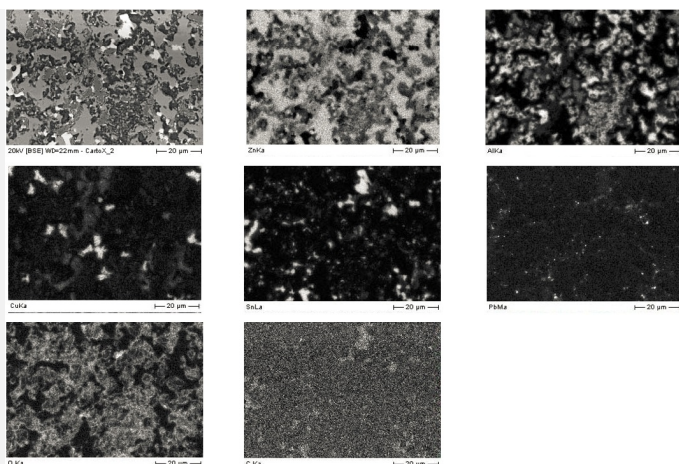
Fig. 6: SEM image, BSE-mode, and elemental chemical distribution of the selected area from Fig. 5. Method of examination: SEM/EDS, Lab of Electronic Microscopy and microanalysis, IMA (Néode), HEI Arc,

The Zn-rich phase is heavily oxidised internally (Fig. 6). The corrosion has developed throughout the entire metal body, generating cracks (Figs. 7 and 8). The cracks are Zn, O and C-rich (Fig. 9) and could be composed of zinc carbonate.

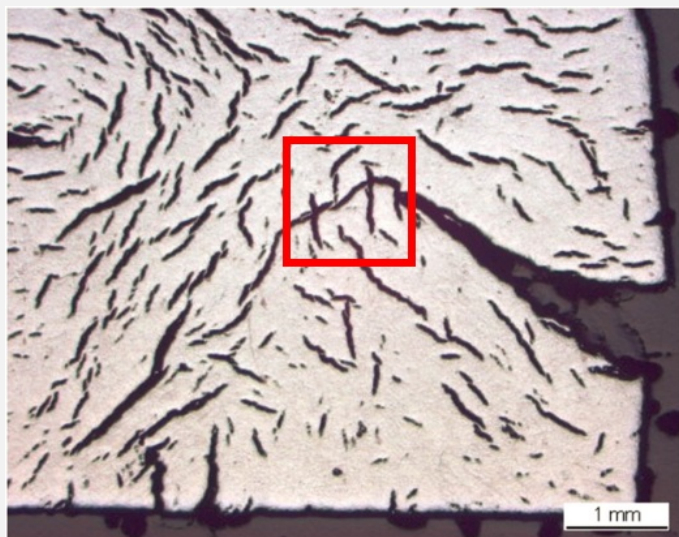
Fig. 7: Micrograph showing the metal - “corrosion products” interface from Fig. 3 (reversed picture, detail), unetched, bright field,

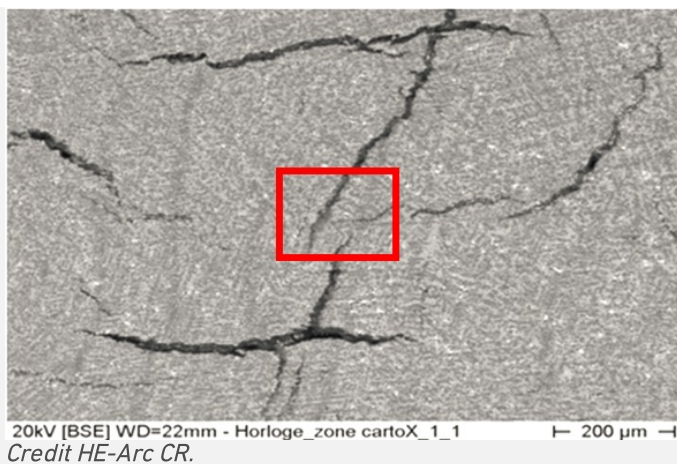
Fig. 8: Micrograph of the metal sample, detail from Fig. 7 (reversed and rotated by 90°), unetched, bright field. A dendritic structure is visible. The area selected for elementary mapping (Fig. 9) is marked by a rectangle. Can be compared to the stratigraphy representation of Fig. 10,

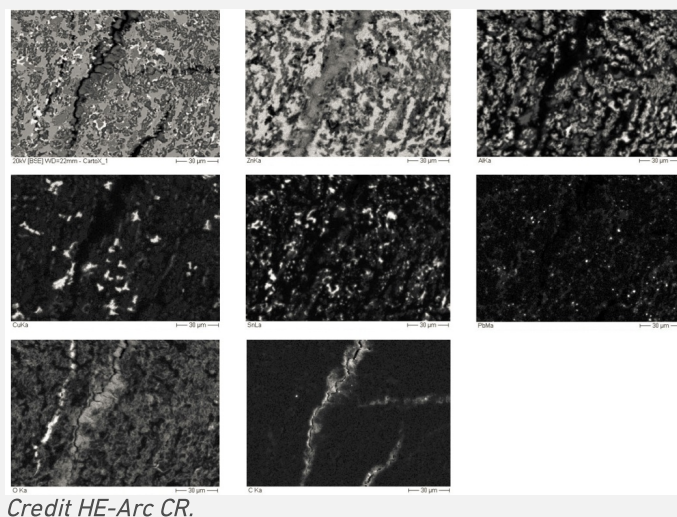
Fig. 9: SEM image, BSE-mode, and elemental chemical distribution of the selected area from Fig. 8 (detail). Method of examination: SEM/EDX, Lab of Electronic Microscopy and microanalysis, IMA (Néode), HEI Arc,
