SITULA EMT09-554.665 - TIN BRONZE - IRON AGE - SWITZERLAND

Artefact name	Situla EMT09-554.665
Authors	Christian. Degriigny (HE-Arc CR, Neuchâtel, Neuchâtel, Switzerland) & Marie-Jeanne. Scholl (HE-Arc CR, Neuchâtel, Neuchâtel, Switzerland) & Valentin. Boissonnas (HE-Arc CR, Neuchâtel, Neuchâtel, Switzerland)
Url	/artefacts/1229/

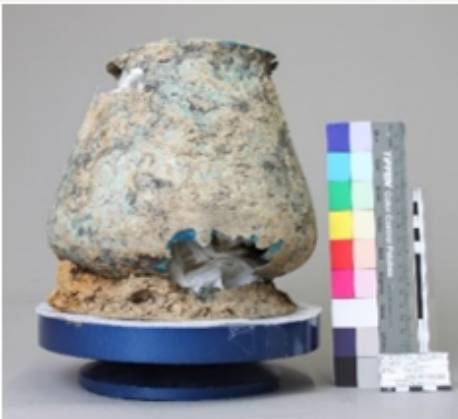
Fig. 1: Situla (Archeodunum (Gollion), 2009) inverted as found in situ,

Description of the artefact	Situla (Fig. 1) covered with blue-green corrosion products and sediments. Attached to two riveted iron loops is an iron handle terminating in two swan heads (not shown here). Dimensions of the main body: Hmax = 340mm, Ømax = 220mm.
Type of artefact	Vessel
Origin	Mormont sanctuary, La Sarraz, Vaud, Switzerland
Recovering date	Excavated in 2011
Chronology category	Iron Age
chronology tpq	<input type="text" value="140"/> B.C. ▾
chronology taq	<input type="text" value="30"/> B.C. ▾
Chronology comment	La Tène D

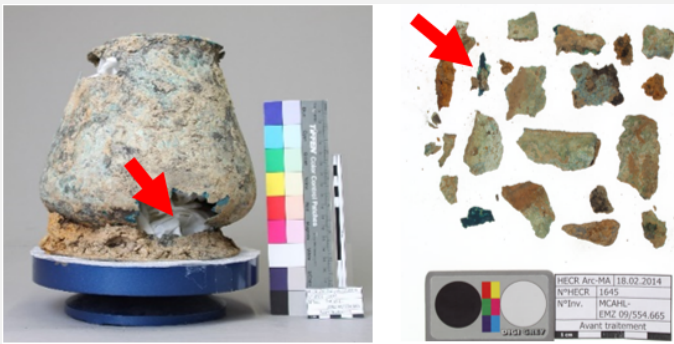
Fig. 2: Location of sampling area and sample selected from detached fragments,

The sample was cut from a detached fragment of the upper part of the main body of the situla in Fig. 2. The cross-section is representative of the entire thickness (0.5 mm) of the object's body where on the outside there is a thicker accumulation of corrosion including curly malachite (?) clusters (Fig. 3). A metallic core is still present inside the corrosion products layers (Fig. 4).

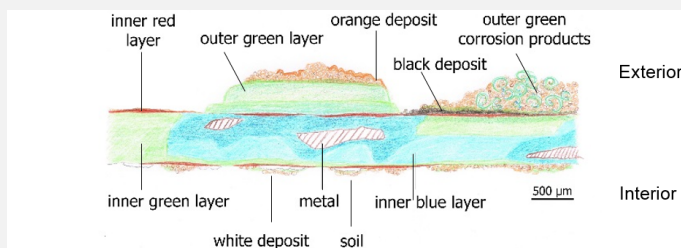
The schematic representation below gives an overview of the corrosion layers encountered on the situla from a first visual macroscopic observation (additional e and i within the coding correspond to strata in contact with the environment (e) and internal strata (i)).

Fig. 3: Stratigraphic representation of the situla by macroscopic observation,

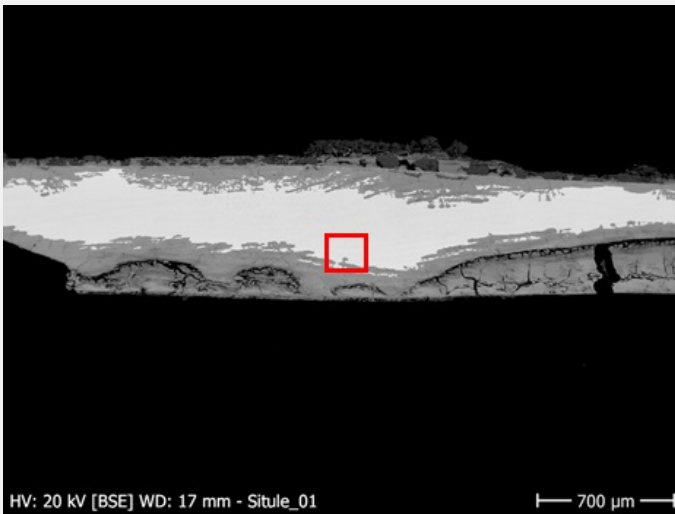
The remaining metal is a dense tin bronze (Fig. 5, Table 1), showing no inclusion. In bright field, the etched alloy shows a structure principally consisting of polygonal alpha phase grains (Fig. 6). Some of the grains include twin lines (Fig. 7). The presence of strain lines (slip lines) indicates a final cold work without annealing.

Fig. 5: SEM image, BSE-mode, of the metal sample from Fig. 4. Area of Fig. 6 is marked by a red square,

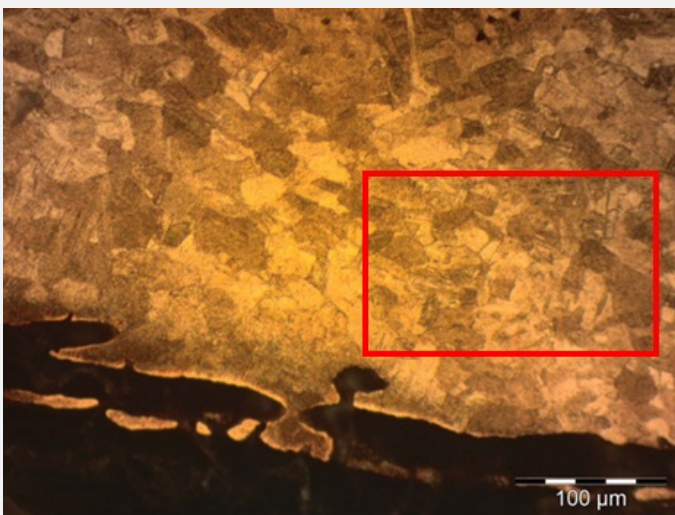
Fig. 6: Micrograph of the metal structure from Fig. 5 (detail), etched, bright field, 50x. The alpha phase of the alloy shows polygonal grains. Area of Fig. 7 is marked by a red rectangle,

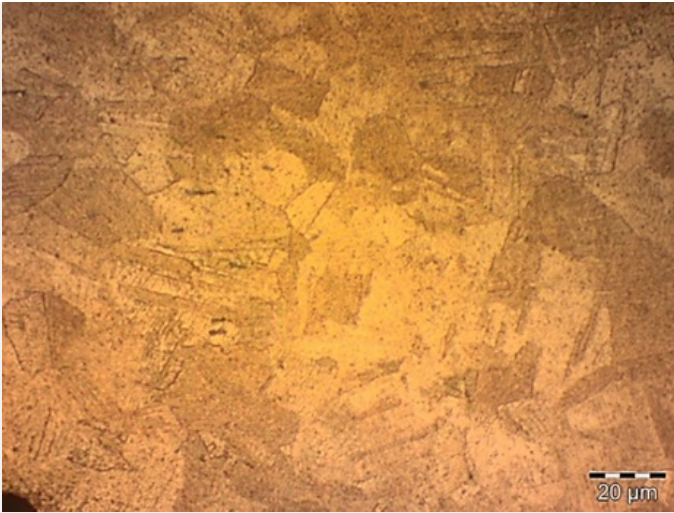
Fig. 7: Micrograph of the selected area of Fig. 6, etched, bright field, 500x. The grains show both twin and strain lines,

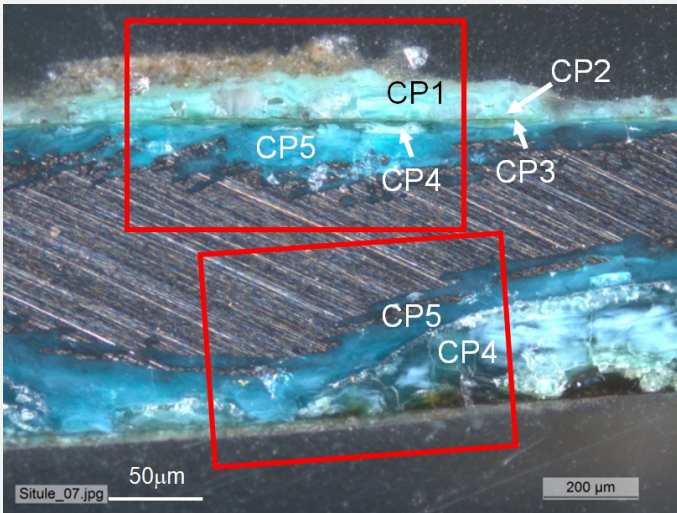
Fig. 8: Micrograph of the metal sample from Fig. 4, unetched, dark field, 50x. Areas of Fig. 9 (bottom, corresponding to the stratigraphy of Fig. 14) and Figs. 10 and 11 (top, corresponding to the stratigraphy of Fig. 15) are marked by a rectangle. Codes are those of Fig. 15,

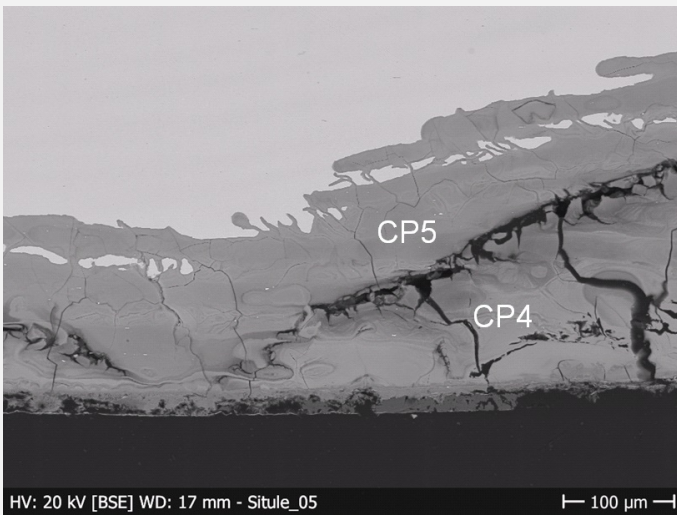
The corrosion crust is heterogeneous and has in places completely replaced the metal. The metal – corrosion products interface is irregular due to transgranular corrosion (Figs 5-6). In most cases, the corrosion crust can be divided in three main layers: first, an inner compact blue layer directly on the metal core (CP5, Figs. 8, 10 and 15 and CP3, Fig. 14). In areas of extensive corrosion this blue layer coexists with a friable light blue-green layer (CP4, Figs. 8, 10 and 15 and CP2, Fig. 14). Secondly, and depending on the area, either a very fine dark green (CP3, Figs. 8 and 15) or red corrosion layer (CP2, Figs. 10 and 15) marks the limit of the original surface. Finally, there is a fourth outer layer, consisting of friable and sometimes curly pale green corrosion products, interspersed with soil products (CP1, Figs. 8, 10 and 15). In heavily worked and fragile parts of the object a cleavage between the inner layers of blue and light blue-green corrosion is present, rendering the light blue-green corrosion vulnerable to loss (Fig. 9).

Fig. 9: SEM image, BSE-mode of the metal sample from Fig. 8 (detail) showing cleavage between the inner blue (CP5) and green (CP4) layers of Fig. 15,

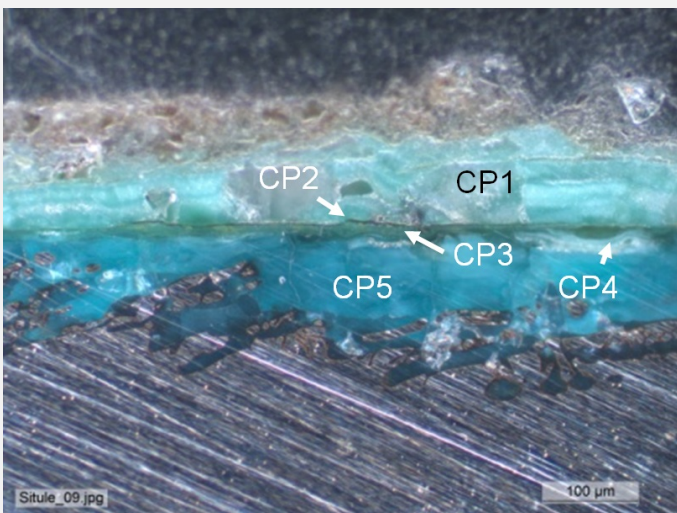
The limit of the original surface is well defined (interface of CP1 and CP2) but due to the fragility of the inner corrosion layers it was difficult to uncover.

Fig. 10: Micrograph of the metal / corrosion interface (detail of Fig. 8) unetched, dark field, 100x. The outer layer (CP1 of Fig. 15) incorporates soil material and the thin dark layer (CP2 of Fig. 15) highlights the limit of the original surface,

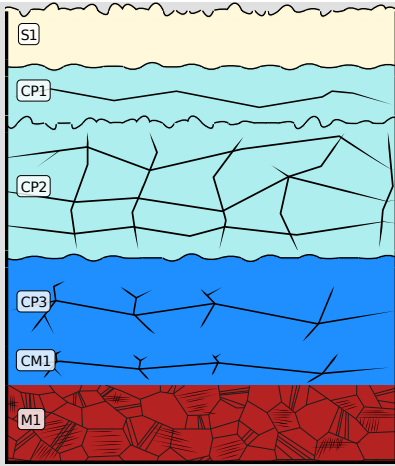
There are 2 stratigraphies (Fig. 14 corresponding to the interior face of the situla and Fig. 15 to its exterior face). The strata are similar in composition but their coding is different: CP1 to CP3 in Fig. 14 correspond to CP3 to CP5 in Fig. 15. Since the stratigraphy of Fig. 15 is more complete, the composition of each of its strata is given below.

of the strata are only accessible by clicking on the drawing that redirects you to the search tool by stratigraphy representation. This representation shows the interior face and can be compared to Fig. 8 (bottom red rectangle), Credit HE-Arc CR, M-J.Scholl.

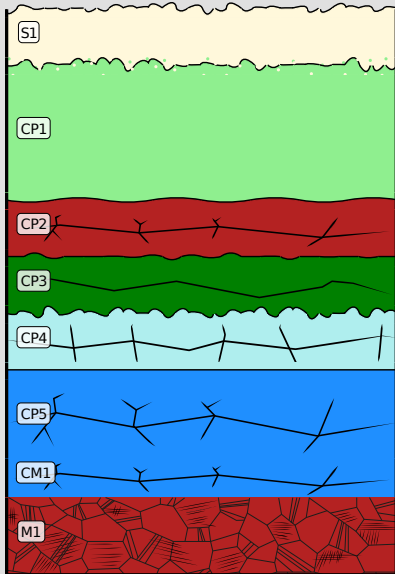
The inner layers (CP3-CP5) are Sn and O-rich and depleted in Cu (Table 2). The outer layers (CP1 and CP2) are Cu and O-rich, contain no Sn, and are contaminated with Ca, Si, Al and Fe coming from the soil (Fig. 11). The colour of the corrosion crust varies according to the content of Sn (the more Sn, the darker green or blue the corrosion). FTIR on the inner blue (CP5 and Fig. 12) and outer green (CP1 and Fig. 13) layers were difficult to interpret. Only malachite could be identified in both cases. XRD spectra could not be interpreted because of the deficiency of peaks.

Fig. 15: Stratigraphic representation of the sample taken from the detached fragment of the situla in cross-section (dark field) using the MiCorr application. The characteristics of the strata are only accessible by clicking on the drawing that redirects you to the search tool by stratigraphy representation. This representation shows the exterior face and can be compared to Fig. 8 (top red rectangle), Credit HE-Arc CR, M-J.Scholl.

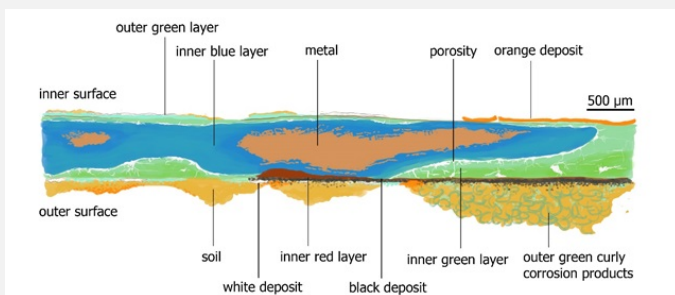
The schematic representation of corrosion layers of Fig. 3 integrating additional information (e and i within the coding correspond to strata in contact with the environment (e) and internal strata (i) based on the analyses carried out is given in Fig. 16.

Fig. 16: Improved stratigraphic representation of the situla from visual observations and analyses,

The metal structure of this low-tin bronze shows extensive cold work and multiple annealing cycles with a final cold work. The total absence of inclusions highlights a highly developed knowledge in bronze metallurgy. The metal is much corroded. Transgranular corrosion is visible. The majority of the internal corrosion products are composed of copper carbonates that have replaced much of the metal. Curly malachite has developed in clusters on the outside of the surface. This pattern is characteristic of a long-term burial period. The presence of inner enriched Sn layers shows a decuprification phenomenon (dissolution of Cu). Because of the friable nature of the inner blue-green layer that supports the limit of the original surface, as well as its cleavage with the blue layer underneath, the original surface has become very fragile. The corrosion is thought to be of type 1 according to Robbiola et al. 1998.
