SITULA EMT09-554.665 - TIN BRONZE - IRON AGE - SWITZERLAND

Artefact name Situla EMT09-554.665

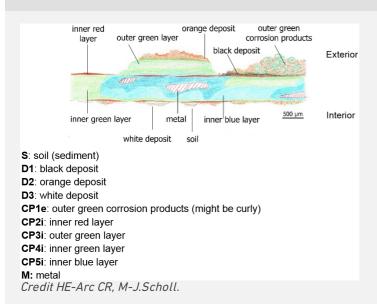
Fig. 3: Stratigraphic representation of the situla by macroscopic observation,

The schematic representation below gives an overview of the corrosion layers encountered on the situla from a first visual macroscopic observation (additional e and i within the coding correspond to strata in contact with the environment (e) and internal strata (i)).

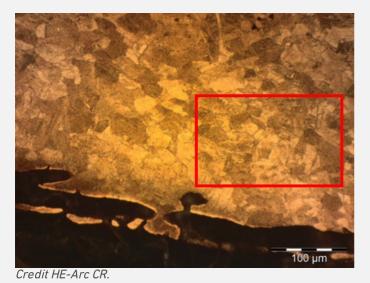
The remaining metal is a dense tin bronze (Fig. 5, Table 1), showing no inclusion. In bright field, the etched alloy shows a structure principally consisting of polygonal alpha phase grains (Fig. 6). Some of the grains include twin lines (Fig. 7). The presence of strain lines (slip lines) indicates a final cold work without annealing.

Fig. 6: Micrograph of the metal structure from Fig. 5 (detail), etched, bright field, 50x. The alpha phase of the alloy shows polygonal grains. Area of Fig. 7 is marked by a red rectangle,

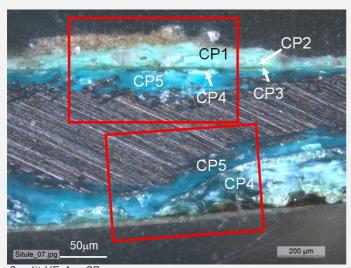
Fig. 8: Micrograph of the metal sample from Fig. 4, unetched, dark field, 50x. Areas of Fig. 9 (bottom, corresponding to the stratigraphy of Fig. 14) and Figs. 10 and 11 (top, corresponding to the stratigraphy of Fig. 15) are marked by a rectangle. Codes are those of Fig. 15,

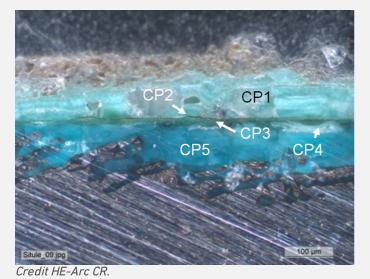
The limit of the original surface is well defined (interface of CP1 and CP2) but due to the fragility of the inner corrosion layers it was difficult to uncover.

Fig. 10: Micrograph of the metal / corrosion interface (detail of Fig. 8) unetched, dark field, 100x. The outer layer (CP1 of Fig. 15) incorporates soil material and the thin dark layer (CP2 of Fig. 15) highlights the limit of the original surface,

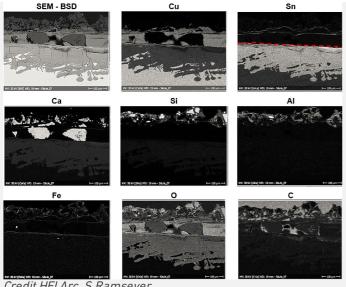
The inner layers (CP3-CP5) are Sn and O-rich and depleted in Cu (Table 2). The outer layers (CP1 and CP2) are Cu and O-rich, contain no Sn, and are contaminated with Ca, Si, Al and Fe coming from the soil (Fig. 11). The colour of the corrosion crust varies according to the content of Sn (the more Sn, the darker green or blue the corrosion). FTIR on the inner blue (CP5 and Fig. 12) and outer green (CP1 and Fig. 13) layers were difficult to interpret. Only malachite could be identified in both cases. XRD spectra could not be interpreted because of the deficiency of peaks.

Fig. 11: SEM image, SE-mode, and elemental chemical distribution of Fig. 10. In red: the limit of the original surface highlighted by the enriched tin layer. Method of examination: SEM-EDS, Lab of Electronic Microscopy and Microanalysis, IMA (Néode), HEI Arc,
