SITULA EMT09-554.665 - TIN BRONZE - IRON AGE - SWITZERLAND

Artefact name	Situla EMT09-554.665
Authors	Christian. Degriigny (HE-Arc CR, Neuchâtel, Neuchâtel, Switzerland) & Marie-Jeanne. Scholl (HE-Arc CR, Neuchâtel, Neuchâtel, Switzerland) & Valentin. Boissonnas (HE-Arc CR, Neuchâtel, Neuchâtel, Switzerland)
Url	/artefacts/1229/

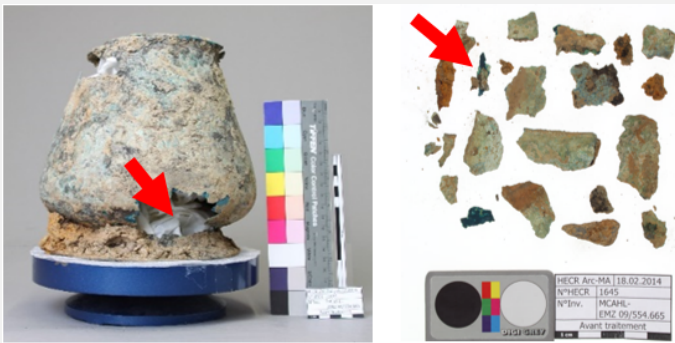
Fig. 2: Location of sampling area and sample selected from detached fragments,

The sample was cut from a detached fragment of the upper part of the main body of the situla in Fig. 2. The cross-section is representative of the entire thickness (0.5 mm) of the object's body where on the outside there is a thicker accumulation of corrosion including curly malachite (?) clusters (Fig. 3). A metallic core is still present inside the corrosion products layers (Fig. 4).

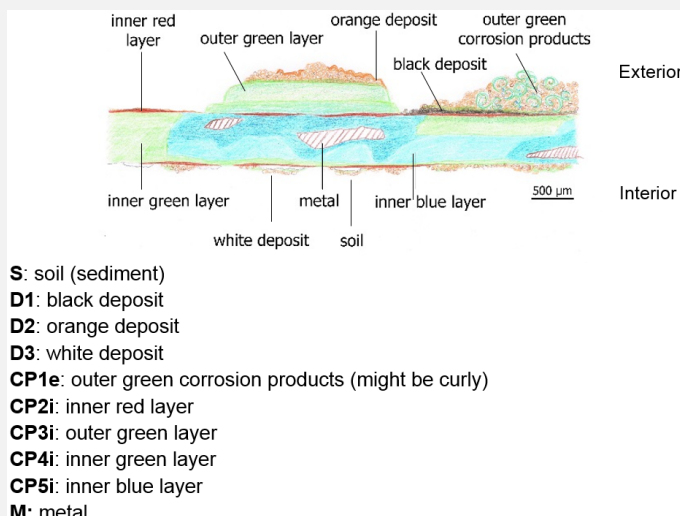
The schematic representation below gives an overview of the corrosion layers encountered on the situla from a first visual macroscopic observation (additional e and i within the coding correspond to strata in contact with the environment (e) and internal strata (i)).

Fig. 3: Stratigraphic representation of the situla by macroscopic observation,

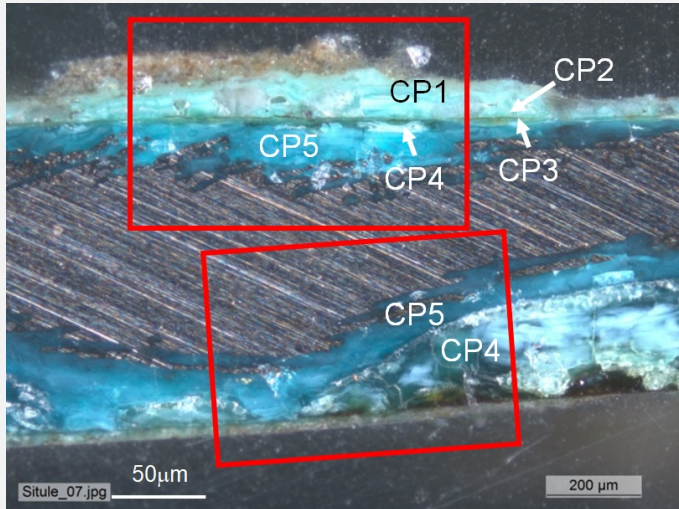
The corrosion crust is heterogeneous and has in places completely replaced the metal. The metal – corrosion products interface is irregular due to transgranular corrosion (Figs 5-6). In most cases, the corrosion crust can be divided in three main layers: first, an inner compact blue layer directly on the metal core (CP5, Figs. 8, 10 and 15 and CP3, Fig. 14). In areas of extensive corrosion this blue layer coexists with a friable light blue-green layer (CP4, Figs. 8, 10 and 15 and CP2, Fig. 14). Secondly, and depending on the area, either a very fine dark green (CP3, Figs. 8 and 15) or red corrosion layer (CP2, Figs. 10 and 15) marks the limit of the original surface. Finally, there is a fourth outer layer, consisting of friable and sometimes curly pale green corrosion products, interspersed with soil products (CP1, Figs. 8, 10 and 15). In heavily worked and fragile parts of the object a cleavage between the inner layers of blue and light blue-green corrosion is present, rendering the light blue-green corrosion vulnerable to loss (Fig. 9).

Fig. 8: Micrograph of the metal sample from Fig. 4, unetched, dark field, 50x. Areas of Fig. 9 (bottom, corresponding to the stratigraphy of Fig. 14) and Figs. 10 and 11 (top, corresponding to the stratigraphy of Fig. 15) are marked by a rectangle. Codes are those of Fig. 15,

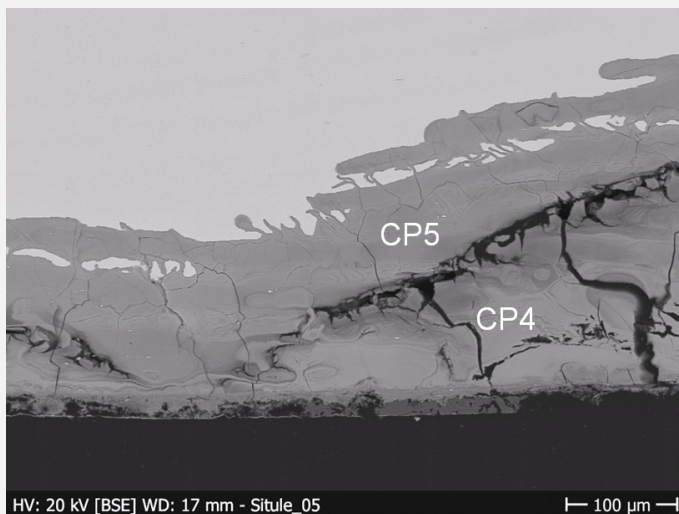
Fig. 9: SEM image, BSE-mode of the metal sample from Fig. 8 (detail) showing cleavage between the inner blue (CP5) and green (CP4) layers of Fig. 15,

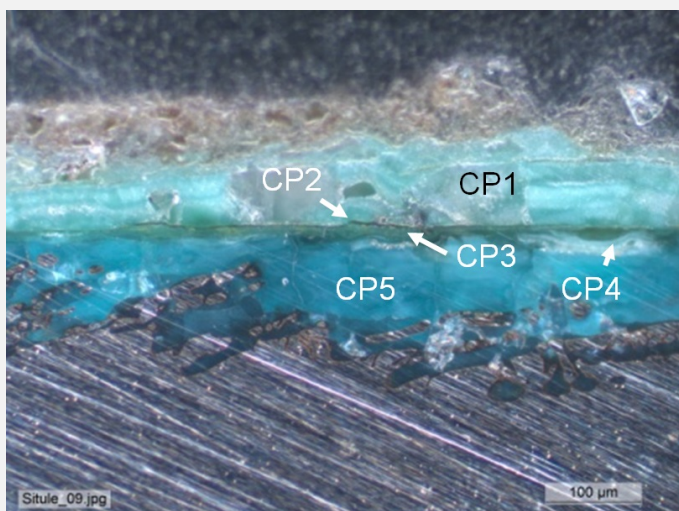
The limit of the original surface is well defined (interface of CP1 and CP2) but due to the fragility of the inner corrosion layers it was difficult to uncover.

Table 2: Chemical composition of the corrosion crust from Fig. 10. SEM-EDS, Lab of Electronic Microscopy and Microanalysis, IMA (Néode) (+++: high concentration, ++ medium concentration, + low concentration, nd: not-detected).

Fig. 10: Micrograph of the metal / corrosion interface (detail of Fig. 8) unetched, dark field, 100x. The outer layer (CP1 of Fig. 15) incorporates soil material and the thin dark layer (CP2 of Fig. 15) highlights the limit of the original surface,

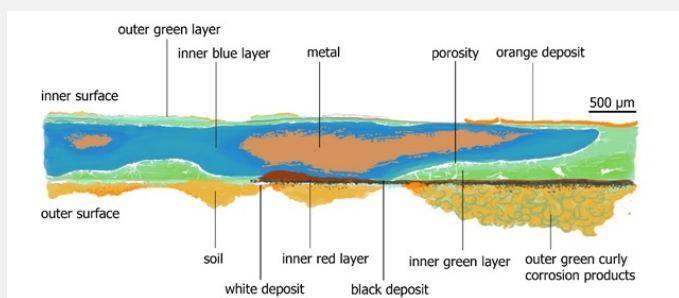
The schematic representation of corrosion layers of Fig. 3 integrating additional information (e and i within the coding correspond to strata in contact with the environment (e) and internal strata (i) based on the analyses carried out is given in Fig. 16.

Fig. 16: Improved stratigraphic representation of the situla from visual observations and analyses,

Strata	Composition
Soil (S)	Ca, Si, Al, Fe
Black deposit (D1)	C
Orange deposit (D2)	Ferrous oxides
White deposit (D3)	Ca
Outer green curly corrosion product (CP1e)	Copper carbonates (curly malachite)
Inner red (CP2i)	Copper oxide (cuprite ?)
Outer green layer (CP3i)	Copper carbonates (malachite)
Inner green layer (CP4i)	Copper carbonates (?) + Sn
Inner blue layer (CP5i)	Copper carbonates (?) + Sn
Remnant metal phase (M)	Bronze (90%Cu, 10% Sn)
