SITULA EMT09-554.665 - TIN BRONZE - IRON AGE - SWITZERLAND

Artefact name	Situla EMT09-554.665
Authors	Christian. Degriigny (HE-Arc CR, Neuchâtel, Neuchâtel, Switzerland) & Marie-Jeanne. Scholl (HE-Arc CR, Neuchâtel, Neuchâtel, Switzerland) & Valentin. Boissonnas (HE-Arc CR, Neuchâtel, Neuchâtel, Switzerland)
Url	/artefacts/1229/

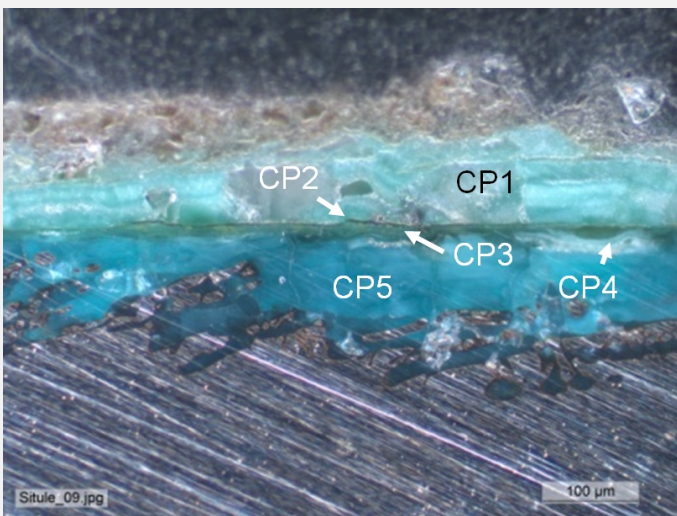
The limit of the original surface is well defined (interface of CP1 and CP2) but due to the fragility of the inner corrosion layers it was difficult to uncover.

Fig. 10: Micrograph of the metal / corrosion interface (detail of Fig. 8) unetched, dark field, 100x. The outer layer (CP1 of Fig. 15) incorporates soil material and the thin dark layer (CP2 of Fig. 15) highlights the limit of the original surface,

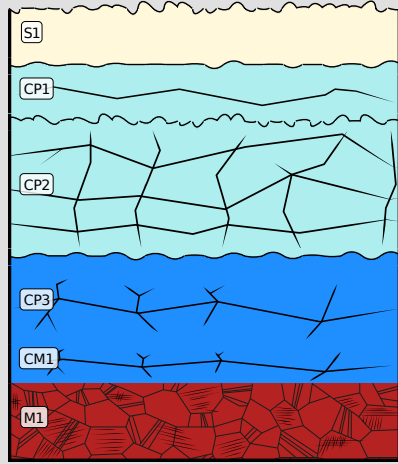
of the strata are only accessible by clicking on the drawing that redirects you to the search tool by stratigraphy representation. This representation shows the interior face and can be compared to Fig. 8 (bottom red rectangle), Credit HE-Arc CR, M-J.Scholl.

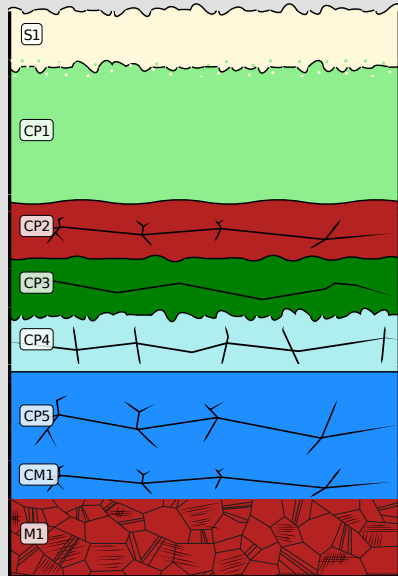
There are 2 stratigraphies (Fig. 14 corresponding to the interior face of the situla and Fig. 15 to its exterior face). The strata are similar in composition but their coding is different: CP1 to CP3 in Fig. 14 correspond to CP3 to CP5 in Fig. 15. Since the stratigraphy of Fig. 15 is more complete, the composition of each of its strata is given below.

Fig. 15: Stratigraphic representation of the sample taken from the detached fragment of the situla in cross-section (dark field) using the MiCorr application. The characteristics of the strata are only accessible by clicking on the drawing that redirects you to the search tool by stratigraphy representation. This representation shows the exterior face and can be compared to Fig. 8 (top red rectangle), Credit HE-Arc CR, M-J.Scholl.

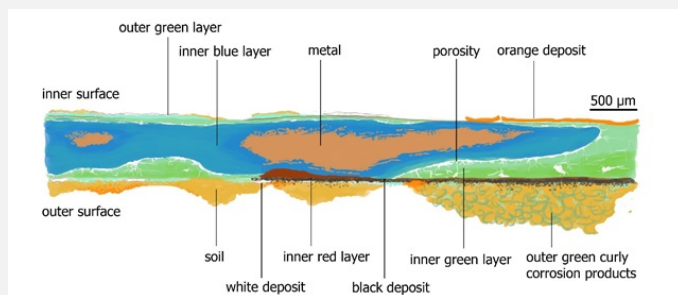
Fig. 16: Improved stratigraphic representation of the situla from visual observations and analyses,

Strata	Composition
Soil (S)	Ca, Si, Al, Fe
Black deposit (D1)	C
Orange deposit (D2)	Ferrous oxides
White deposit (D3)	Ca
Outer green curly corrosion product (CP1e)	Copper carbonates (curly malachite)
Inner red (CP2i)	Copper oxide (cuprite ?)
Outer green layer (CP3i)	Copper carbonates (malachite)
Inner green layer (CP4i)	Copper carbonates (?) + Sn
Inner blue layer (CP5i)	Copper carbonates (?) + Sn
Remnant metal phase (M)	Bronze (90%Cu, 10% Sn)
