# AIRCRAFT REAR FASTENING PLATE VHS-497 – AL ALLOY – MODERN TIMES

**Artefact name** Aircraft rear fastening plate VHS-497

**Authors** Marianne. Senn (Empa, Dübendorf, Zurich, Switzerland) & Christian. Degrigny (HE-Arc CR, Neuchâtel, Neuchâtel, Switzerland)

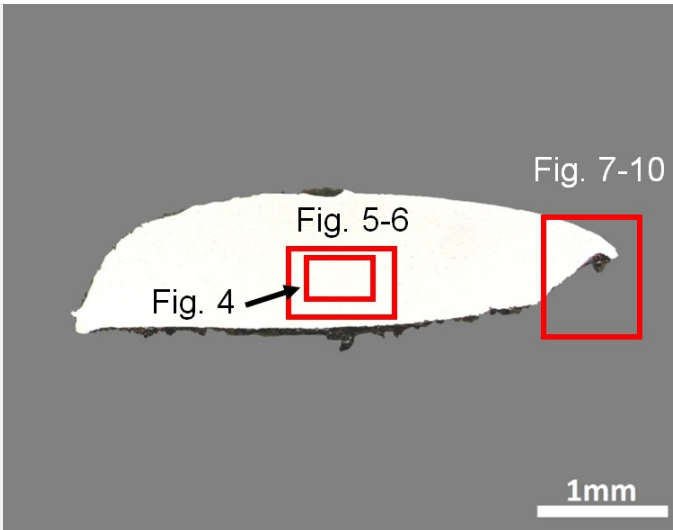
Fig. 3: Micrograph of the cross-section of the sample taken from the back fastening plate showing the location of Figs. 4 to 10,

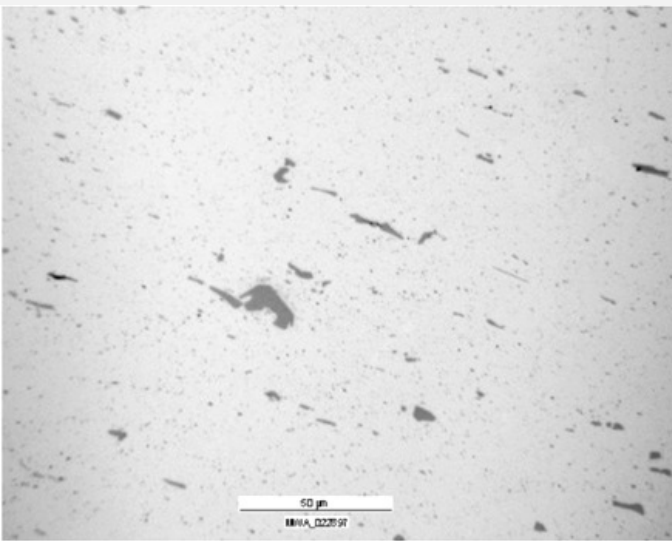
The metal is a relatively pure aluminium alloy with numerous inclusions (Table 1). From the chemical composition of the inclusions they can be interpreted as alpha-AlFeSi intermetallic compounds. In bright field we observe elongated inclusions indicating that the metal was rolled (Fig. 4). The alloy composition is similar to an unalloyed primary aluminium (Al content between 99 and 99.8 mass%). The O content reflects the immediate oxidation of the metal and is not part of the alloy. After etching the organisation of inclusions in rows is more easily seen (Fig. 5). The SEM image shows large grains formed after annealing (Fig. 6). The average hardness of the metal is HV1 40.

Fig. 4: Micrograph of the metal sample from Fig. 3 (detail), unetched, bright field. The metal matrix is in white, the elongated inclusions in grey,

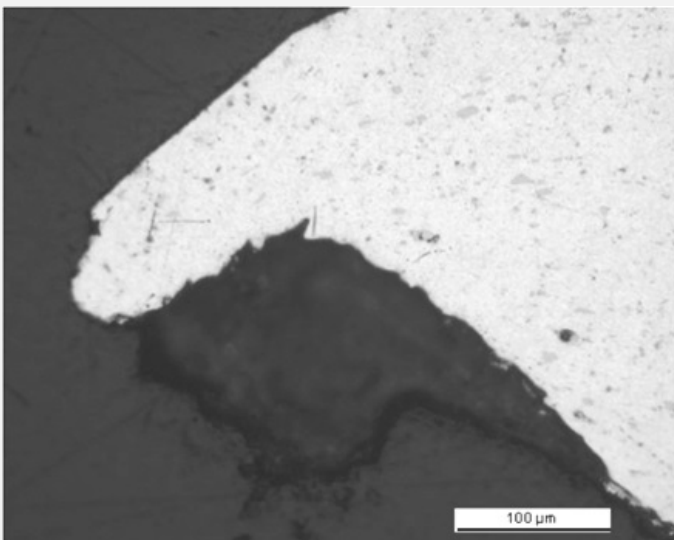
The metal is covered by a very thin corrosion layer (CP1). In addition to this, locally thicker adhering materials can be observed (NMM1, appearing as dark-grey area in Fig. 7). Under polarized light, they appear blue-brown (Fig. 8). Analysis by SEM-EDS indicates that the metal is, as expected, covered by a very thin Al and O-rich layer whereas the particles in the adherent material contain C, O, Si, Ca, Fe, Zn, S and even Ti (Figs. 9 and 10). The location of the adherent material and the presence of both Zn and Ti suggest that it is a residue of a paint coating.

Fig. 7: Micrograph showing the metal - adhering material interface from Fig. 3 (reversed picture, detail), unetched, bright field. We observe in white the metal matrix and dark-grey the adhering material,

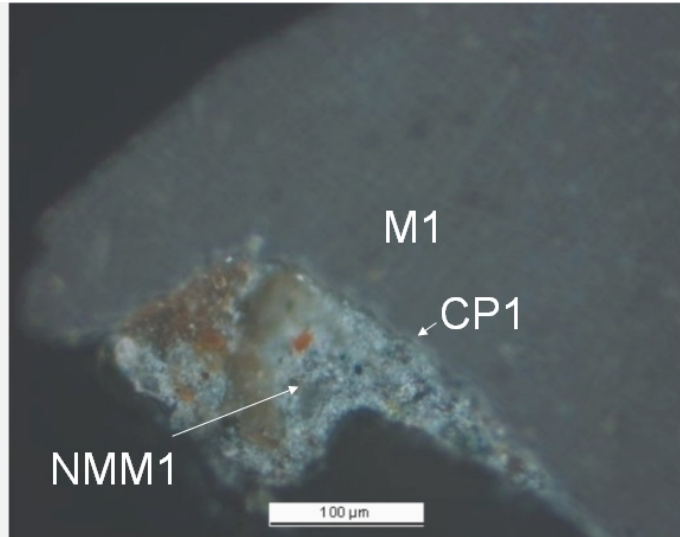
Fig. 8: Micrograph (same as Fig. 7) and corresponding to the stratigraphy of Fig. 11, unetched, polarised light. We observe

in grey the metal matrix and blue-brown the adhering material,

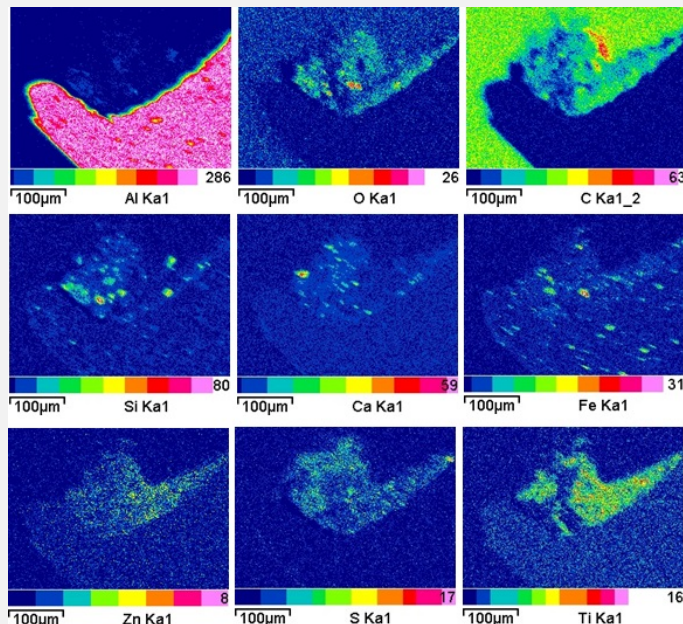
Fig. 10: Elemental chemical distribution of the selected area from Fig. 9. Method of examination: SEM/EDS, Laboratory of Analytical Chemistry, Empa,

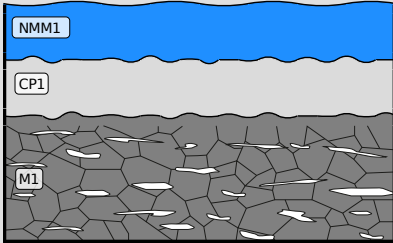
Fig. 11: Stratigraphic representation of the sample taken from the back fastening plate in cross-section (dark field) using the MiCorr application. The characteristics of the strata are only accessible by clicking on the drawing that redirects you to the search tool by stratigraphy representation. This representation can be compared to Fig. 8, Credit HE-Arc CR.
