AIRCRAFT REAR FASTENING PLATE VHS-497 – AL ALLOY – MODERN TIMES

Artefact name	Aircraft rear fastening plate VHS-497
Authors	Marianne. Senn (Empa, Dübendorf, Zurich, Switzerland) & Christian. Degriigny (HE-Arc CR, Neuchâtel, Neuchâtel, Switzerland)
Url	/artefacts/1235/

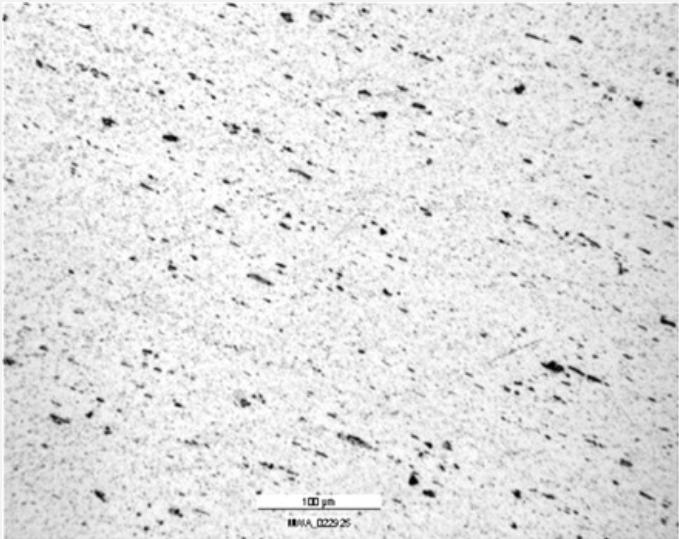
Fig. 5: Micrograph of the metal sample from Fig. 3 (detail), etched, bright field. The metal matrix is in white, the elongated inclusions in dark-grey and black,

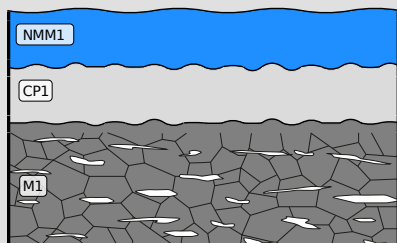
Fig. 11: Stratigraphic representation of the sample taken from the back fastening plate in cross-section (dark field) using the MiCorr application. The characteristics of the strata are only accessible by clicking on the drawing that redirects you to the search tool by stratigraphy representation. This representation can be compared to Fig. 8, Credit HE-Arc CR.
