AIRCRAFT FRONT FASTENING PLATE VHS-497 (2) – AL CU SN ZN SI ALLOY – MODERN TIMES

Artefact name	Aircraft front fastening plate VHS-497 (2)
Authors	Marianne. Senn (Empa, Dübendorf, Zurich, Switzerland) & Christian. Degriigny (HE-Arc CR, Neuchâtel, Neuchâtel, Switzerland)
Url	/artefacts/1236/

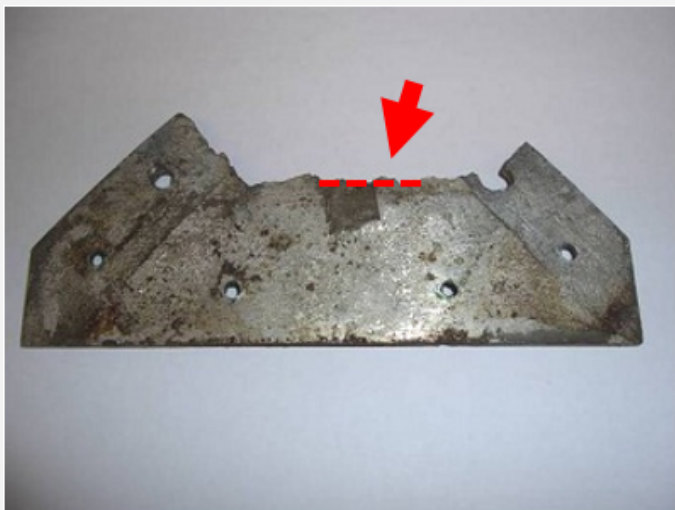
Fig. 2: Location of sampling area,

Description of sample	The top part has been cut during sampling (Fig. 2). The more regular right side is the plate surface and the irregular side is the broken edge (Fig. 3). Dimensions: L = 4mm ; W = 4mm.
Alloy	Al Cu Sn Zn Si Alloy
Technology	As-cast
Lab number of sample	DUF-4
Sample location	HE-Arc CR, Neuchâtel, Neuchâtel
Responsible institution	Swiss Museum of Transport, Luzern, Lucerne
Date and aim of sampling	September 2007, metallography and alloy composition

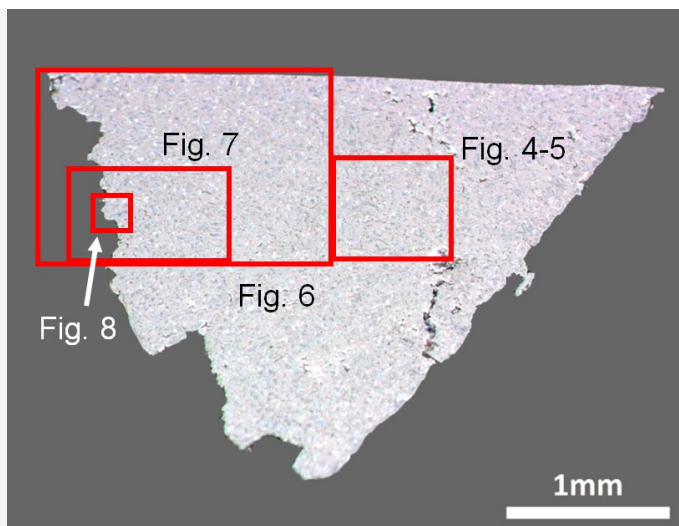
Fig. 3: Micrograph of the cross-section of the sample taken from the front fastening plate showing the location of Figs. 4 to 8,

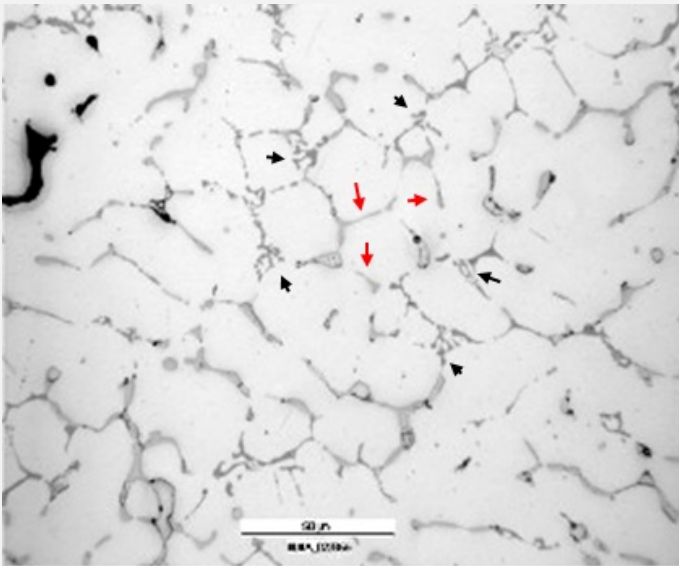
The metal is an aluminium alloy containing Cu, Sn, Zn and Si (Table 1). The unetched metal shows an as-cast structure consisting of the aluminium matrix with Sn (not soluble in Al) inclusions (Figs. 4 and 5), intermetallic compounds such as Al₂Cu (Fig. 4, red arrows) and clusters of Al,Fe,Cu & Si phases (Fig. 4, black arrows). There are porosities in the metal (Figs. 3 and 5). The average hardness of the metal is HV1 80.

Fig. 4: Micrograph of the metal sample from Fig. 3 (detail), unetched, bright field. The cast structure is revealed by light grey intermetallic compounds (Al₂Cu, red arrows), dark-grey Al,Fe,Si & Cu phase clusters (black arrows) and Sn inclusions (nodules). On the top left some pores can be seen,

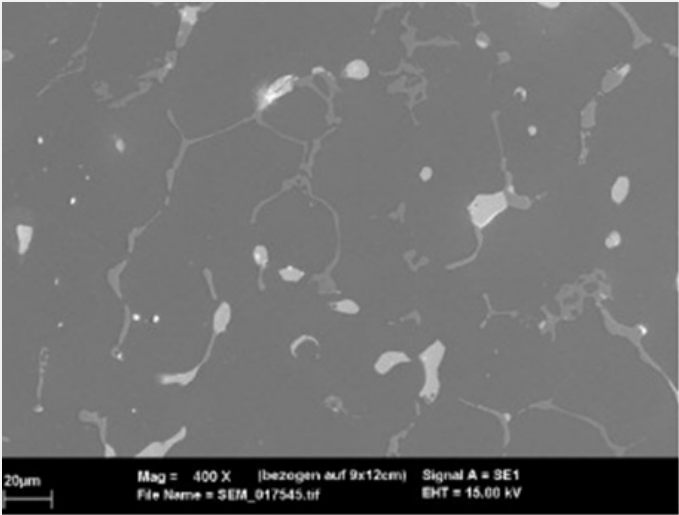
Fig. 5: SEM image of the metal sample from Fig. 3 (detail), SE-mode, unetched. We observe in dark-grey the metal matrix, in medium-grey the intermetallic compound Al₂Cu as well as Al,Fe,Si & Cu phase clusters and in light-grey the Sn inclusions,

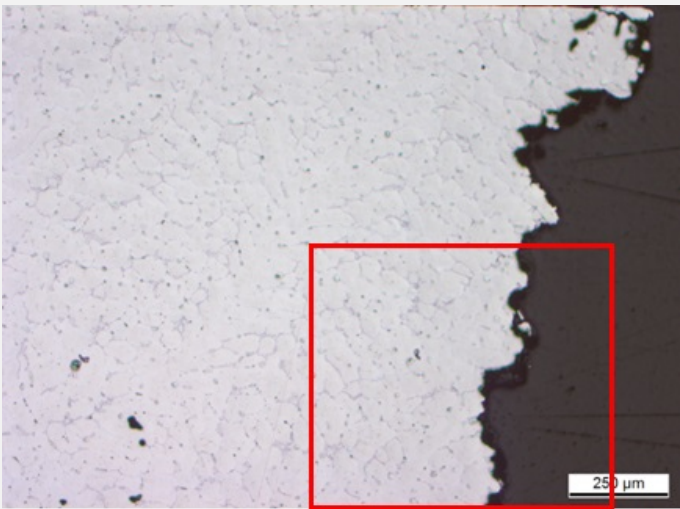
No corrosion layer can be seen on the metal surface (Figs. 3 and 6). Under polarized light small white and brown particles are visible on the broken edge (D1, Fig. 7). Their analysis reveals the presence of silica particles surrounded by dirt (Table 2 and Fig. 8). The metal surface is covered by a thin oxygen bearing skin (CP1, Fig. 8).

Fig. 6: Micrograph showing the metal - "corrosion products" interface from Fig. 3 (reversed picture, detail), unetched, bright field. We observe in white the metal matrix, in dark-grey Al,Fe, Si & Cu phase and light-grey Al₂Cu intermetallic compounds. The micrograph of Fig. 7 is marked by a rectangle,

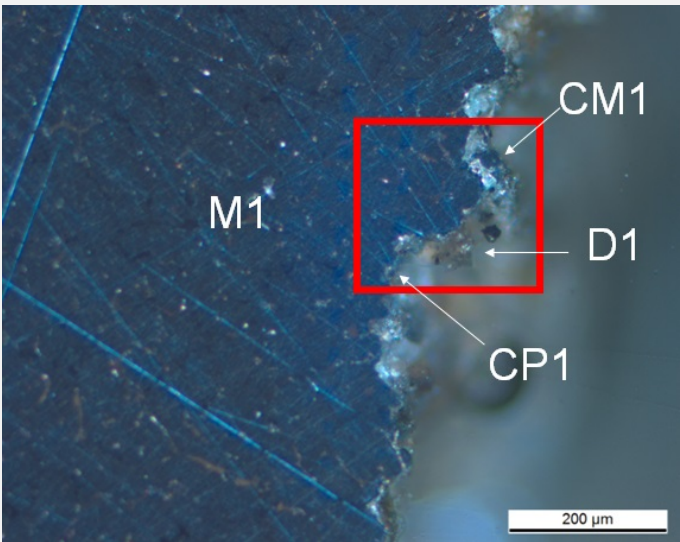
Fig. 7: Micrograph from Fig. 6 (detail) and corresponding to the stratigraphy of Fig. 9, unetched, polarised light. We observe in dark blue the metal matrix and blue-brown the adherent material. The area selected for elemental chemical distribution (Fig. 8) is marked by a rectangle,

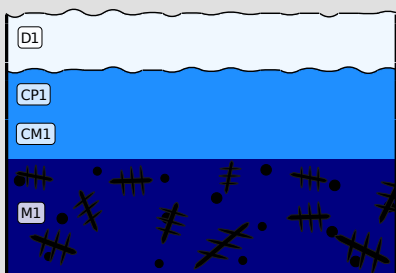
Fig. 9: Stratigraphic representation of the sample taken from the front fastening plate in cross-section (dark field) using the MiCorr application. The characteristics of the strata are only accessible by clicking on the drawing that redirects you to the search tool by stratigraphy representation. This representation can be compared to Fig. 7, Credit HE-Arc CR.
