AIRCRAFT FRONT FASTENING PLATE VHS-497 (2) – AL CU SN ZN SI ALLOY – MODERN TIMES

Artefact name	Aircraft front fastening plate VHS-497 (2)
Authors	Marianne. Senn (Empa, Dübendorf, Zurich, Switzerland) & Christian. Degriigny (HE-Arc CR, Neuchâtel, Neuchâtel, Switzerland)
Url	/artefacts/1236/

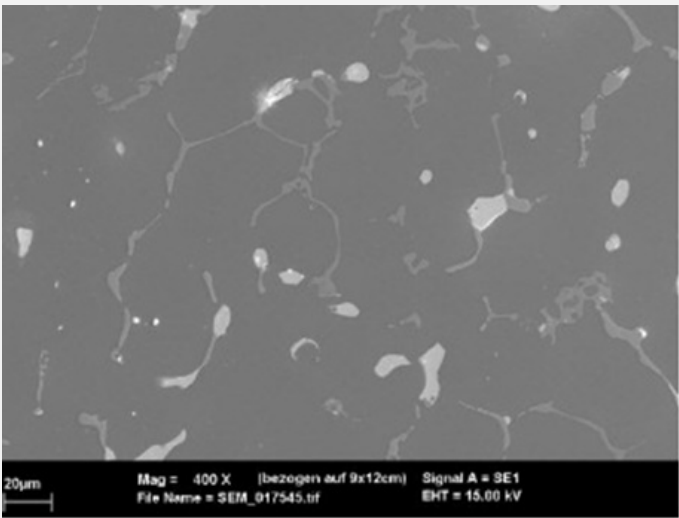
The metal is an aluminium alloy containing Cu, Sn, Zn and Si (Table 1). The unetched metal shows an as-cast structure consisting of the aluminium matrix with Sn (not soluble in Al) inclusions (Figs. 4 and 5), intermetallic compounds such as Al₂Cu (Fig. 4, red arrows) and clusters of Al,Fe,Cu & Si phases (Fig. 4, black arrows). There are porosities in the metal (Figs. 3 and 5). The average hardness of the metal is HV1 80.

Fig. 5: SEM image of the metal sample from Fig. 3 (detail), SE-mode, unetched. We observe in dark-grey the metal matrix, in medium-grey the intermetallic compound Al₂Cu as well as Al,Fe,Si & Cu phase clusters and in light-grey the Sn inclusions,

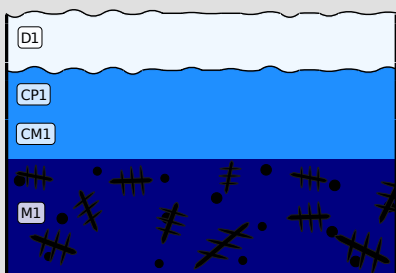
Fig. 9: Stratigraphic representation of the sample taken from the front fastening plate in cross-section (dark field) using the MiCorr application. The characteristics of the strata are only accessible by clicking on the drawing that redirects you to the search tool by stratigraphy representation. This representation can be compared to Fig. 7, Credit HE-Arc CR.
