AIRCRAFT FRONT FASTENING PLATE VHS-497 (2) - AL CU SN ZN SI ALLOY - MODERN TIMES

Artefact name Aircraft front fastening plate VHS-497 (2)

Authors Marianne. Senn (Empa, Dübendorf, Zurich, Switzerland) & Christian. Degriigny (HE-Arc CR, Neuchâtel, Neuchâtel, Switzerland)

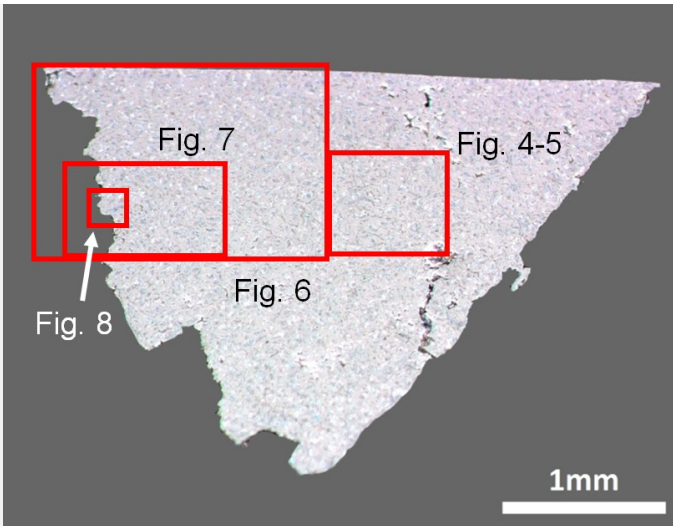
Fig. 3: Micrograph of the cross-section of the sample taken from the front fastening plate showing the location of Figs. 4 to 8,

Description of sample	The top part has been cut during sampling (Fig. 2). The more regular right side is the plate surface and the irregular side is the broken edge (Fig. 3). Dimensions: L = 4mm ; W = 4mm.
Alloy	Al Cu Sn Zn Si Alloy
Technology	As-cast
Lab number of sample	DUF-4
Sample location	HE-Arc CR, Neuchâtel, Neuchâtel
Responsible institution	Swiss Museum of Transport, Luzern, Lucerne
Date and aim of sampling	September 2007, metallography and alloy composition

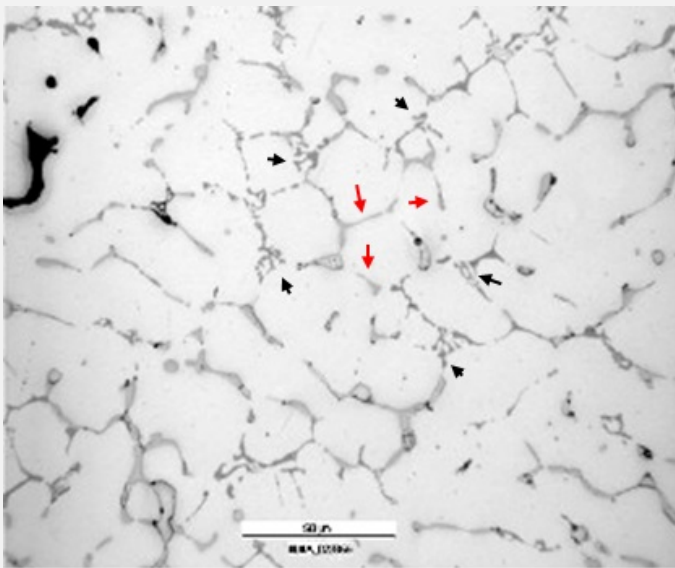
The metal is an aluminium alloy containing Cu, Sn, Zn and Si (Table 1). The unetched metal shows an as-cast structure consisting of the aluminium matrix with Sn (not soluble in Al) inclusions (Figs. 4 and 5), intermetallic compounds such as Al₂Cu (Fig. 4, red arrows) and clusters of Al,Fe,Cu & Si phases (Fig. 4, black arrows). There are porosities in the metal (Figs. 3 and 5). The average hardness of the metal is HV1 80.

Fig. 4: Micrograph of the metal sample from Fig. 3 (detail), unetched, bright field. The cast structure is revealed by light grey intermetallic compounds (Al₂Cu, red arrows), dark-grey Al,Fe,Si & Cu phase clusters (black arrows) and Sn inclusions (nodules). On the top left some pores can be seen,

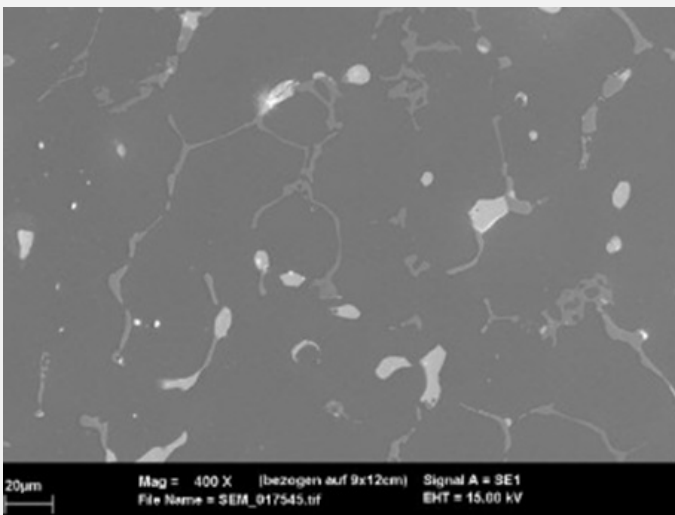
Fig. 5: SEM image of the metal sample from Fig. 3 (detail), SE-mode, unetched. We observe in dark-grey the metal matrix, in medium-grey the intermetallic compound Al₂Cu as well as Al,Fe,Si & Cu phase clusters and in light-grey the Sn inclusions,

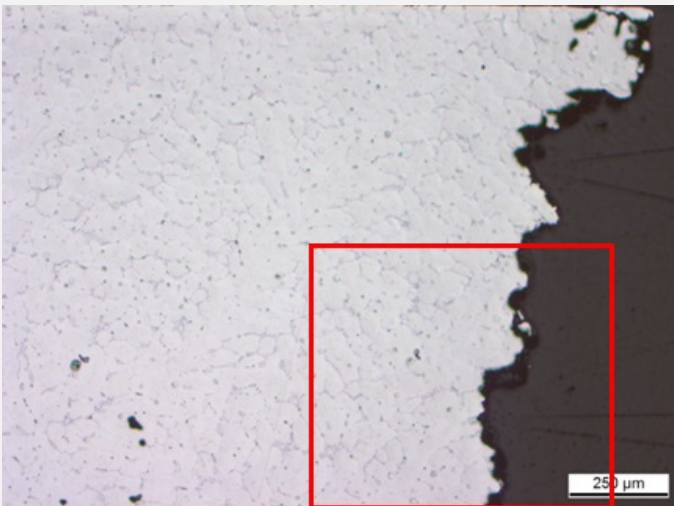
No corrosion layer can be seen on the metal surface (Figs. 3 and 6). Under polarized light small white and brown particles are visible on the broken edge (D1, Fig. 7). Their analysis reveals the presence of silica particles surrounded by dirt (Table 2 and Fig. 8). The metal surface is covered by a thin oxygen bearing skin (CP1, Fig. 8).

Fig. 6: Micrograph showing the metal - "corrosion products" interface from Fig. 3 (reversed picture, detail), unetched, bright field. We observe in white the metal matrix, in dark-grey Al, Fe, Si & Cu phase and light-grey Al₂Cu intermetallic compounds. The micrograph of Fig. 7 is marked by a rectangle,

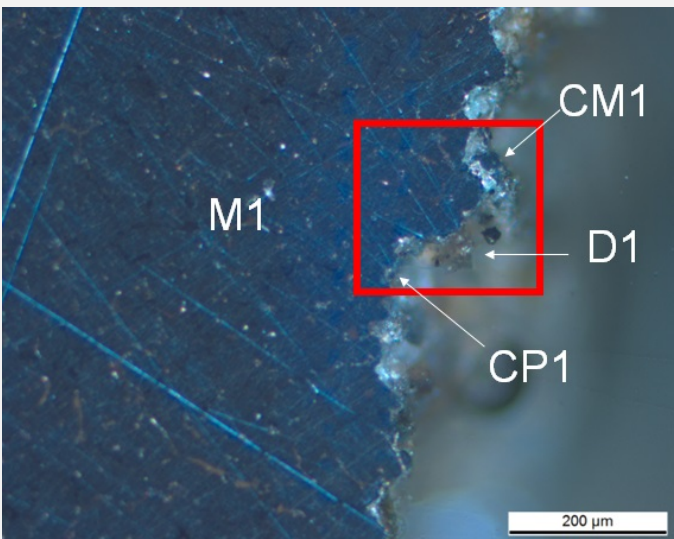
Fig. 7: Micrograph from Fig. 6 (detail) and corresponding to the stratigraphy of Fig. 9, unetched, polarised light. We observe in dark blue the metal matrix and blue-brown the adherent material. The area selected for elemental chemical distribution (Fig. 8) is marked by a rectangle,

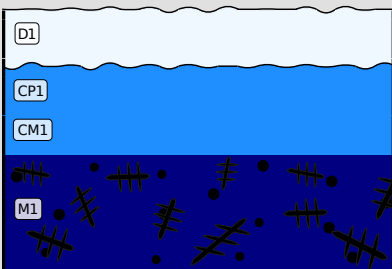
Fig. 9: Stratigraphic representation of the sample taken from the front fastening plate in cross-section (dark field) using the MiCorr application. The characteristics of the strata are only accessible by clicking on the drawing that redirects you to the search tool by stratigraphy representation. This representation can be compared to Fig. 7, Credit HE-Arc CR.
