AIRCRAFT FRONT FASTENING PLATE VHS-497 (2) - AL CU SN ZN SI ALLOY - MODERN TIMES

Artefact name	Aircraft front fastening plate VHS-497 (2)
Authors	Marianne. Senn (Empa, Dübendorf, Zurich, Switzerland) & Christian. Degriigny (HE-Arc CR, Neuchâtel, Neuchâtel, Switzerland)
Url	/artefacts/1236/

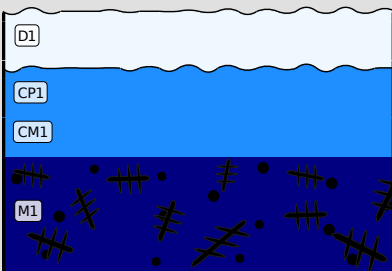
Fig. 9: Stratigraphic representation of the sample taken from the front fastening plate in cross-section (dark field) using the MiCorr application. The characteristics of the strata are only accessible by clicking on the drawing that redirects you to the search tool by stratigraphy representation. This representation can be compared to Fig. 7, Credit HE-Arc CR.
