# AIRCRAFT FRONT FASTENING PLATE VHS-497 (2) – AL CU SN ZN SI ALLOY – MODERN TIMES

Artefact name	Aircraft front fastening plate VHS-497 (2)
Authors	Marianne. Senn (Empa, Dübendorf, Zurich, Switzerland) & Christian. Degryny (HE-Arc CR, Neuchâtel, Neuchâtel, Switzerland)
Url	/artefacts/1236/

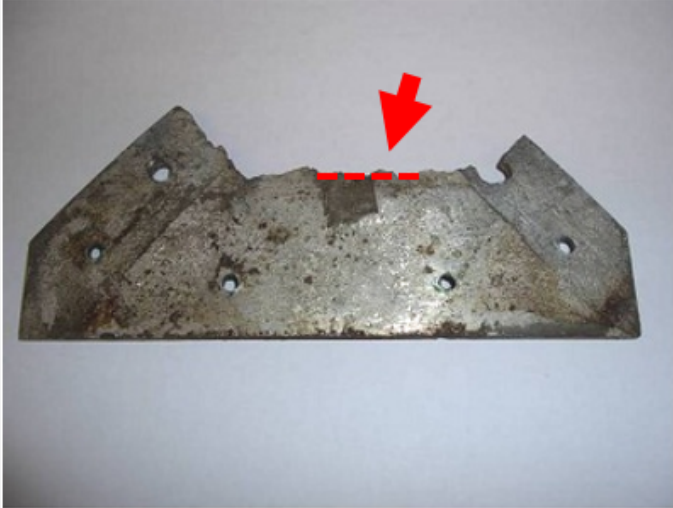
Fig. 2: Location of sampling area,

The top part has been cut during sampling (Fig. 2). The more regular right side is the plate surface and the irregular side is the broken edge (Fig. 3). Dimensions: L = 4mm ; W = 4mm.

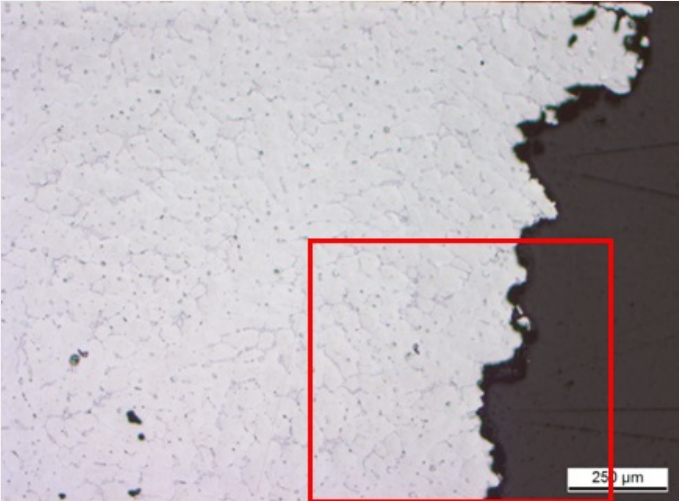
No corrosion layer can be seen on the metal surface (Figs. 3 and 6). Under polarized light small white and brown particles are visible on the broken edge (D1, Fig. 7). Their analysis reveals the presence of silica particles surrounded by dirt (Table 2 and Fig. 8). The metal surface is covered by a thin oxygen bearing skin (CP1, Fig. 8).

Fig. 6: Micrograph showing the metal - “corrosion products” interface from Fig. 3 (reversed picture, detail), unetched, bright field. We observe in white the metal matrix, in dark-grey Al,Fe, Si & Cu phase and light-grey Al<sub>2</sub>Cu intermetallic compounds. The micrograph of Fig. 7 is marked by a rectangle,

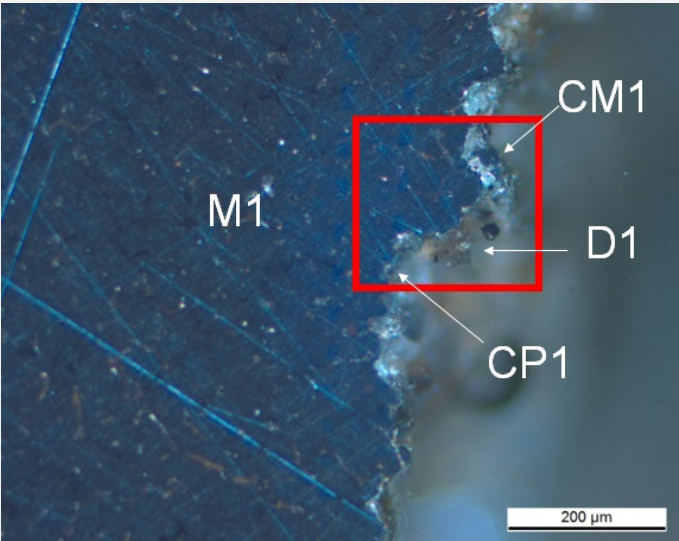
Fig. 7: Micrograph from Fig. 6 (detail) and corresponding to the stratigraphy of Fig. 9, unetched, polarised light. We observe in dark blue the metal matrix and blue-brown the adherent material. The area selected for elemental chemical distribution (Fig. 8) is marked by a rectangle,

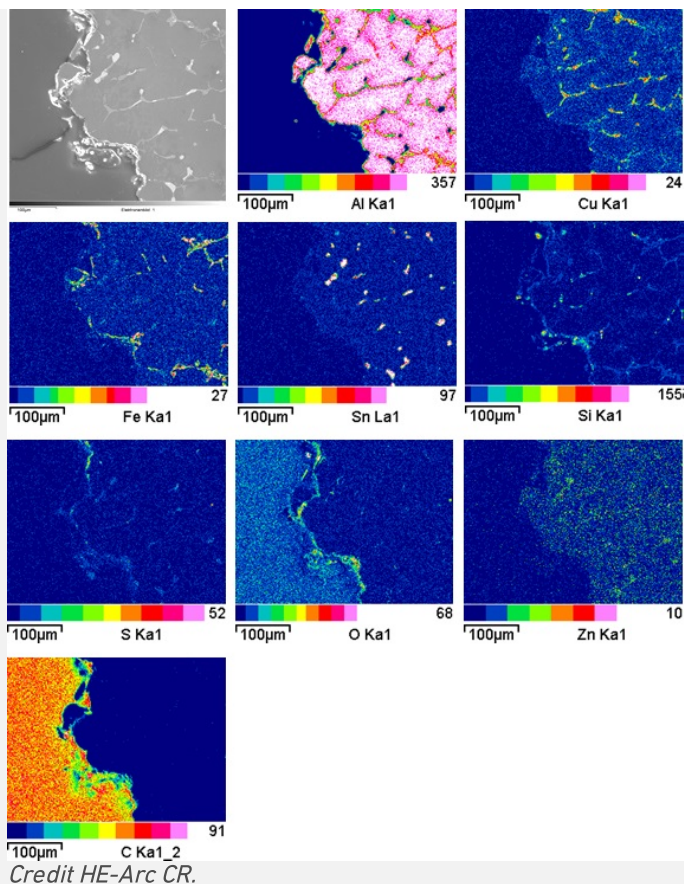
Fig. 8: SEM image, BSE-mode, and elemental chemical distribution of the selected area from Fig. 7 (reversed picture, detail). Method of examination: SEM/EDS, Laboratory of Analytical Chemistry, Empa,

This front fastening plate of Dufaux IV plane is made in cast Al-Cu-Sn-Zn-Si, an alloy rather common at the beginning of the 20th century. No corrosion layer has been found on the metal surface except adherent silica-rich particles and the thin oxidised skin typical of Al alloys. The presence of these materials can be explained by the regular maintenance of the metal, probably using silicon carbide abrasive paper.

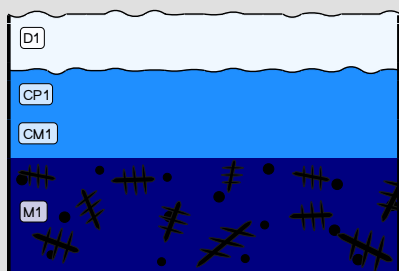
Fig. 9: Stratigraphic representation of the sample taken from the front fastening plate in cross-section (dark field) using the MiCorr application. The characteristics of the strata are only accessible by clicking on the drawing that redirects you to the search tool by stratigraphy representation. This representation can be compared to Fig. 7, Credit HE-Arc CR.
