CORRODED METAL SHEET FN 655.13.01 – FE ALLOY – MODERN TIMES – SWITZERLAND

Artefact name	Corroded metal sheet FN 655.13.01
Authors	Marianne. Senn (Empa, Dübendorf, Zurich, Switzerland) & Christian. Degriigny (HE-Arc CR, Neuchâtel, Neuchâtel, Switzerland)
Url	/artefacts/1237/

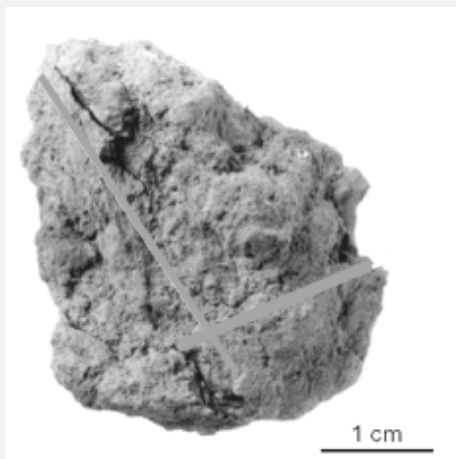
Fig. 1: Metal sheet (after Senn Bischofberger 2005, 137),

Description of the artefact	Metal (iron-based) sheet with middle rib. The shape is no longer discernible (Fig. 1). The metal is covered by a thick corrosion crust. Dimensions: L = 4.5cm; WT = 35g.
Type of artefact	Metal sheet
Origin	Steinmöri, Neftenbach / Dorf Neftenbach, Zurich, Switzerland
Recovering date	Excavation of the Roman villa, 1986-1990, phase S2, StbII.2 (2nd/3rd century AD)
Chronology category	Modern Times
chronology tpq	1900 A.D. ▼
chronology taq	2000 A.D. ▼
Chronology comment	Product of the 20th century AD introduced accidentally into a Roman layer

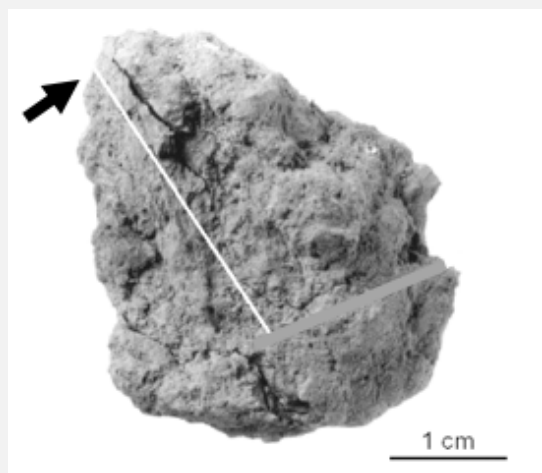
Fig. 2: Location of sampling area,

Description of sample	A longitudinal cut has been made through the sheet (Fig. 2). Large parts of the corrosion crust fell off during sampling (Fig. 3).
Alloy	Fe Alloy
Technology	Forged with final cold work
Lab number of sample	NEF 655
Sample location	HE-Arc CR, Neuchâtel, Neuchâtel
Responsible institution	Kantonsarchäologie, Dübendorf, Zurich
Date and aim of sampling	2000, metallography

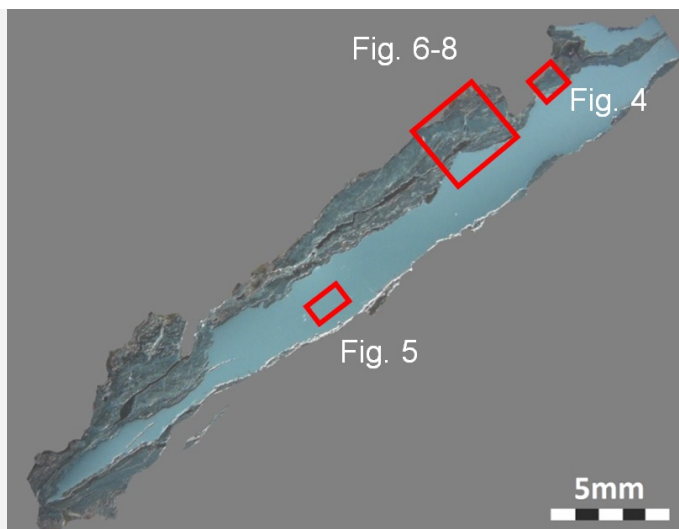
Fig. 3: Micrograph of the cross-section of the metal sheet showing the location of Figs. 4 to 8,

The corrosion is massive and large parts of the outer corrosion layers have been lost during the sample preparation. The heavily cracked corrosion crust represents about one third of the thickness of the sample (Fig. 3) and is located on one side of the metal (the rest having been lost during the cutting process). It does not show well defined layers. Despite this, three areas can be distinguished (Figs. 6 and 7). Adhering to the metal (area 1), we find an orange-red-brown layer enriched in Cl (CP3 in Fig. 9, Fig. 8 and Table 3). The dark or violet middle area 2 is richer in Fe (CP2 in Fig. 9). The outer area 3 is red-brown (CP1 in Fig. 9) and strongly contaminated by soil material (rock fragment inclusion and elements like Si, Al, P etc.). This layer is enriched in O (Fig. 9).

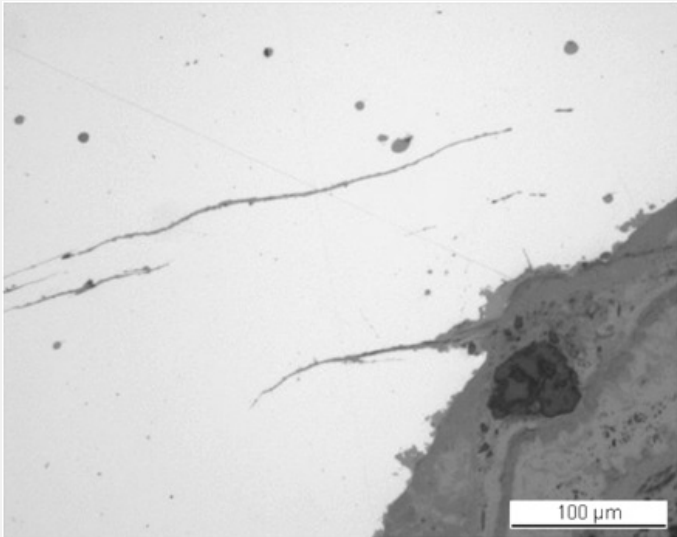
The remaining metal is an iron containing elevated (more than 1g/kg) concentrations of Co and Ni (Table 1), small round slag inclusions and cracks resulting from corrosion and deformation (Fig. 4). The composition of the round, elongated slag inclusions is similar to wüstite-FeO (Table 2). Iron reduced in the direct smelting process never contains such pure compounds and only FeO inclusions. In modern steels FeO occurs in low carbon alloys and Armco-iron (Schumann 1991, 474). After etching, the cross-section shows a heavily deformed ferritic microstructure from cold working (Fig. 6). The cracks have the same orientation as the deformation. The average hardness of the metal is HV1 195.

Fig. 4: Micrograph of metal sample from Fig. 3 (inverted picture, detail), unetched, bright field. In white the metal with round slag inclusions as well as cracks filled with corrosion products,

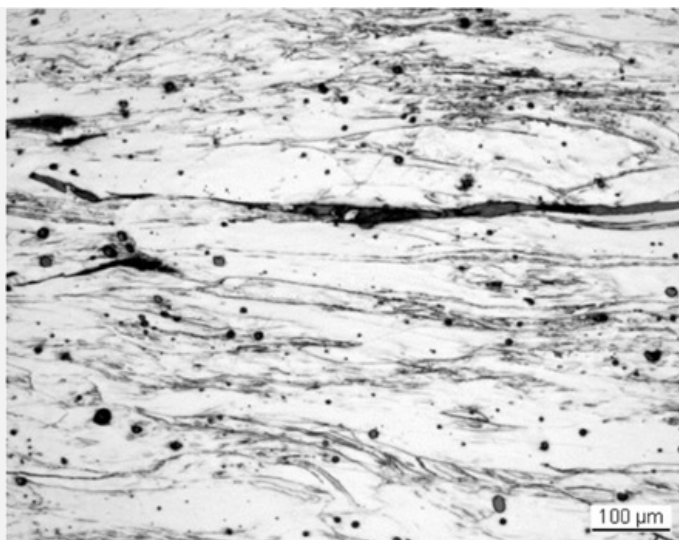
Fig. 5: Micrograph of metal sample from Fig. 3 (detail), etched, bright field. The heavily cold worked metal shows elongated grains with nearly invisible grain boundaries and cracks parallel to the grains,

Microstructure	Heavily deformed ferritic microstructure
First metal element	Fe
Other metal elements	Co, Ni

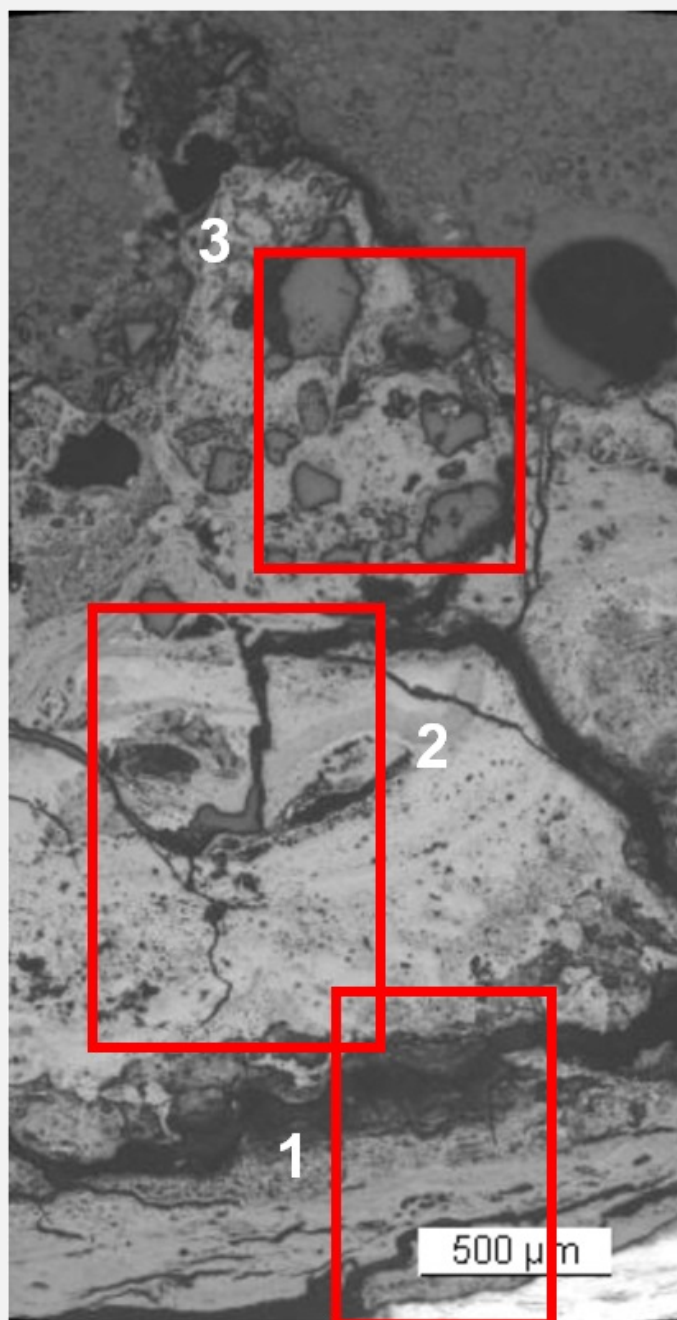
Fig. 6: Micrograph of the corrosion layer from Fig. 3 showing the metal - corrosion crust interface (detail, rotated by 45°) and corresponding to the stratigraphy of Fig. 9, unetched, bright field. The areas 1 (for CP3), 2 (for CP2) and 3 (for CP3) selected for elemental chemical distribution (Fig. 8) are marked by red rectangles,

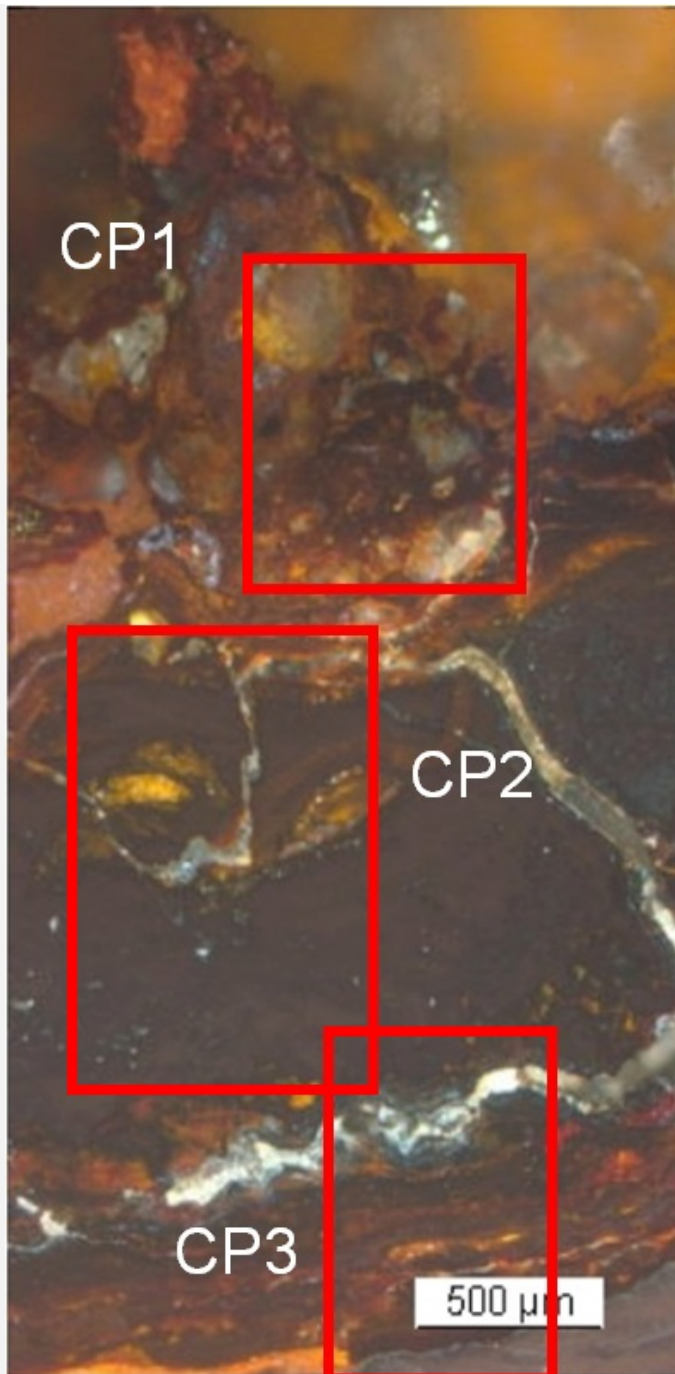
Fig. 7: Micrograph (same as Fig.6) and corresponding to the stratigraphy of Fig. 9, polarised light. The inner layer (CP3) is red-brown, area 2 is brown-violet (CP2) and the outer brown area contains rock fragment inclusions (CP1),

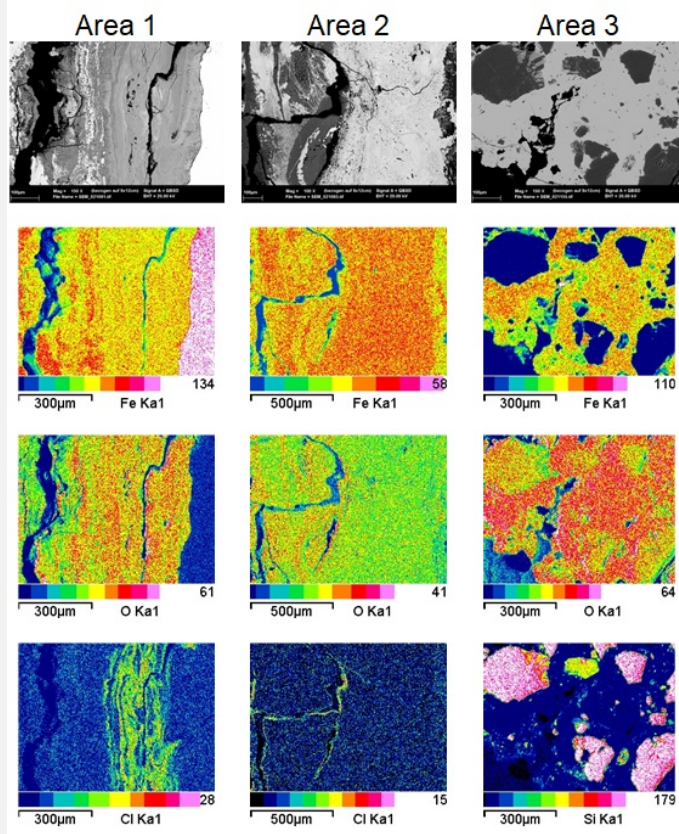
Fig. 8: SEM images, BSE-mode, and elemental chemical distribution of the selected areas from Figs. 6 and 7 (reversed picture rotated by 270°, details). First column: mapping on area 1 (CP3) where an inner layer enriched in Cl appears near the metal surface. 2nd column: area 2 (CP2) where iron oxides prevail. 3rd column: area 3 (CP1) where the outer O-rich layer includes rock fragments rich in Si. Method of examination: SEM/EDS, Lab. Anal. Chem. Empa,

This iron-based sheet is entirely cold worked and hard compared to an annealed metal. The corrosion is massive and masks the shape of the object. The presence of Cl adjacent to the metal surface indicates that the corrosion front is potentially active. The very thick top corrosion layers may have slowed down the corrosion. The object was mentioned as being Roman in Senn Bischofberger 2005, however the chemical composition of the slag inclusions shows that it is a product of the 20th century AD which has been accidentally introduced into a Roman layer.

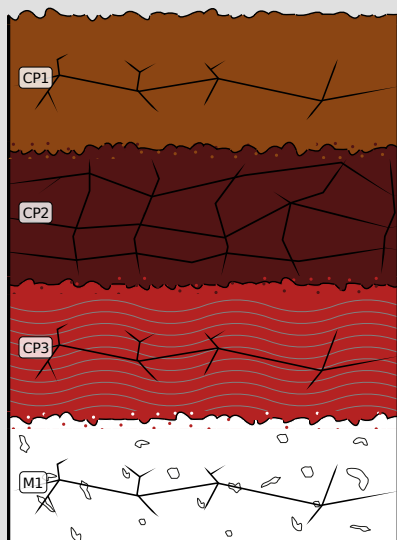
Fig. 9: Stratigraphic representation of the iron-based sheet in cross-section (dark field) using the MiCorr application. The characteristics of the strata are only accessible by clicking on the drawing that redirects you to the search tool by stratigraphy representation. This representation can be compared to Figs. 7, Credit HE-Arc CR.
